Zagreb earthquake of 22 March 2020 – preliminary report on seismologic aspects and damage to buildings

Research Paper

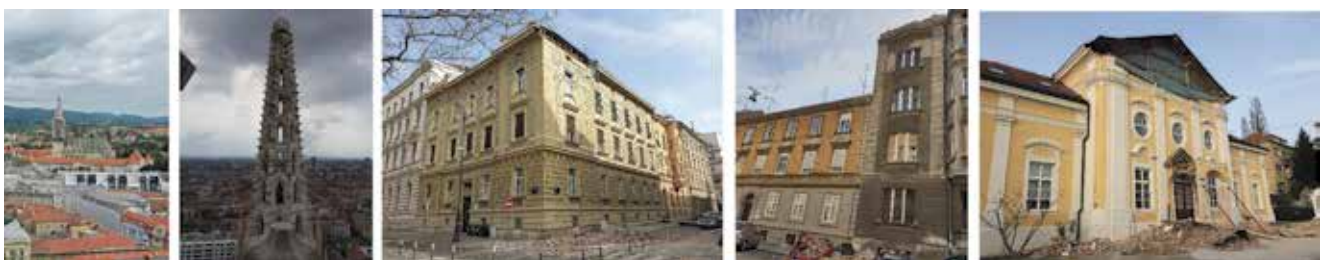
Figure 1. Earthquake effects in historic centre of the city (photos courtesy of: AIR-RMLD d.o.o. www.air-rmld.com, Filip Foretić, Karlo Jandrić)

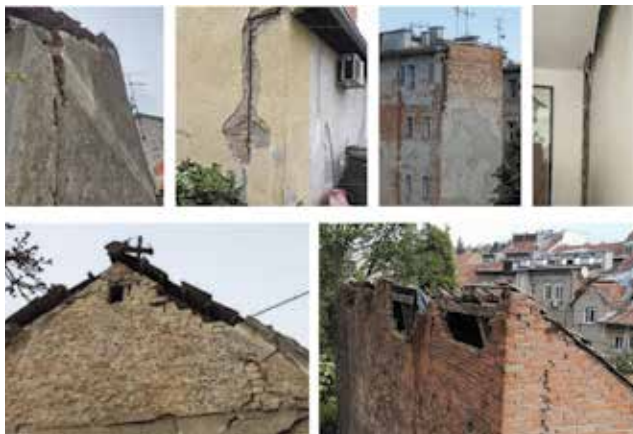
In addition to local collapse of attic gable walls, in more difficult cases the damage involved detachment of gable walls along the entire height or through several floors (Figure 19). The reason is poor connection with walls from the other direction.

Figure 19. Detachment of gable wall and typical cracks in internal part of the building (photos courtesy of Mario Todorčić and [39])

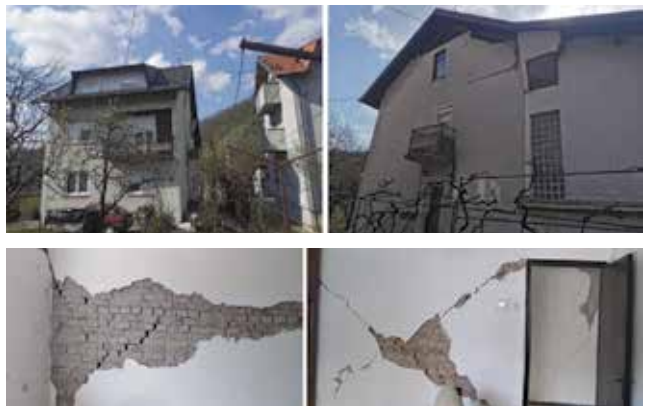
Figures 28 and 29 show frequent damage to houses near the epicentral area. As already pointed out, these are mostly masonry houses without tie beams, but various mixed systems were also encountered because old single storey houses were often subsequently raised by adding a floor.

Figure 29. Damage to houses at LB Dankovec, CD Gornja Dubrava (photo courtesy of Luka Božić and [39])
