Analysis of Tram Traffic-Induced Vibration Influence on Earthquake Damaged Buildings

Haladin, Ivo; Bogut, Marijan; Lakušić, Stjepan

Source / Izvornik: **Buildings, 2021, 11**

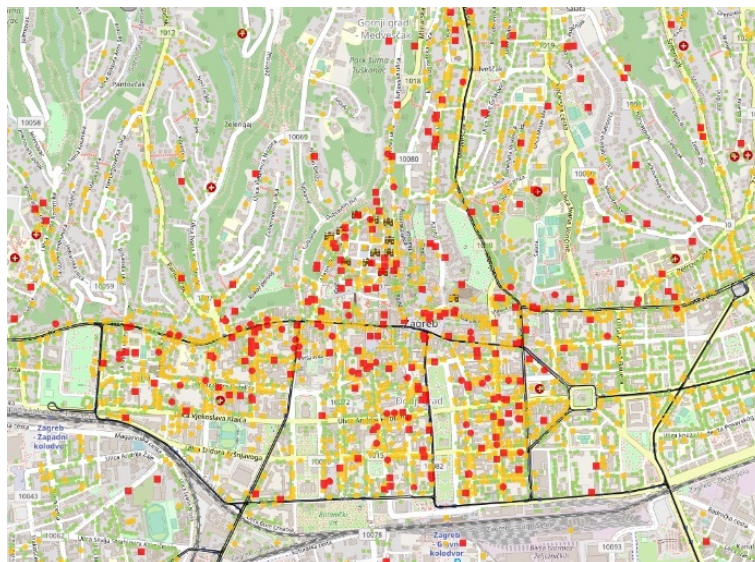
Figure 1. Tram network (black line) and earthquake damage to buildings based on initial inspection (yellow squares—temporarily unusable, red squares—permanently unusable).

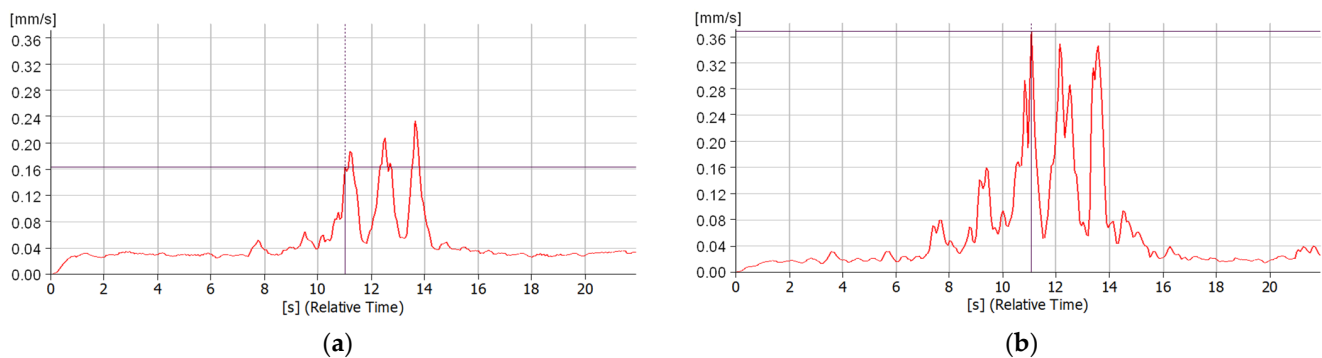
Second pass-by of the reference tram, Figure 11, induced maximum vibrations in terms of PPV when compared to any other observed pass of all trams, and it was therefore used to evaluate the level of long-term vibration exposure. Table 1 gives an overview of available thresholds for assessing the impact of vibrations on structures. According to a standard currently in place in Croatia [19], the long-term vibration exposure of sensitive structures should not exceed 2.5 mm/s of PPV calculated according to Equation (2). The maximum level was recorded in Z direction $-v_{z, \max} = 0.68$ mm/s, well below the allowable limit. If the Swiss standard [18] is considered, PPV calculated according to Equation (1) is 0.724 mm/s, which is also below the recommended value of 1.5 mm/s for vibration-sensitive buildings exposed to long-term vibrations. Therefore, damage occurrence due to tram vibrations has a very low probability.

Figure 11. Vertical (Z) vibration velocity trends at (a) M8 and (b) M10 for the second pass-by of the reference tram.

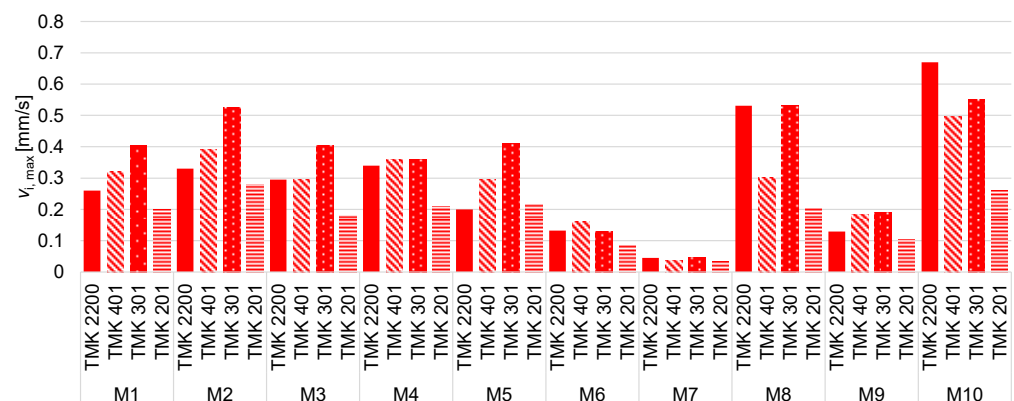
Figure 12. Peak vibration velocities in Z direction according to tram type.

By comparing four pass-bys, the highest vibration amplitudes can be observed in the vertical (Z) direction. Additionally, for all pass-bys, maximum levels were measured at location M10. For each of the tram types, vibrations at M8 are similar in amplitude for all directions. As to the south-central axis (M1–M5), the highest vibrations were induced by TMK 301 tram. Overall maximum vibration levels were induced by TMK 2200 at M10.
