Evaluation of tramway overhead line system in city of Osijek

Ivo Haladin^{1*}, Stjepan Lakušić¹, and Ivan Duvnjak²

Abstract. Overhead line system is a vital element of any electrified railway infrastructure. Its performance reflects to all vital parameters such as traction, reliability, availability and safety of railway infrastructure. Operator GPP Osijek runs a 27.5 km long tramway network which plays a key role in transit system of the city of Osijek, Croatia. In 2016 GPP Osijek applied to a tender for acquisition of new rolling stock with 85% EU investment. Mayor requirement prior to rolling stock acquisition was to document, analyse and upgrade current infrastructure (including track structure, electric substations and catenary) to an optimal level. Task of measurement and evaluation of tram track structure and catenary has been appointed to University of Zagreb Faculty of Civil Engineering. Overhead line analysis comprised from several measuring procedures, including supporting columns evaluation, catenary stagger, height, shocks and wear. Such extensive analysis included GPS positioning and on-site evaluation of 1214 supporting columns of overhead line, as well as overhead

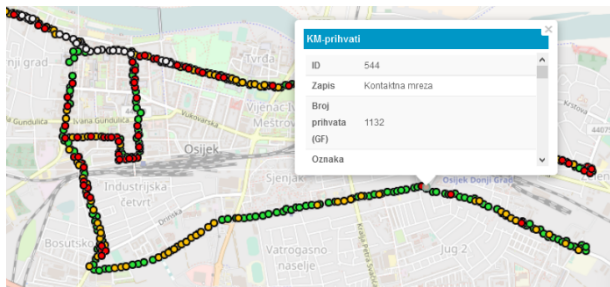
Fig. 1. Acquired GIS dataset of 1214 analysed supports.

According to analysis, 20 % of columns were characterized as substantially damaged (bent out of vertical axis, corrosion damage, shrapnel damage etc.), as presented in Figure 2; 32 % endangered (minor corrosion or dents); 48 % in good state (not bent, no corrosion or dents).

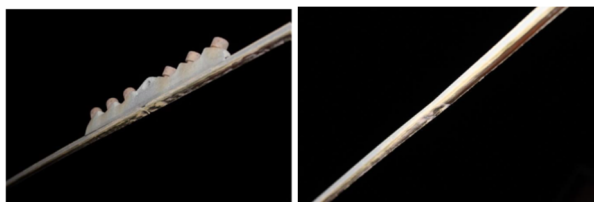
Fig. 10. Inspection of wire joints and potential weak spots.

Such inspection, together with historic data of GPP Osijek maintenance division, revealed 79 joints due to wire breakage, 46 substantially worn spots and other potentially critical points, Figure 10.
