Case-study of the out-of-plane wall failure of a typical downtown building in Zagreb

Source / Izvornik: **1st Croatian Conference on Earthquake Engineering 1CroCEE, 2021, 1557 - 1567**

Matea Sruk¹, Marija Demšić², Maja Baniček³

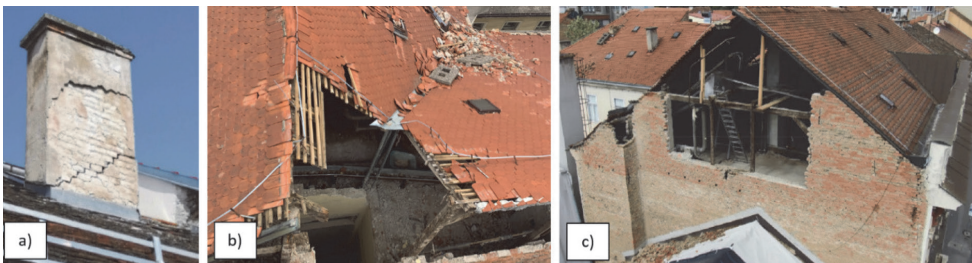
The earthquake that hit Zagreb, the capital city of Croatia, on March 22, 2020 at 6:24 local time was magnitude 5.5, according to Richter. The epicenter was located 7 km north of the Zagreb historic centre. The earthquake, although of moderate magnitude, caused great material damage, especially to the buildings in the historic core of the city. The building fund of the City of Zagreb includes a large number of traditional unreinforced masonry buildings. This kind of buildings are most often consisting of interconnected load-bearing masonry walls and flexible horizontal structures with wooden beam elements. The damage to this type of structures during earthquakes most often occurs due to uneven distribution of seismic forces due to flexible floor structures, inappropriate or non-existent interconnections of elements, and poor contact with the roof and floor structure [1]. Postearthquake survey of buildings in Zagreb showed that the most common damage to this kind of masonry buildings in the city center is associated with local damage to the roof (Figure 1.b.), collapse of attic chimneys (Figure 1.a), and partial or complete collapse of gable attic walls (Figure 1.c) [2].

Figure 1. a) Collapse of chimneys; b) roof damage; c) collapse of attic gable wall [2]
