Case-study of the out-of-plane wall failure of a typical downtown building in Zagreb

1st Croatian Conference on Earthquake Engineering 1CroCEE 22-24 March 2021 Zagreb, Croatia

Matea Sruk¹, Marija Demšić², Maja Baniček³

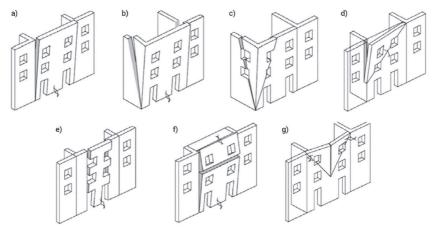
Figure 2. Out-of-plane failure patterns [2]

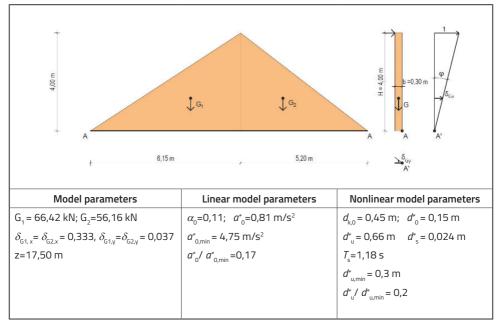
Table 2. Mechanism 2 – gable wall of 3rd floor including attic

For mechanism 1, only 17 % of the linear model demand and 20 % of the nonlinear model demand is fulfilled. This wall, however, only partially collapsed in the earthquake in March 2020. The model used in the analysis assumes complete separation of the wall from the rest of the structure, but it can be seen from the photographs on Figure 5. a) and b) that in the thirds of the length the wall was thickened with an additional layer of bricks, that certainly helped to prevent complete separation. It should be noted that cracks exist in these parts of wall that are visible from the outside (Figure 5.b). We also emphasize here that the main direction of the earthquake that happened, was approximately parallel to the gable wall plane, which certainly influenced the maximum value of the acceleration that affected this wall. The same wall was analysed in mechanism 2 were it includes the part of the wall on the storey below the attic. In the linear model, there is the fulfilment of 12 % of the demand, while the displacement capacity demand is fulfilled with 47 %. For this wall the connections with perpendicular walls is not completely impaired, so there are some reserves in terms of friction force that is present at the junction of the walls that was not considered in the analysis. The results of street facade wall considered in mechanism 3 showed that the wall should have been most likely activated during earthquake since linear model had fulfilment of 30 %. However, in the nonlinear model, the model had almost complete fulfilment of the demand that was 98 %. This wall, unlike the gable wall, was exposed to a greater acceleration values when considering the main direction of the earthquake. The façade wall on the courtyard side, mechanism 4, have satisfied requirement of the linear model so it was concluded that it was not activated in earthquake, therefore, the nonlinear model was not considered.

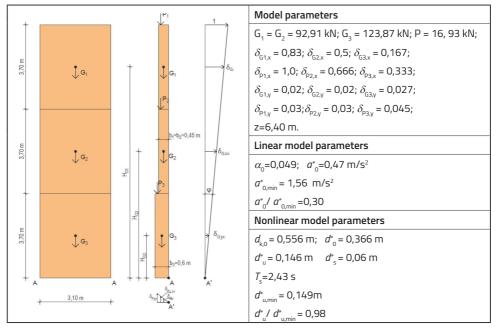
Table 4. Mechanism 4 - façade wall on courtyard side
