# Post-earthquake assessment and documentation of timber roofs

## POST-EARTHQUAKE ASSESSMENT AND DOCUMENTATION OF TIMBER ROOFS

Mislav Stepinac<sup>1</sup>, David Andić<sup>2</sup>, Juraj Pojatina<sup>3</sup>

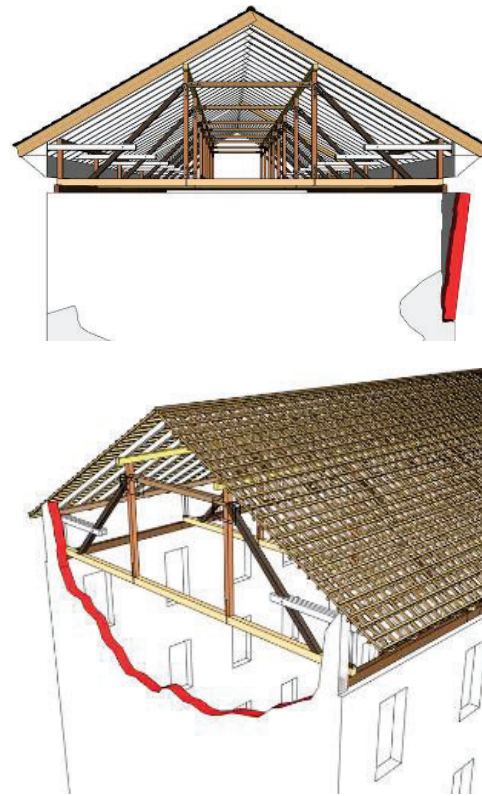
The failure of non-structural elements such as chimneys and decorative elements on facades was observed on almost all buildings in the city center. Failure of gable walls, masonry columns, wall sections between or under windows, vaults, ceilings, staircases, etc. was common. Since the two materials (timber and masonry) have very different properties and masses, the post-earthquake damage was also very different. The two most typical masonry damages, due to the "pushing" of timber elements and the poor connection with masonry walls, are shown in Figures 3 & 4.

Figure 3: Typical damages to masonry walls

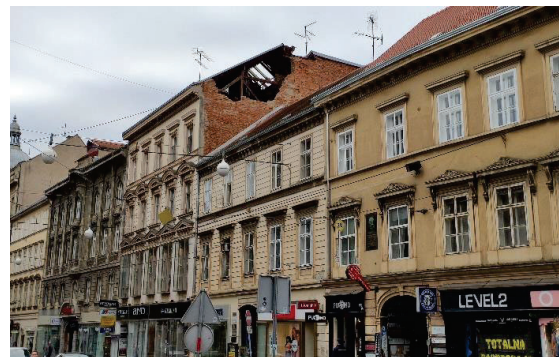
Figure 4: Failure of gable walls (photo credit: M. Stepinac)

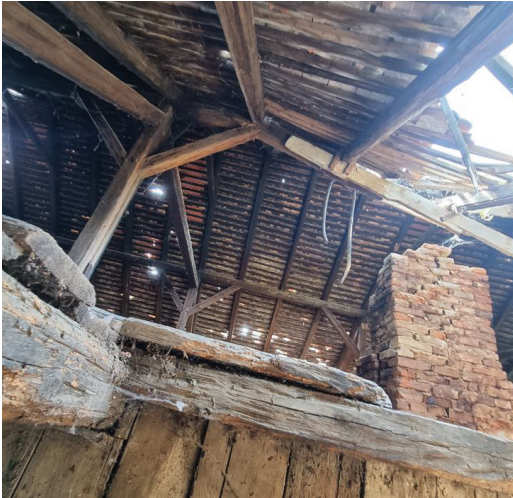
Roof systems often become unstable due to the collapse of individual load-bearing walls beneath them or severe chimney failures (Figure 5 & 6). Post-earthquake inspections showed that many of the chimney failures resulted in direct damage to the roofs. In some locations, the chimneys damaged the supporting roof structure, but in most cases only the rafters broke and the integrity of the roof was maintained (Figures 7 and 8).

**Figure 5:** Failure of timber elements due to chimney failure (photo credit: R. Gulić)

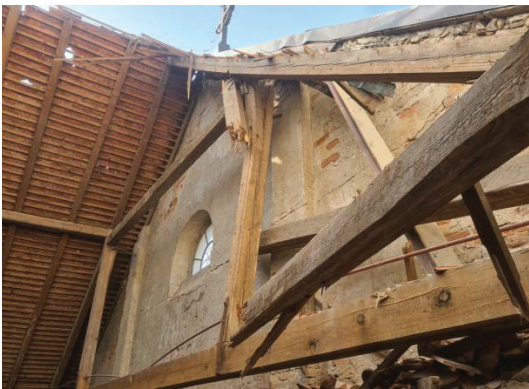
**Figure 6:** Timber roof collapse – Sisak cathedral (photo credit: Studio Arhing d.o.o.)

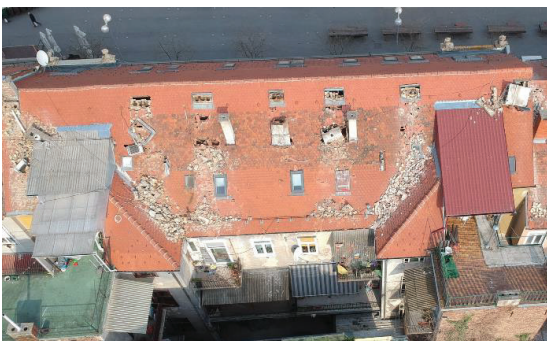
**Figure 7:** Failure of chimneys (from outside) (photo credit: M. Stepinac)

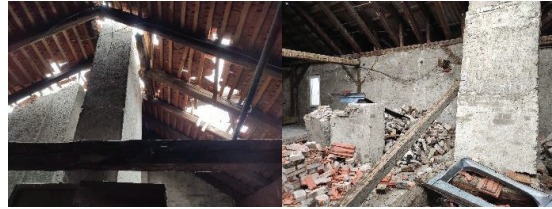
**Figure 8:** Failure of chimneys (from inside) (photo credit: M. Stepinac)

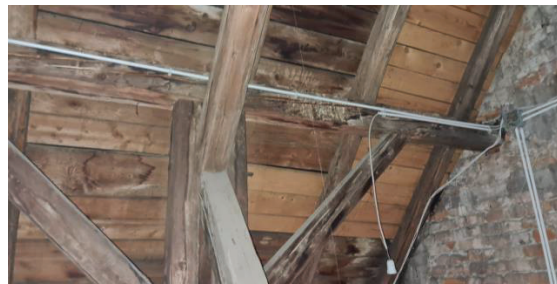
Maintenance was identified as one of the most important aspects that contributed to the condition of buildings after the earthquake. Since a large number of buildings were poorly maintained or not maintained at all, the properties of the masonry deteriorated over the years, and the seismic performance of such buildings was worse [5]. In many cases, water penetration degraded the properties of both masonry and wood elements (Figure 9).

**Figure 9:** Failure of timber elements due to water leakage and seismic excitations (photo credit: Studio Arhing d.o.o.)

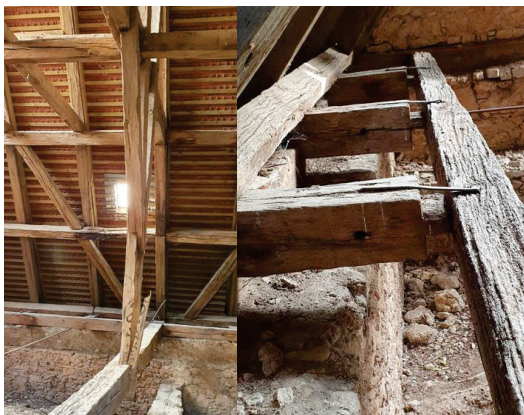
Timber beams on wall parapets along with attic ceiling wooden beams were severely deteriorated due to aforementioned lack of maintenance and due to original defects at the time of construction. The inadequate connections and bad detailing is common and one example is shown in Figure 10. As carpentry joint were used for connections, often, “secondary constructive” screws were missing. Although carpentry joints are considered good in terms of characteristic load combinations, when it comes to dynamic loading with cyclic nature, like earthquake, poor behavior was observed in several cases.

**Figure 10:** Bad detailing (photo credit: Studio Arhing d.o.o.)

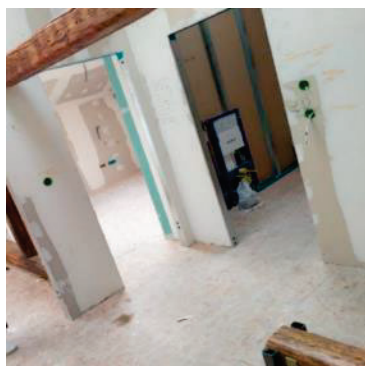
Typical conversions of building spaces convert non-living spaces (e.g., basements, attics, or utility rooms). This room conversion often involved demolition of partition walls, and undesirable intervention in the load-bearing walls is also common. The conversion of the attic for living purposes resulted in numerous changes to the roof structure. Often timber tie elements were cut to insert the door (Figure 11), which significantly changed the basic static system of the roof structure itself. Also, traditional timber structural systems were replaced by masonry or concrete elements as shown in Figure 12.

**Figure 11:** Improper attic modifications (photo credit: HCPI [4])

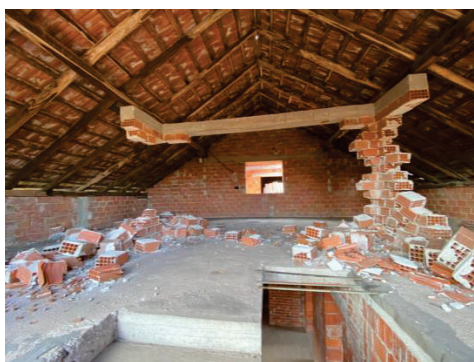
**Figure 12:** Improper attic modifications (photo credit: HCPI [4])

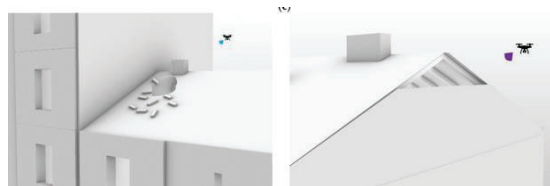
**Figure 13:** Possible damage on the roof level of a building after an earthquake [16]
