# Post-Earthquake Rapid Damage Assessment of Road Bridges in Glina County

Source / Izvornik: **Buildings, 2022, 12(1)**

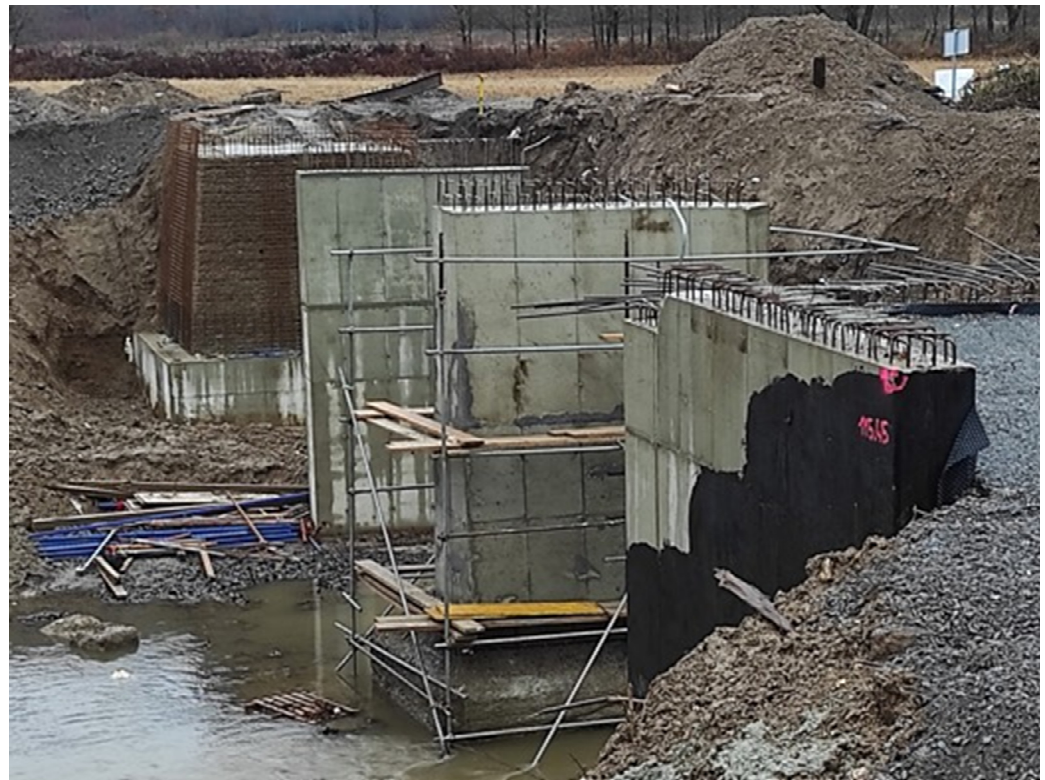
**Figure 16.** Progress of rehabilitation work of Matija Gubec street bridge.

Following the detailed evaluation and assessment of the previously strengthened bridge, it was concluded that extensive rehabilitation work was needed. The bridge stone wall abutment was deemed unsalvageable and to be replaced with new reinforced concrete abutment. The new reinforced concrete abutment will have a deeper and wider foundations, with the stone and shotcrete cladding of the embankment slope and river bank to prevent scour. One of the columns that showed scour signs and had an insufficient foundation-bearing capacity is also to be replaced. The new reinforced concrete column will have an  $80 \times 400$  cm cross-section and a  $300 \times 550$  cm, 100 cm thick foundation slab. This foundation will also be protected by stone and shotcrete cladding. One column and east abutment are to be salvaged and jacketed with a new 10 cm thick layer of reinforced concrete. Since the superstructure was heavily degraded, with progressive structural steel and reinforcement corrosion, missing parts of the footways, and low remaining load-bearing capacity, it was decided that it also needs to be replaced. The new 50 cm thick reinforced concrete slab superstructure will also be wider (600 cm), accommodating more traffic width for vehicles and pedestrians. The superstructure and substructure elements will be integrally connected without any bearings to achieve better durability. The bridge will be equipped with waterproofing and closed drainage system. Figure 16 shows the current progress of this rehabilitation.
