The Assessment and Retrofitting of Cultural Heritage—A Case Study of a Residential Building in Glina

Karlo Ožić¹, Ivan Markić², Antonela Moretić^{1,*} and Luka Lulić¹

Abstract: The focus of the study is on the renovation of a specific case study, which is a 19th century building under cultural heritage protection. It highlights the particular challenges faced by civil engineers in the structural renovation of buildings that are under heritage protection. Preserving the identity of these buildings limits the available methods for strengthening their seismic capacity. At the beginning, information about the seismic activity and the different post-earthquake evaluation procedures are presented to identify the damage and take appropriate further steps. Then, basic information about the building is given and supported by graphic attachments. In the following, the methods and materials are explained, focusing on in situ testing with the semi-destructive flat-jack method and the analysis of the structure with the nonlinear method implemented in the software. Subsequently, the obtained results are presented and discussed, accompanied by graphics. An approach for strengthening the structu

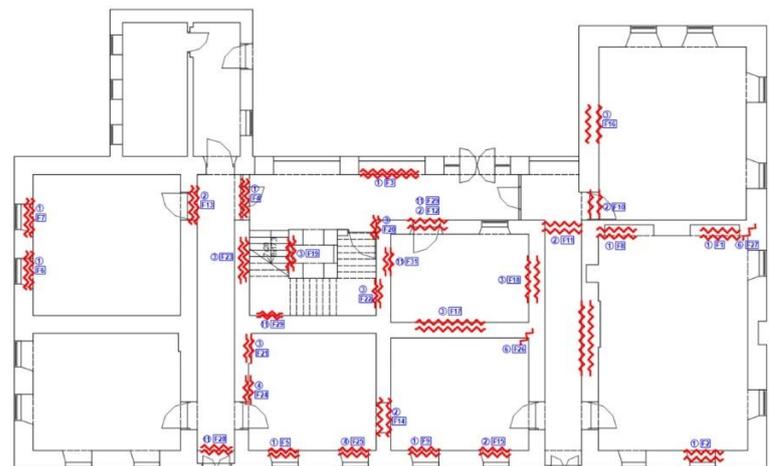
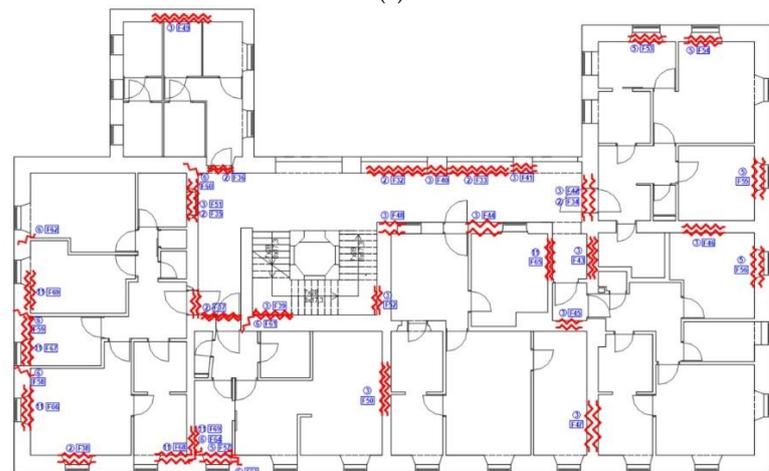
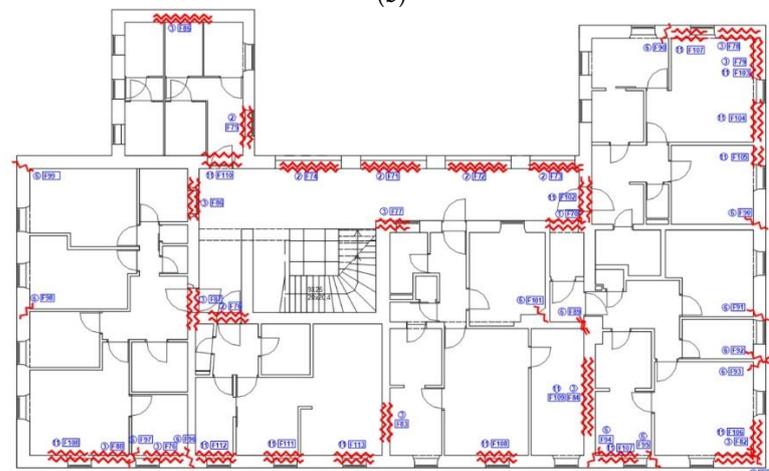
After a rapid inspection, a detailed inspection of the building was carried out in May 2022. All instances of damage, structural and non-structural (Figure 7), were photographed and described in reports on the floors of the building and the individual rooms in which they are located, and proposed measures for their repair were given. A detailed recording of the existing condition was also made for the purpose of creating digital floor plans of the building.

Figure 7. Damage patterns (red marks): (a) ground floor, (b) first floor, and (c) second floor.

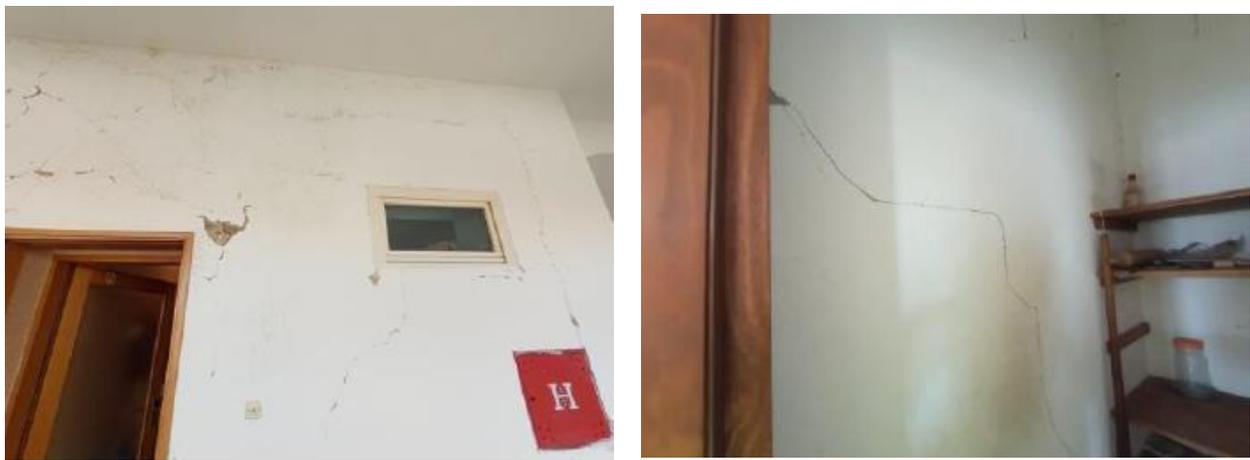
Detailed inspections of the residential building (former gymnasium building) revealed the following recorded instances of damage: on the ground floor, there is visible damage in the form of cracks in the wall coverings (Figure 8), arches, vaults and ceilings, as well as separation and localized falling off of the plaster. Minor local damage to structural elements (walls, columns, and arches) is also visible. Damage is visible on all floors in the form of cracks and falling plaster on the walls. Minor local damage to the walls is also visible, and there are locally visible cracks at the junctions of load-bearing walls and ceilings (Figure 9). At the edges of the building, oblique cracks are visible on the load-bearing walls, and can also be seen on the facade of the building. In addition to the previously documented damage to the construction elements of the building, damage to other elements was observed. The partition walls are mostly damaged. Other instances of damage include the chipping of plaster on structural and non-structural elements, damage to the finishing coverings on the walls and floors, and the collapse of part of the cornice and other decorative elements (Figure 10). The roof was damaged in several places, and the roof covering near the chimneys collapsed (Figure 11).

Figure 8. Cracks on the load-bearing walls on the first floor.

Based on the detailed assessment, the entirety of the building necessitates rehabilitation and retrofitting measures. Subsequently, it is imperative to conduct a comprehensive examination encompassing both static and dynamic analyses of the existing structural conditions. Before that, it is necessary to carry out investigative work to determine the characteristics of the walls and other necessary data for the analysis of the structure.

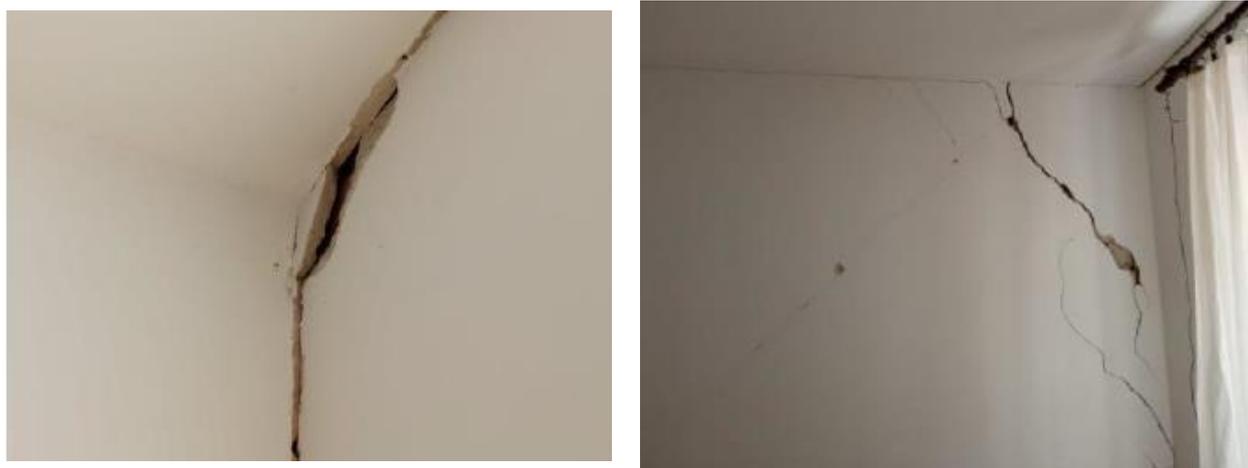
Figure 9. Cracks at the junctions of load-bearing walls.

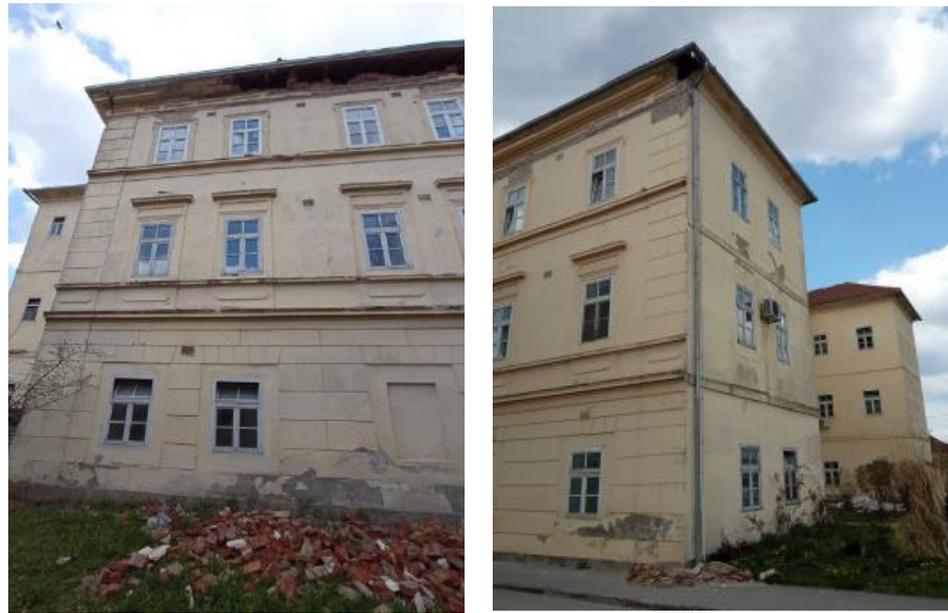
Figure 10. Damage to the facade.

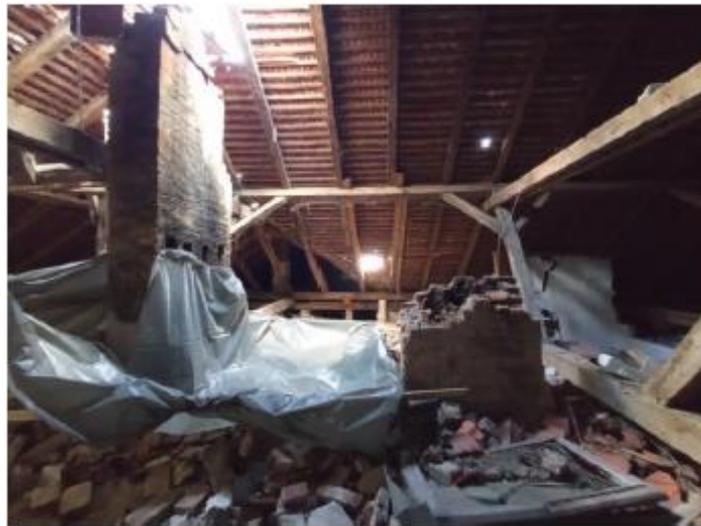
Figure 11. Collapsed chimney and damaged roof covering.

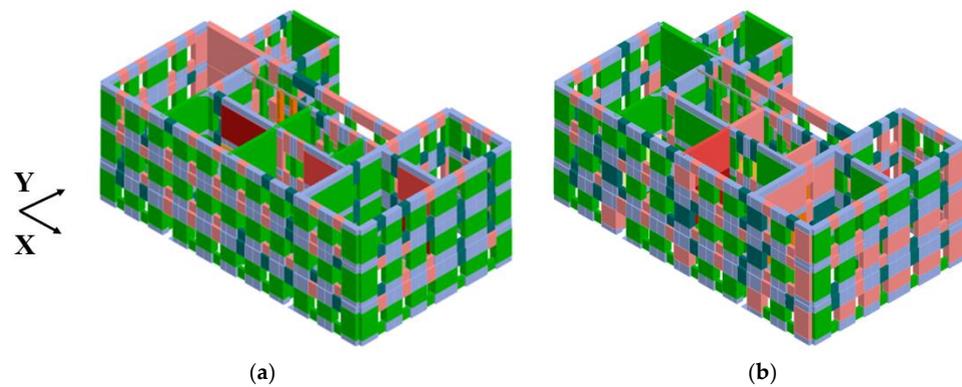
A visualization of the damage from the critical analyses is displayed in Figure 16. The images highlight the critical parts of the structure, which correspond to the actual damage scenarios (damaged spandrels and load-bearing walls in the longitudinal and transversal direction of the central part). Figure 17 displays the capacity curves in the X and Y direction, which are derived from the pushover curves with the lowest risk indices. The radial lines defined by the slope of the first part of the capacity curve represent the elastic structural period T^* . The intersecting point of the period and the seismic demand is the elastic displacement of the SDoF. It is visible that the seismic capacity is equal in both directions. Still, the seismic demand is lower for the Y direction than the X direction. The latter justifies the higher risk indices in the Y direction, which are shown in Table 6. Accordingly, the structure does not satisfy the seismic requirements.

Figure 16. Damage visualization for the most critical analysis in the (a) X direction and (b) Y direction.

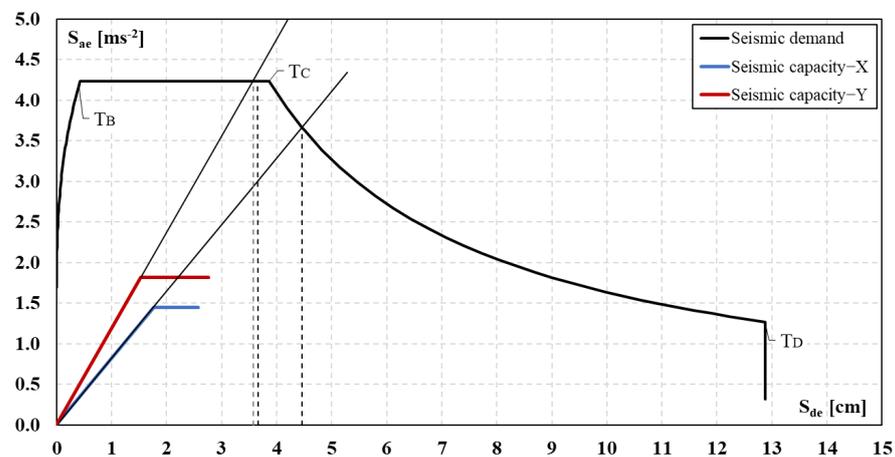
Figure 17. Seismic demand and capacity of the existing structure.
