Seismic Retrofitting of Dual Structural Systems-A Case Study of an Educational Building in Croatia

Seismic Retrofitting of Dual Structural Systems—A Case Study of an Educational Building in Croatia

The building of the higher education institution in Petrinja, Croatia, was built in 1963 and underwent energy renovation in 2018. The building consists of the ground, 1st, and 2nd floors; the area on the ground floor is 1294.3 m² and on the upper floors 603.4 m². The total gross floor area of the building is 2501.1 m², while the useful heated area of the building is approximately 2130 m². The building has an irregular T-shaped layout and consists of three volumes connected into one whole (Figure 3). In the northwest–southeast direction (hereafter X-dir), there are two volumes that have only the ground floor. The volume marked as V1 is 3.84 m high, while the volume V2 in the southeastern part of the building is 5.52 m high and consists of a one large hall. The central volume V3 of the building is arranged in a northeast–southwest direction (hereafter Y-dir) and has three stories with a total height of 11.52 m.

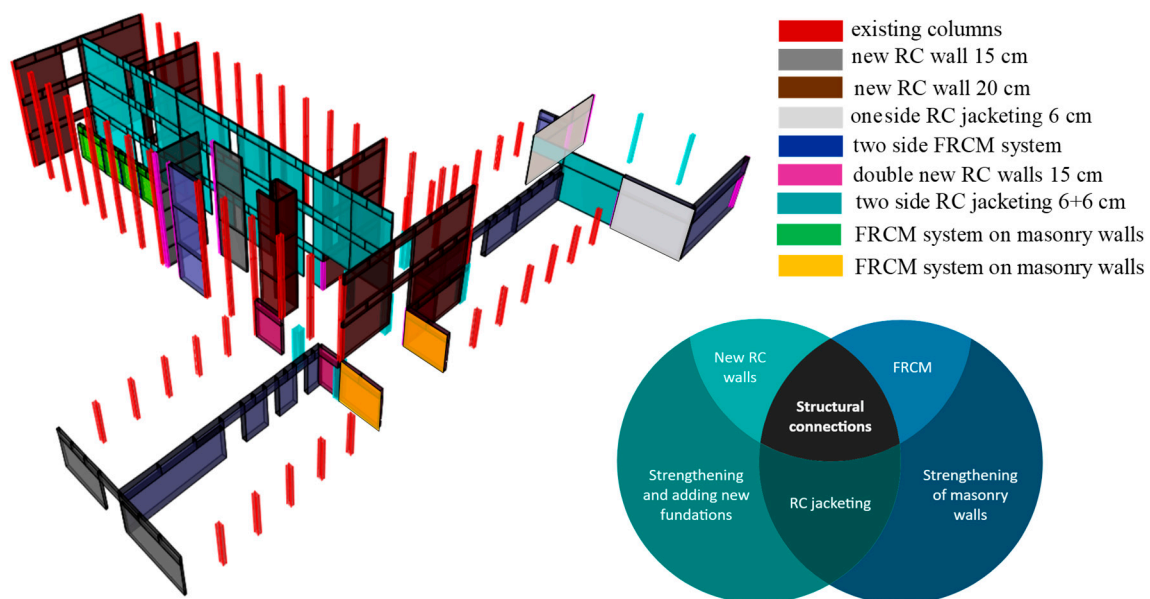
Figure 22. Scheme of strengthening for vertical elements.

The proposed structural strengthening measures are shown in Figure 22. The most significant retrofitting intervention concerns the addition of new RC walls. Along the staircase masonry walls, new RC walls with a thickness of 15 cm are added. On the ground floor, RC walls with a thickness of 15 cm are added next to each brick wall face. In fact, this axis is significantly strengthened because it is a position of eccentricity of the columns on the floor above. Next, new 20 cm thick RC walls are added over the entire height in the building volume V3. These include perimeter walls next to the existing brick walls and walls inside the structure at the positions of the partition walls. In addition to providing additional functionality to the building, it is planned to install a new elevator RC core inside the building. To further connect these walls to the RC slab, new RC beams must be added as the new opening will weaken it. Other retrofit measures include the RC-jacketing of the columns and beams in the ground floor entrance hall and the RC-jacketing of the central masonry wall along the entire height of volume V3, and to the masonry walls of the large hall (volume V2). In order to avoid the formation of other weak elements, FRCM overlay is provided for other masonry walls that were not found to be critical in the analysis of the seismic performance of existing structure.

It is important to emphasize that the connections with the existing structural elements must be ensured and the continuation of longitudinal rebars through the existing RC slab

for all new shear walls and an RC-jacketing system. In addition, an adequate foundation must be ensured for new shear walls as well as for the RC-jacketing of vertical elements (columns and masonry walls).
