# Seismic Retrofitting of Dual Structural Systems—A Case Study of an Educational Building in Croatia

**Abstract:** On 29 December 2020, a devastating Mw6.4 earthquake struck near the town of Petrinja, Croatia. The main earthquake was preceded by a Mw4.9 foreshock the day before. The earthquakes caused extensive damage to buildings, especially historic buildings made of unreinforced masonry but also to buildings of other typologies and to critical infrastructure. Today, recovery efforts in Croatia focus primarily on reconstruction and seismic retrofitting. Family homes and public, cultural, educational, and other facilities are top priorities. In this paper, a comprehensive study of existing building in the educational sector is presented as a case study. The seismic performance of the building is evaluated using numerical methods, first for the as-built condition and then for the retrofitted building. For each condition, the collapse mechanisms of the building were determined and critical structural elements were identified. The presented retrofit strategy of the dual structural system consisting of RC frame system and masonry walls aims to reduce the displacements of the RC frame

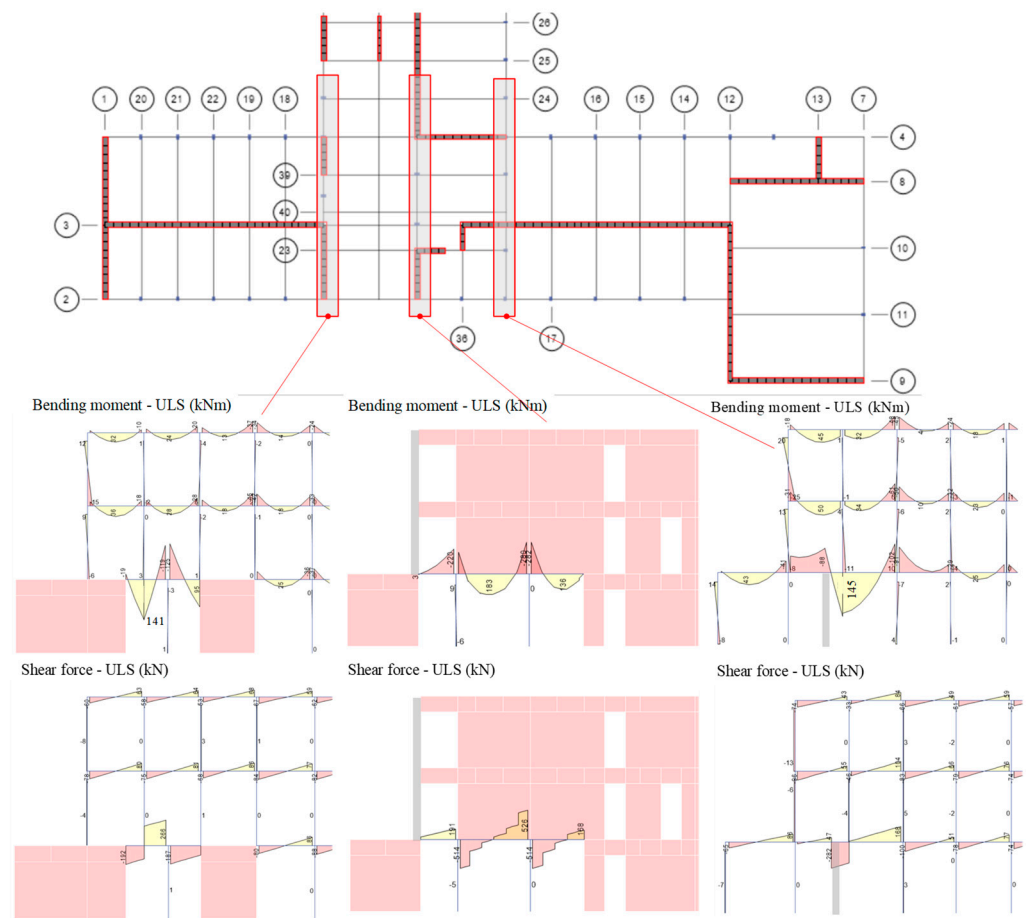
In addition, it was found that the existing reinforcement mostly meets the requirements for permanent vertical action. However, there were three critical positions in structural system that need to be strengthened. These are the beams on the ground floor in the axis marked in Figure 12. They are all located in the entrance area of the building. Their exceeding load capacity is the result of the displaced position of the columns as well as the existence of masonry walls in the upper floors, which has interrupted the flow of forces in the structure. It is mainly a matter of lack of transverse reinforcement, but in some places the longitudinal reinforcement is also lacking.

Figure 12. Weak positions in the structure due to vertical loads.

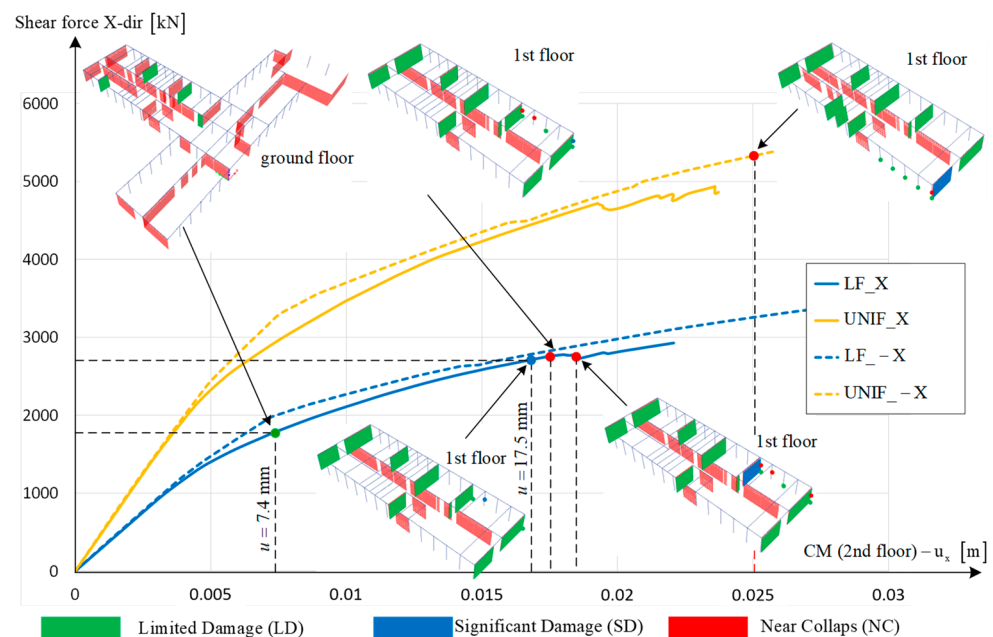
The most significant pushover curves for the action of the lateral force in the X-dir are shown in Figure 15. It can be seen that some elements of the structure come to a state of limited damage, which is reflected on the curve as a decrease in stiffness, i.e., the slope at a force of 1800 kN (base shear coefficient, B.S. = 5.6%) and a displacement of 7.4 mm. Then there is the initial opening of cracks and a reduction in the stiffness of individual elements. The diagram shows elements on the ground floor where cracks appear, even though they are present on all floors. The beginning of the failure of the structural elements occurs at a force of 2900 kN (B.S. = 9.1%) and at a displacement of 17.5 mm. The columns on the 1st floor reach the SD limit state due to exceeding the shear capacity. Since such damage of the columns is non-ductile, exceeding their ultimate capacity means that they soon reach the NC limit state.

**Figure 15.** Pushover curves in X-dir for as-built structure.

The next important point is the failure of these columns at a lateral force of 2900 kN and for a displacement of 18 mm. The masonry wall on the 1st floor next to the critical columns is also in a SD limit state, but it still has not utilized total load-bearing capacity. At this point, it can be said that the bearing capacity of part of the building is reached and that a local failure of the building is possible. As a result, the local failure of the floors may occur. It can already be said that the building is in a NC limit state, and it can be classified as having the highest degree of damage. However, even in the case of local failure, it is unlikely that the rest of the structure will collapse at this level of loading. The walls and

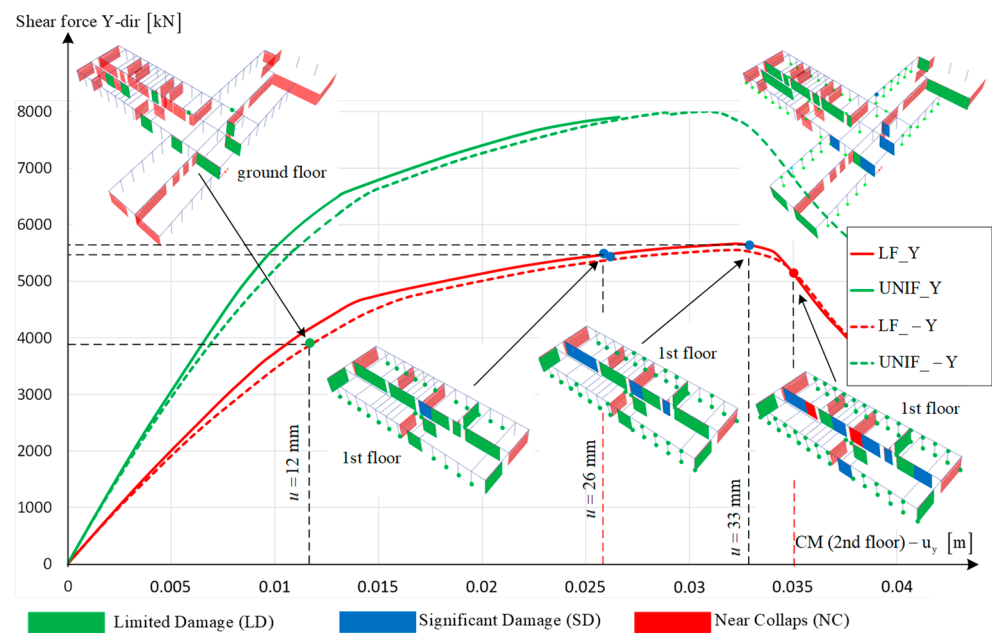
Figure 16 shows the most significant pushover curves for the action of the lateral force in the positive Y-dir with markings of the points, indicating the state of structural damage. At a force of 3900 kN (B.S. = 12.1%) and a displacement of 12 mm, limited damage occurs on several elements. Significant damage in the structural system occurs at a force value of 5500 kN (B.S. = 17%) and a displacement of 26 mm. The critical elements that first reach the SD limit state are the masonry walls in the central axis on the 1st floor. Subsequently, other walls in the same axis reach the SD limit state. Eventually, the failure of several walls occurs, and the bearing capacity of the structure decreases significantly with a maximum displacement of about 33 mm. The walls on the ground floor and the 2nd floor have not been shown to be critical to the action in the Y-dir.

Figure 16. Pushover curves in Y-dir for as-built structure.

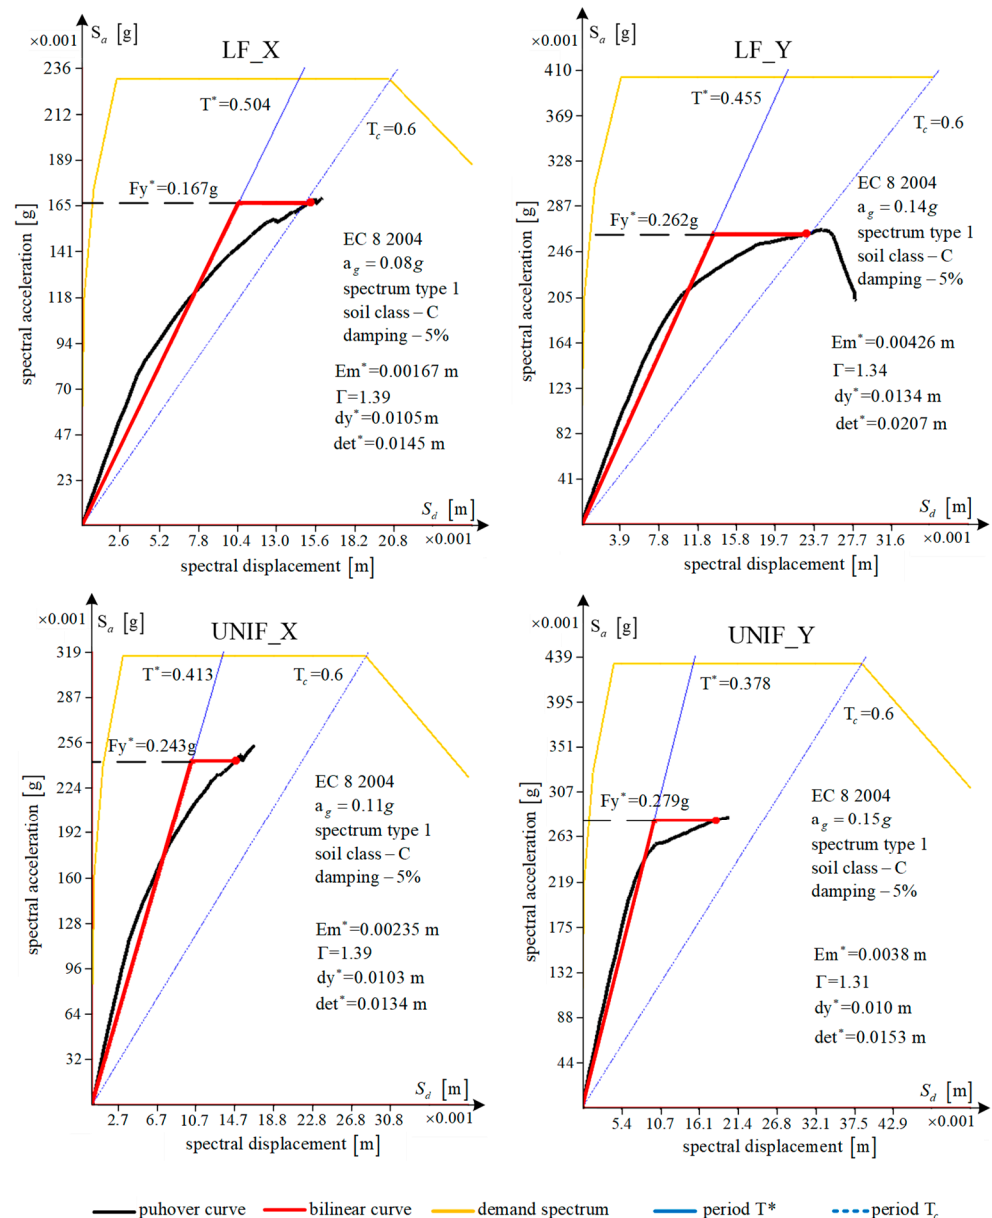
Bearing capacity and building deformation requirement by reducing the system to an equivalent system with one-degree-of-freedom (1DOF) was also determined. The procedure is carried out according to the N2 method [40,41]. The Figure 18 shows the relevant idealized capacity curves correspond to ground acceleration on the bedrock of 0.08g for X-dir and LF load pattern, while for the UNIF load pattern, the value equals 0.11g. On the right, the idealized curves show the idealized capacity curve for Y-dir, which results in 0.14g and 0.15g of peak ground acceleration on bedrock for LF and UNIF patterns of lateral load, respectively. Corresponding critical value of SDI is 0.44 and 0.78, for X-dir and Y-dir, respectively.

**Figure 18.** Capacity curves and displacement requirement of an equivalent 1DOF system.

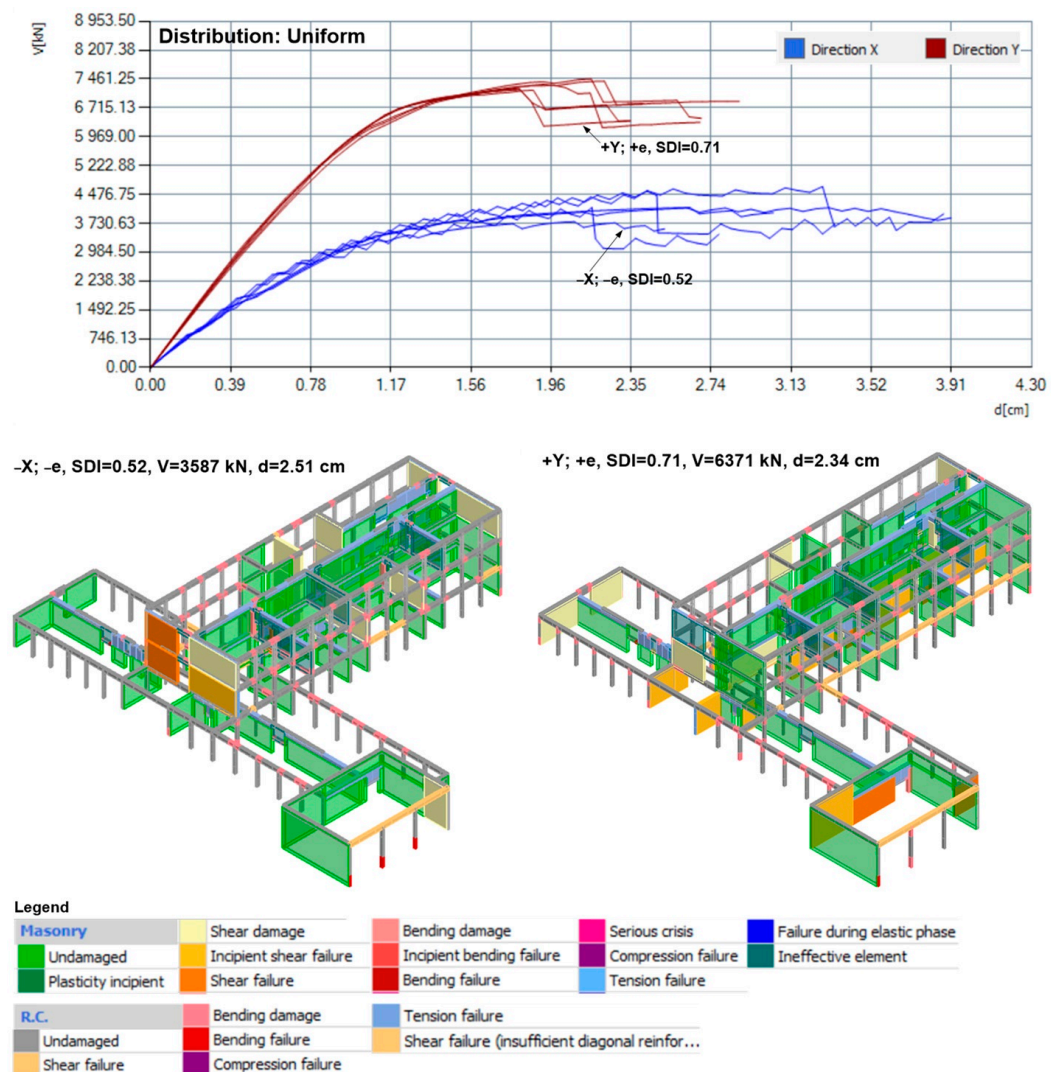
In the case of uniform distribution (Uniform, Figure 20) in the X-dir, the maximum value of the lateral force ranges from 3700 kN to 4500 kN, and the relevant analysis indicates a failure mechanism caused by the shear failure of the perimeter walls on the P20 axis, and of the walls that are not continuous in height on the axes P14, P21, P23, and P24, as well as the wall of the staircase P7 and the walls on the 2nd floor on the axis P3. Damage also occurs on the elements of the edge frames, most of which is damage to beams and columns due to bending, while the shear failure of beams is visible on axes P1, P2, and P19. The critical value of SDI for the X-dir is 0.52. The pushover curves obtained in the Y direction indicate the structure has a significantly higher load capacity, which is approximately 7400 kN, and the relevant damaging mechanisms indicate that the walls of the ground floor on axis P9 and the walls of the large hall on axis P17 are particularly critical. Furthermore, damage to the walls on axis P1 and P12 due to the shear mechanism is also noticeable, and in addition to this, there is shear damage to the walls in the X-direction on axes P3 and P20. On the edge frames, the failure of the beams at the ground floor level due to shear is critical. The smallest value SDI is 0.71 and corresponds to the +Y-dir and a positive eccentricity value.

**Figure 20.** EFM results: pushover curves and corresponding damage mechanism of the building obtained using the uniform load pattern.

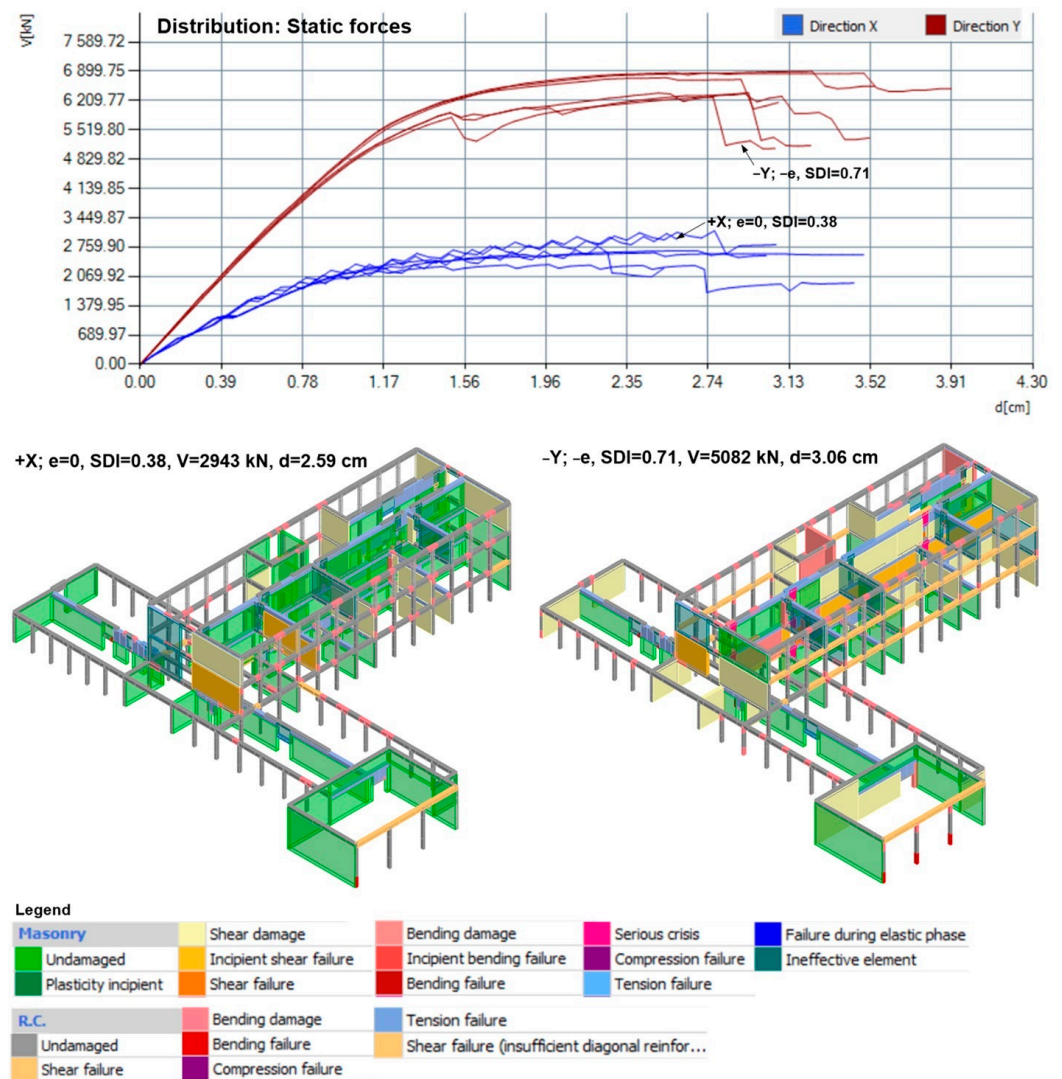
The analysis performed for the load distribution pattern according to the lateral force method (Static forces, Figure 21) proves to be less favorable for the structure than the previous case. Although the relevant structural failure mechanisms remain almost unchanged for the X-dir, the peak lateral force is around 2900 kN and the corresponding SDI is 0.38. In the Y-dir, significant damage is observed on a large number of walls on all floors, and in addition to the shear failure mechanism, there is also damage due to bending. However, the critical elements are the walls on the P9 axis, whose damage is noticeable on all floors. The main analysis performed for this direction has an SDI of 0.71.

**Figure 21.** EFM results: pushover curves and corresponding damage mechanism of the building obtained using the static forces load patterns.

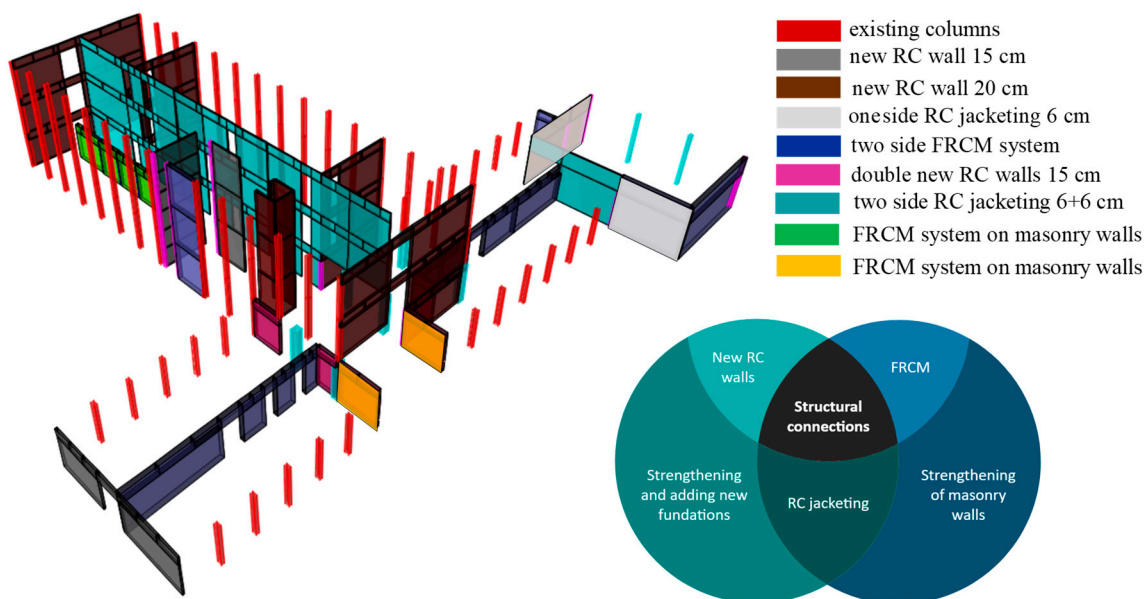
Figure 22. Scheme of strengthening for vertical elements.

The proposed structural strengthening measures are shown in Figure 22. The most significant retrofitting intervention concerns the addition of new RC walls. Along the staircase masonry walls, new RC walls with a thickness of 15 cm are added. On the ground floor, RC walls with a thickness of 15 cm are added next to each brick wall face. In fact, this axis is significantly strengthened because it is a position of eccentricity of the columns on the floor above. Next, new 20 cm thick RC walls are added over the entire height in the building volume V3. These include perimeter walls next to the existing brick walls and walls inside the structure at the positions of the partition walls. In addition to providing additional functionality to the building, it is planned to install a new elevator RC core inside the building. To further connect these walls to the RC slab, new RC beams must be added as the new opening will weaken it. Other retrofit measures include the RC-jacketing of the columns and beams in the ground floor entrance hall and the RC-jacketing of the central masonry wall along the entire height of volume V3, and to the masonry walls of the large hall (volume V2). In order to avoid the formation of other weak elements, FRCM overlay is provided for other masonry walls that were not found to be critical in the analysis of the seismic performance of existing structure.

for all new shear walls and an RC-jacketing system. In addition, an adequate foundation must be ensured for new shear walls as well as for the RC-jacketing of vertical elements (columns and masonry walls).
