The December 2020 magnitude (Mw) 6.4 Petrinja earthquake, Croatia: seismological aspects, emergency response and impacts

Source / Izvornik: **Bulletin of earthquake engineering, 2023, 21, 5767 - 5808**

Josip Atalić¹ · Marija Demšić¹ · Maja Baniček² · Mario Uroš¹ · Iva Dasović³ · Snježan Prevolnik³ · Alen Kadić² · Marta Šavor Novak¹ · Miroslav Nastev⁴

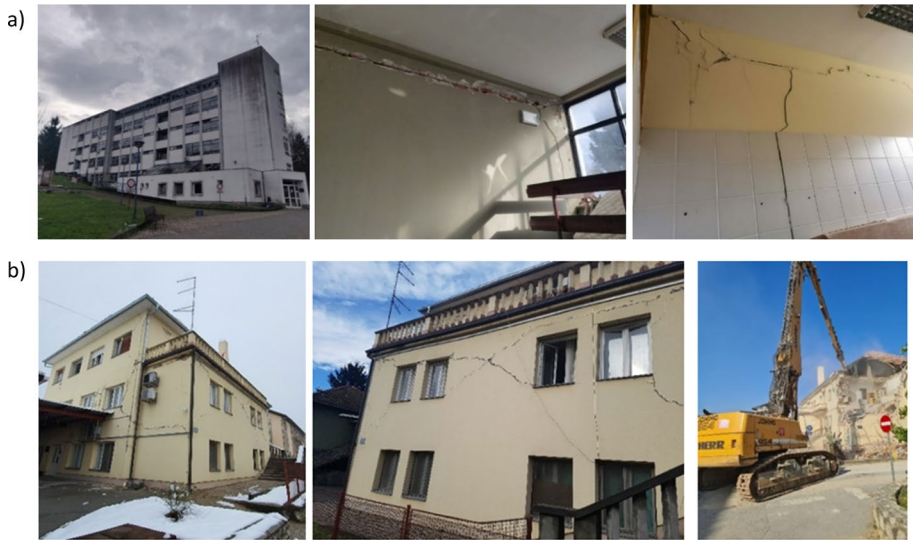
The Special hospital for chronic diseases in Petrinja was moderately damaged and was evaluated as temporarily unusable pending a detailed engineering inspection. Damage to gable and partition walls is given in Fig. 10a. Another important health care facility in

Fig. 10 Petrinja, damage to buildings in the health sector: **a** Special hospital for chronic diseases and **b** Health center in Petrinja (photos: private collection of authors and courtesy of Tina Nikolić, Joning d.o.o.)

Petrinja, the Community Health center also suffered heavy damage (Fig. 10b). Most of the load-bearing walls were significantly damaged and the chimneys collapsed. The building has a reinforced concrete ribbed slab which prevented the development of out-of-plane failure mechanisms. Partition walls were severely damaged and a number of them collapsed. Following a detailed inspection, it was decided to demolish the building.

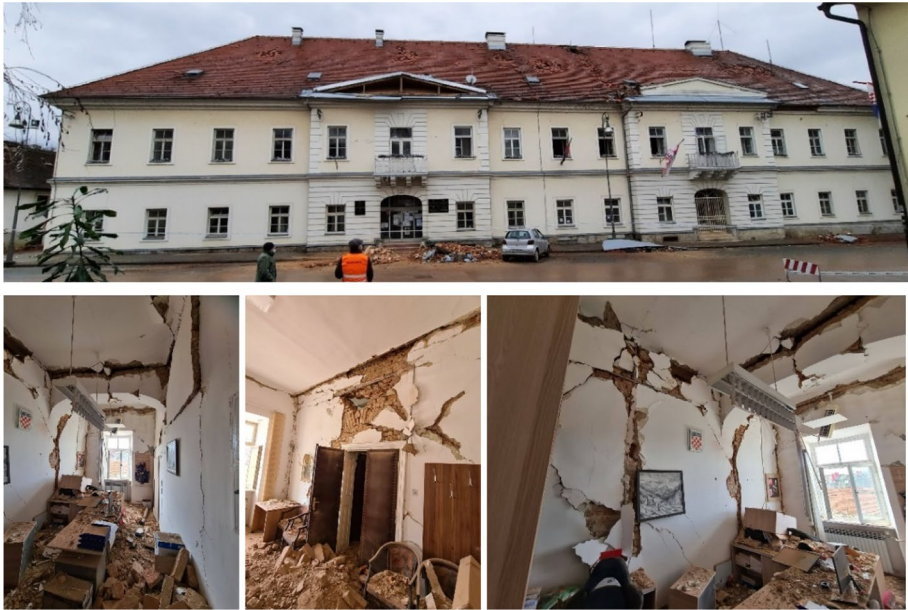
Fig. 12 Damage to buildings in the public sector, Petrinja City Hall (CCEE 2022)

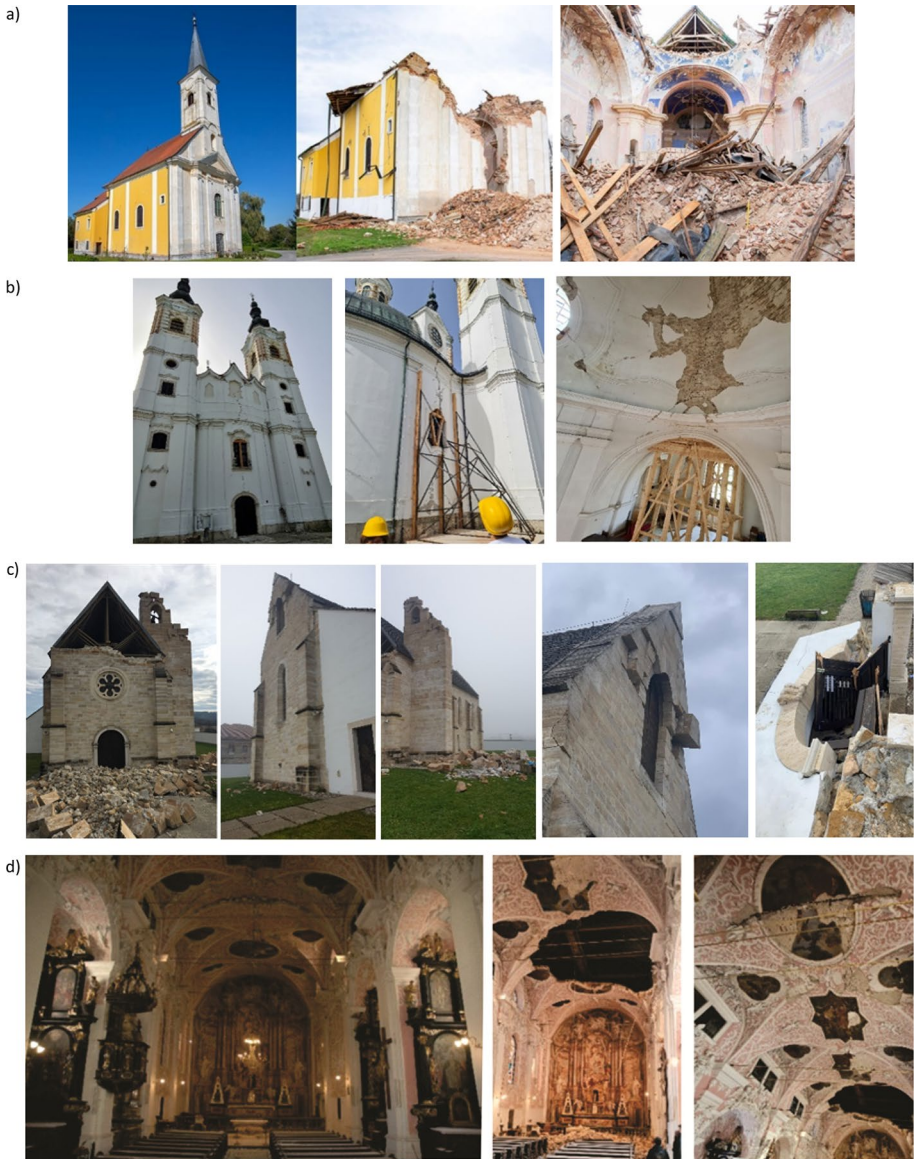
Figure 14a shows the church of St. Nicholas and St. Vid in Žažina, which suffered considerable structural damage caused by collapse of the bell tower. Part of the roof of the main nave also collapsed as did the vaults supporting the roof structure. Unfortunately, the organist of the parish lost his life under the rubble in this church. One of the most valuable and beautiful Baroque churches in continental Croatia is certainly the parish church of St. Mary Magdalene in Sela near Sisak (Fig. 14b). Both towers of the church, the entrance portal, the lintels and walls, and the dome were severely damaged. Urgent protective measures were therefore implemented including the erection of supporting scaffolding to alleviate any threat of collapse of arches and external walls, and stabilization of both towers. The third example shown here is the parish church of the Assumption of the Virgin Mary in Gora. This church was destroyed and rebuilt several times over the centuries. The last facsimile reconstruction of this early Gothic Templar church of carved stone blocks was completed in 2015 without any modern materials and techniques. The authentic reconstruction work was based on extensive archaeological and conservation-restoration research (Miletić and Valjato Fabris 2014). However, the project obviously lacked awareness of the seismic risks, and the new church sustained extensive damage, the tower collapsed together with several arches and part of the roof structure (Fig. 14c).

Due to the significant number of damaged buildings following the March 2020 Zagreb earthquake and insufficient time and resources, a large portion of those buildings remained without proper preventive measures and reconstruction. When the December 2020 Petrinja earthquake hit the region, it caused additional damage to structures already damaged by the previous earthquake. An example of such progressive damage is the church of St. Catherine in the Upper Town Zagreb, whose vaults extensively damaged during the previous earthquake collapsed together with parts of the ceiling (Fig. 14d).

Fig. 14 Damage to sacral buildings: **a** Church of St. Nicholas and St. Vid in Žažina, **b** Church of St. Mary Magdalene in Sela, **c** Church of the Assumption of the Virgin Mary in Gora, and **d** Church of St. Catherine in Zagreb after Zagreb earthquake (left) and after Petrinja earthquake (center and right) (photos: courtesy of Sisak archdiocese 2021; CCEE 2022; and Martina Vujanović, 2022)

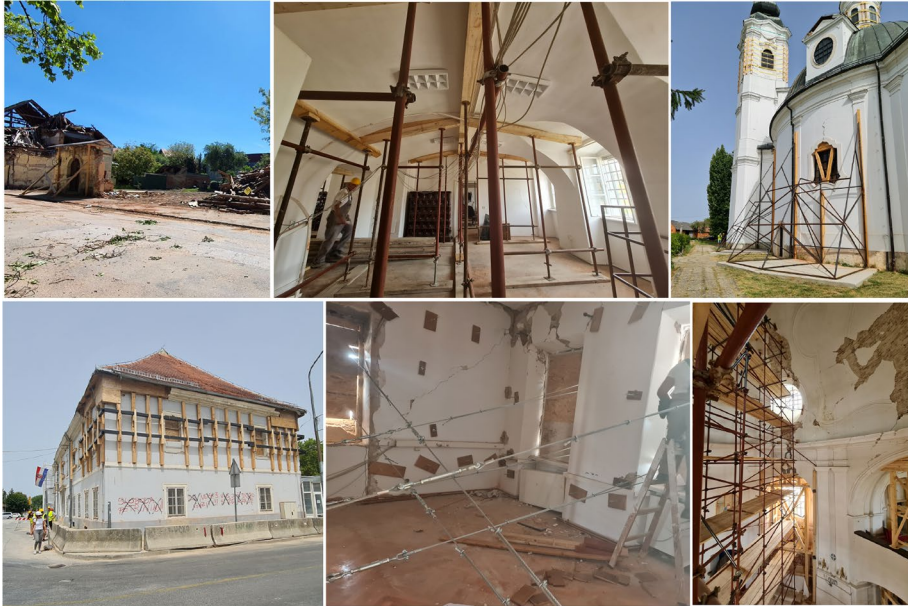
In addition to the sacral buildings, many other heritage buildings have also suffered significant damage. The historical core of the town of Petrinja was hit the hardest, with damage ranging from very severe to devastating. Most of the heritage buildings in the center of Petrinja suffered structural collapse due to their proximity to the epicenter and had to be demolished due to widespread damage and total loss of structural stability. Where possible, emergency measures were taken to stabilize the structure and remove severely damaged

Fig. 15 Demolition and emergency measures in heritage buildings

parts and debris (Fig. 15). In some cases, only portals were left, while the rest of the building had to be demolished and later reconstructed in facsimile.

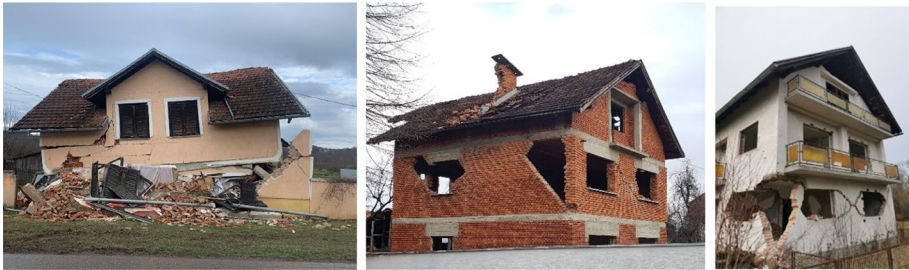
Fig. 19 Damage to URM family houses including a collapse due to irregularity in elevation (left) and combined in-plane and out-of plane failures due to lack of vertical confinement (centre and right) (CCEE 2022)

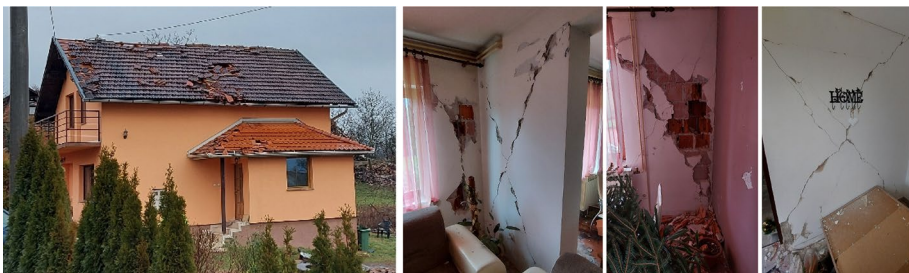
On the other hand, the regular confined masonry buildings suffered mostly light to moderate damage. The most common damage patterns included damage to roofs, overturning of chimneys and gable walls, and damage to partition walls. In addition, moderate structural damage to load-bearing masonry walls was observed less frequently, mainly in the corners of openings or in masonry piers between openings where no vertical confining elements are present (Fig. 21).

Fig. 21 Damage to confined masonry family houses (CCEE 2022)

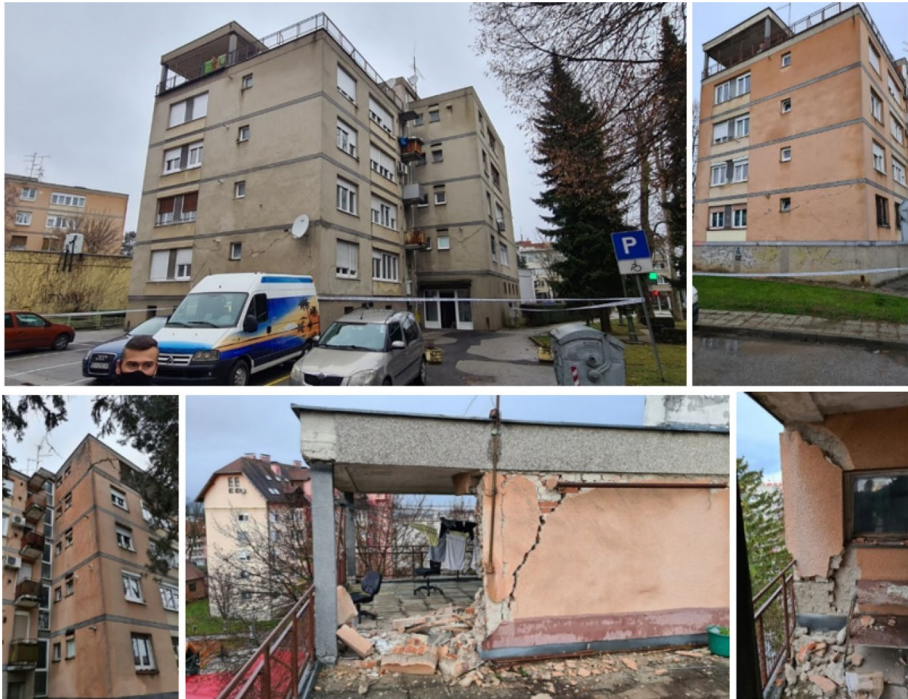
It is interesting to present herein the impacts to a few multi-storey residential masonry buildings in Zaprëšić, a town located more than 60 km from the epicenter (Fig. 23). The causes of the relatively heavy and unexpected damage are still not known. As no damage to foundations or soil failure could have been identified, the high damage could be attributed to inadequate details in the construction and/or to the potential amplification of the seismic shaking as a result of local effects encountered by the seismic waves on their way towards the location. Preliminary results of earthquake simulations for the Petrinja earthquake suggest a potential channeling of the seismic waves in the area, located between the Samobor hills and Medvednica Mt., a phenomenon which increases the shaking intensity (Stipčević et al. 2021). As well, Zaprëšić is situated in the lowlands between Sava and Krapina rivers

Fig. 23 Damage to multi-storey residential buildings in Zaprešić, located more than 60 km from the epicenter (CCEE 2022)

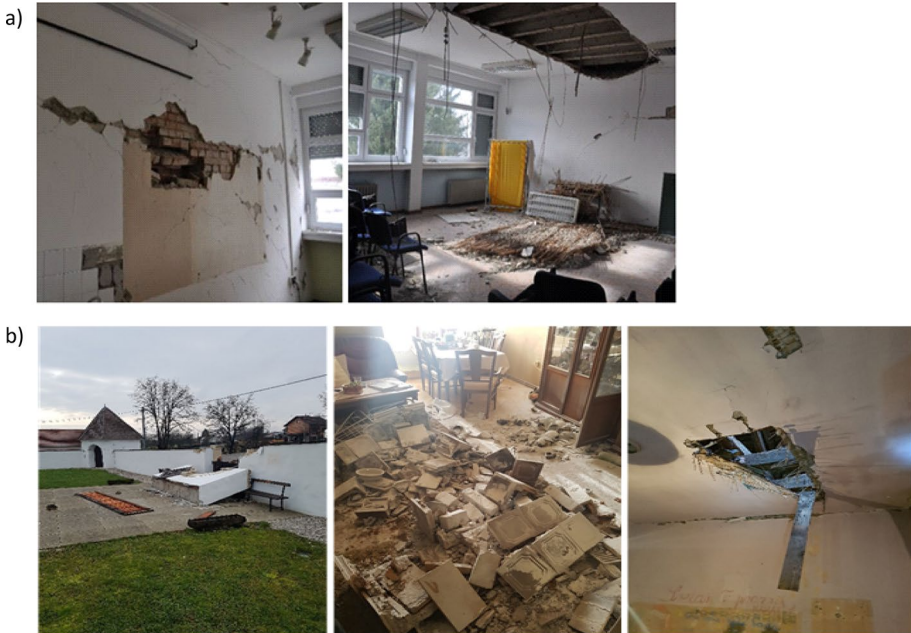
Damage to non-structural elements was by far the most frequent including damage to chimneys, to different parts of the roof, such as cracking and occasional falling of overhangs, cornices and roof tiles, and to various decorative elements. Almost all 'baroque' buildings in the epicenter suffered severe damage in their non-structural elements. These include cornices and significant cracking visible in decorative elements. As well, in many residential buildings, partition walls were damaged due to inadequate thickness and slenderness, or became completely detached from the load-bearing wall and had to be removed to avoid risk of complete collapse (Fig. 26a left).

Fig. 26 Damage to non-structural elements: **a** failure of partition walls and plaster detachment, **b** toppling of the outer wall, toppling of the heavy tile stove, and hole in the floor structure due to chimney collapse (CCEE 2022)

Cracks and detachment of plaster walls and ceilings (Fig. 26a right) from the inside as well as from the building facade were common in older buildings. More severe damage included the collapse of false ceilings. Damage was also observed to massive non-structural elements such as cantilevered concrete and masonry elements, as well as toppling of outer walls and rarely heavy tile stoves, which in some cases caused further damage (Fig. 26b).

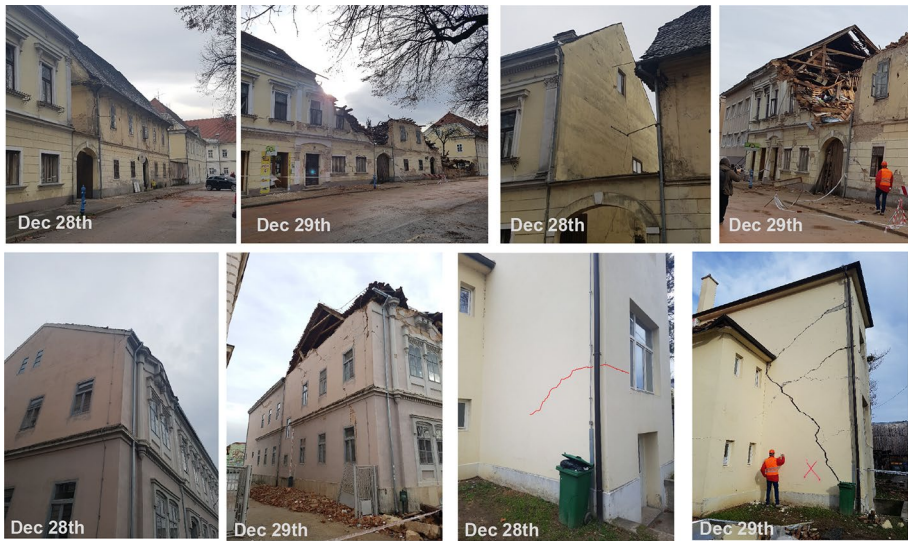
Fig. 27 Comparison of damage to buildings in Petrinja following the foreshock (indicated with Dec 28th) and the main shock (indicated with Dec 29th)
