The December 2020 magnitude (M_w) 6.4 Petrinja earthquake, Croatia: seismological aspects, emergency response and impacts

Josip Atalić¹ · Marija Demšić¹ · Maja Baniček² · Mario Uroš¹ · Iva Dasović³ · Snježan Prevolnik³ · Alen Kadić² · Marta Šavor Novak¹ · Miroslav Nastev⁴

Received: 5 October 2022 / Accepted: 3 August 2023 / Published online: 28 August 2023
© The Author(s) 2023

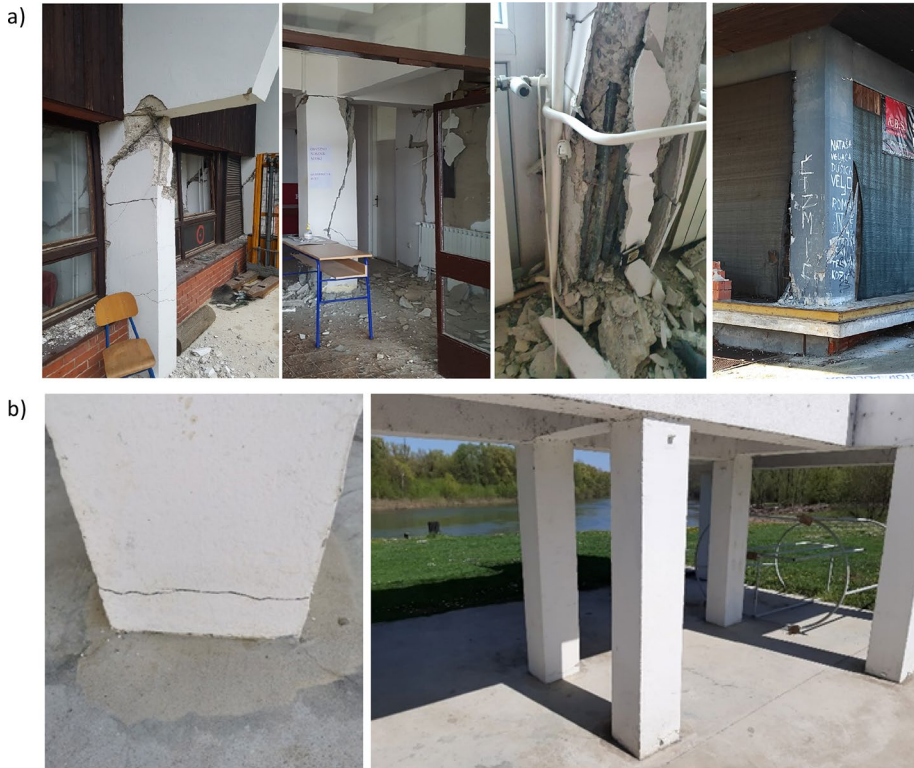
The absence of transverse reinforcement is characteristic of construction until 1964 and even later until 1981, when the first modern seismic codes were introduced that considered the ductility of joints and the prevention of brittle failure. Until then, the transverse reinforcement in the columns served mainly to connect the longitudinal reinforcement, and it was not considered in the load-carrying capacity because the horizontal seismic loads were not very high. Since the seismic forces were much lower according to the regulations of the time, it was not even necessary to provide the columns with

Fig. 24 Typical damage to RC building: **a** brittle fractures and **b** bending cracks in columns (CCEE 2022)
