# The December 2020 magnitude (Mw) 6.4 Petrinja earthquake, Croatia: seismological aspects, emergency response and impacts

*Source / Izvornik:* **Bulletin of earthquake engineering, 2023, 21, 5767 - 5808**

**Journal article, Published version**

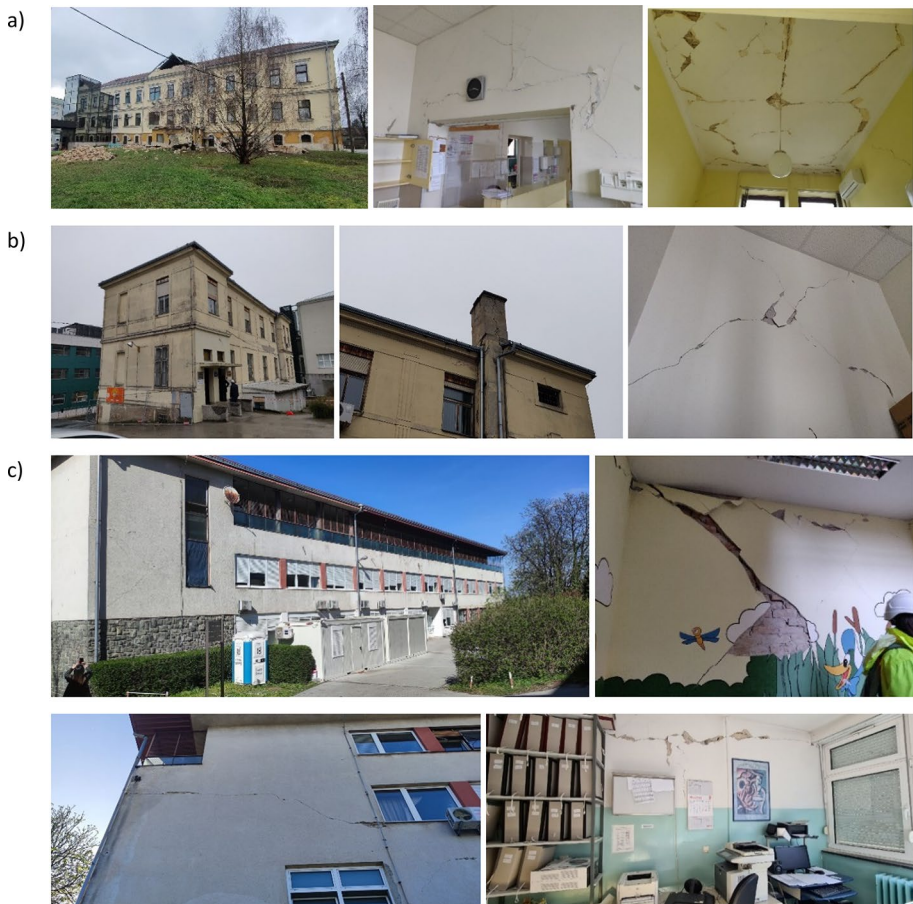
**Fig. 9** Sisak, damage to buildings in the health sector, Hospital "Dr. Ivo Pedišić": **a** Internal clinic, **b** Administrative building, and **c** Pediatrics building (CCEE 2022)

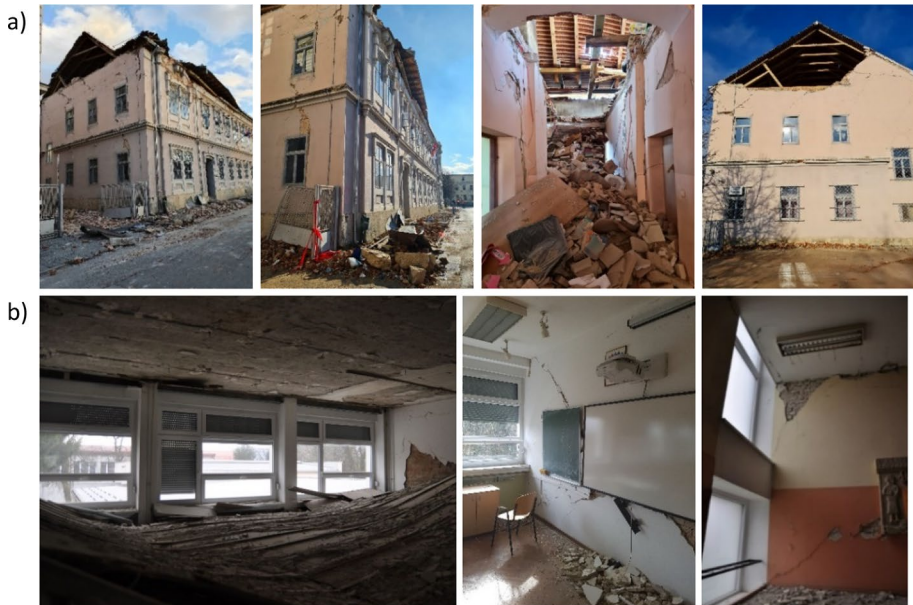
The Faculty of teachers' education in Petrinja was constructed in the 1960s. The building is of irregular footprint and height and consists of three large interconnected wings. The load-bearing structure consists of a system of peripheral RC frames and interior URM walls. The floor structure is made of RC slabs and beams connected to the vertical load-bearing system. The building suffered light to locally moderate structural damage. The

**Fig. 11** Petrinja, damage to buildings in the educational sector in: **a** Primary school, and **b** Faculty of teachers' education (CCEE 2022)

masonry spandrels sustained severe damage, whereas the load-bearing walls were only slightly to moderately damaged, particularly those supporting the stair landings. Cracks in the concrete floor structure were limited to contacts with a significant change in structural geometry. In several classrooms, ceiling layers collapsed completely or partially, and all partition walls were severely damaged due to the exceedance of shear force.

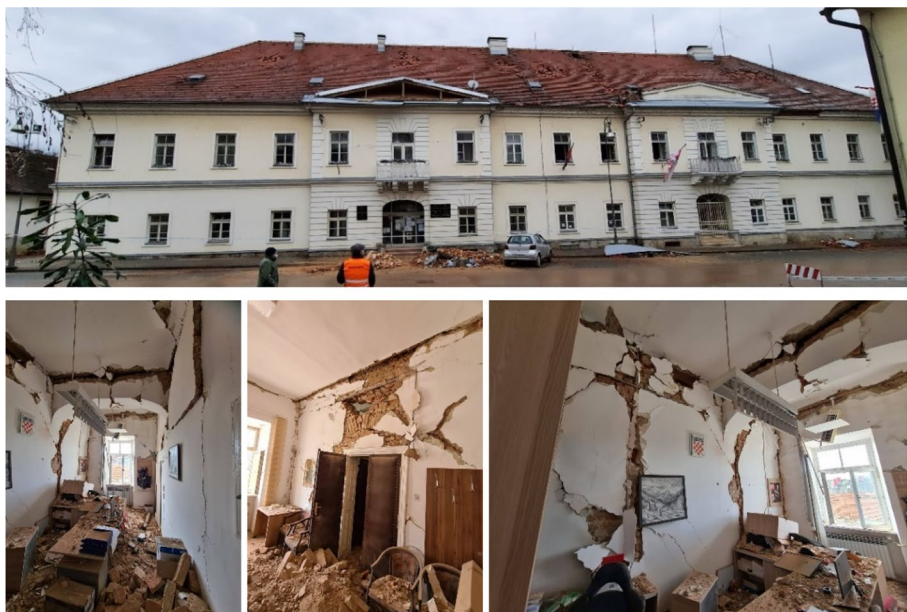
**Fig. 12** Damage to buildings in the public sector, Petrinja City Hall (CCEE 2022)

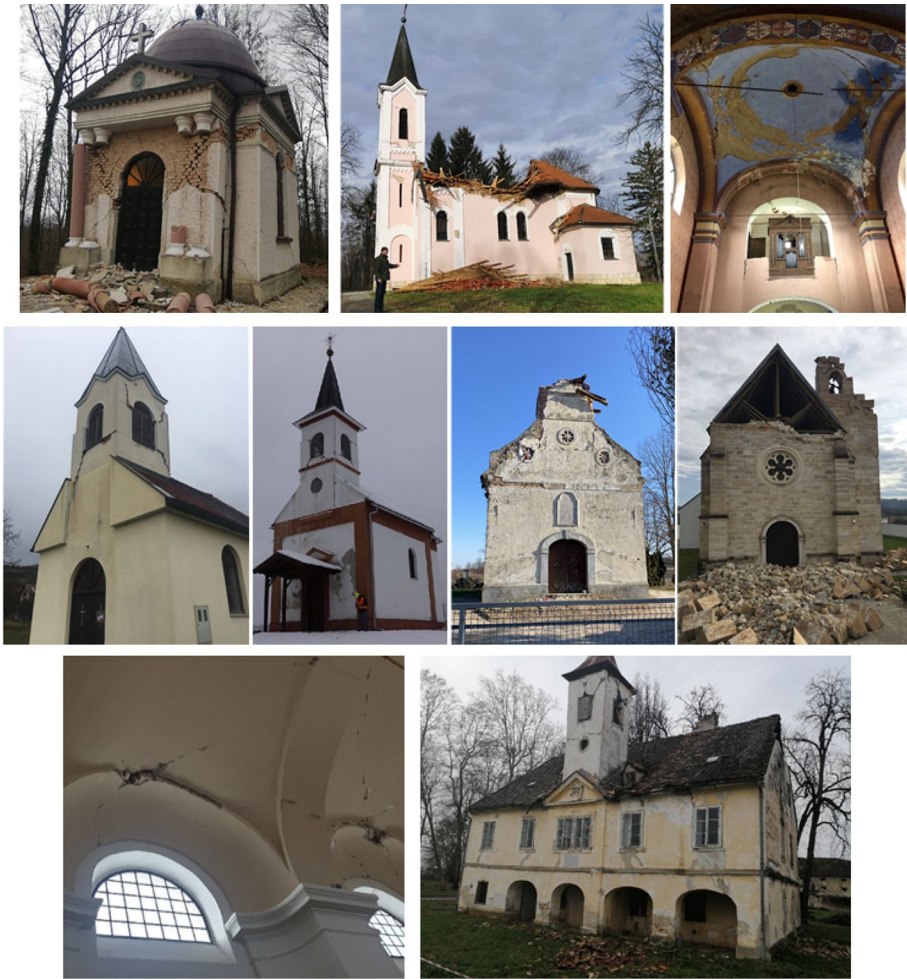
**Fig. 13** Examples of damage to sacral buildings (CCEE 2022)

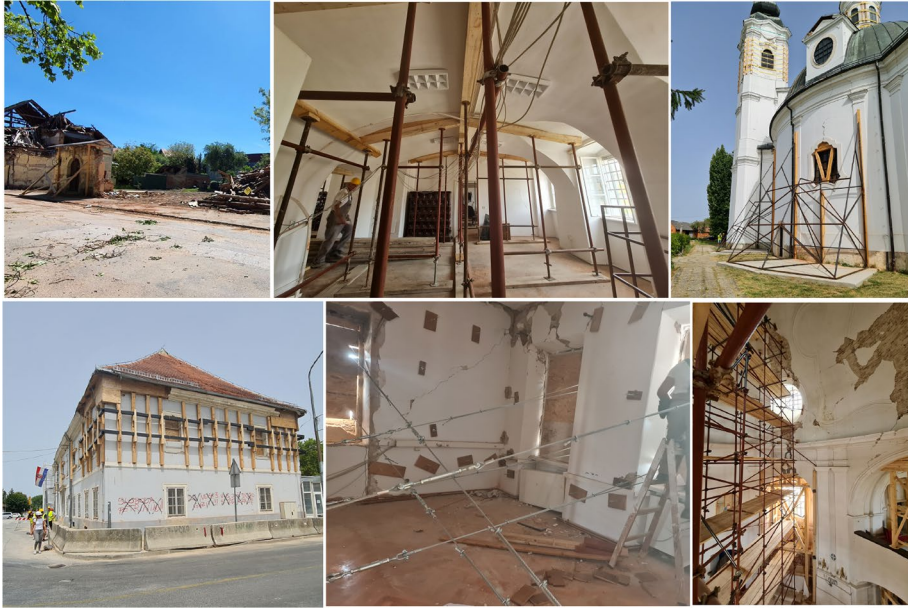
**Fig. 15** Demolition and emergency measures in heritage buildings

parts and debris (Fig. 15). In some cases, only portals were left, while the rest of the building had to be demolished and later reconstructed in facsimile.

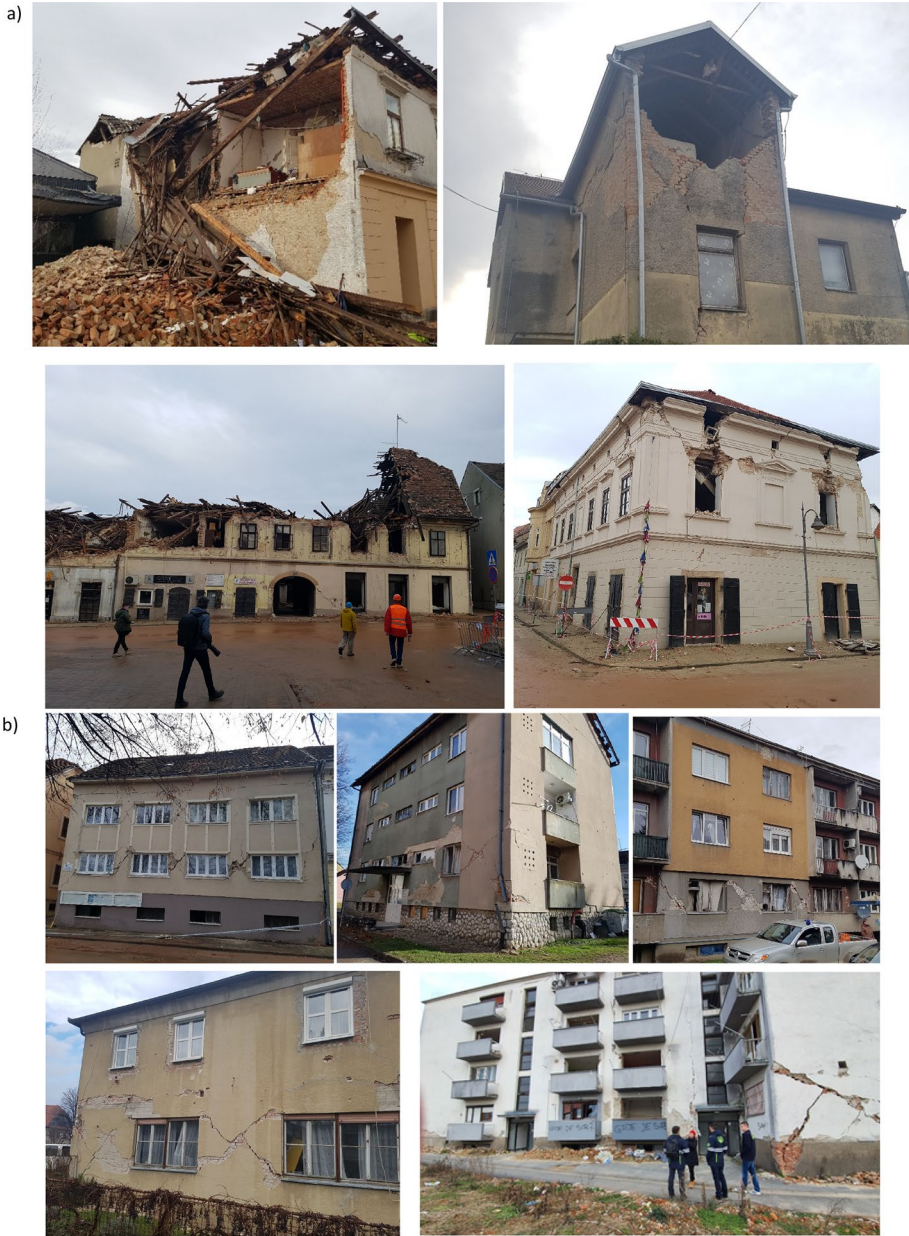
On the other hand, exceedance of the in-plane bearing capacity in load-bearing walls was observed in masonry buildings confined with rigid floor structures that contributed to the box-like behavior. The shear mechanism in the bearing walls is manifested with typical diagonal cracks accompanied by cracking at joints owing to the poor quality of the mortar. The extent of damage concentrated on the ground floor indicates that the first mode dominates the dynamic response (Fig. 17b). Despite the relatively low lateral load capacity of masonry buildings, this confirms their moderate ductility due to the strong nonlinear behavior that includes stiffness changes due to cracking. The introduction of adequate diaphragm interconnecting the load-bearing elements, where installed, provided a favorable load distribution resulting in increasing of the building's global resistance to seismic loading. Although details of the connection between the confining

**Fig. 17** Damage to unreinforced masonry buildings: **a** out-of-plane failure mechanisms, **b** in-plane failure mechanisms (CCEE 2022)

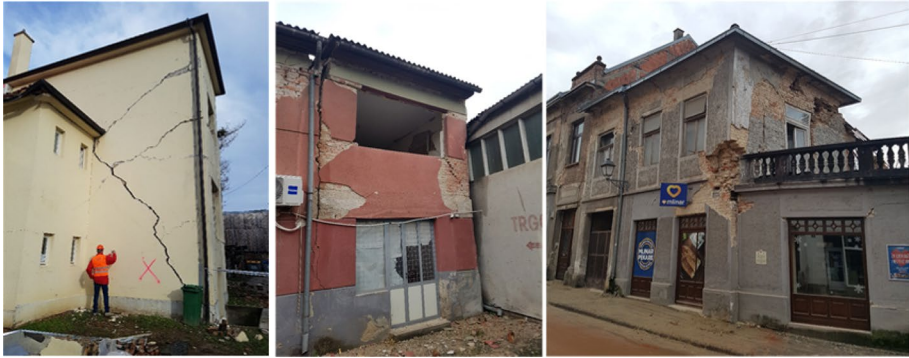
**Fig. 18** Typical damage: In-plane wall failures and pounding effect (CCEE 2022)

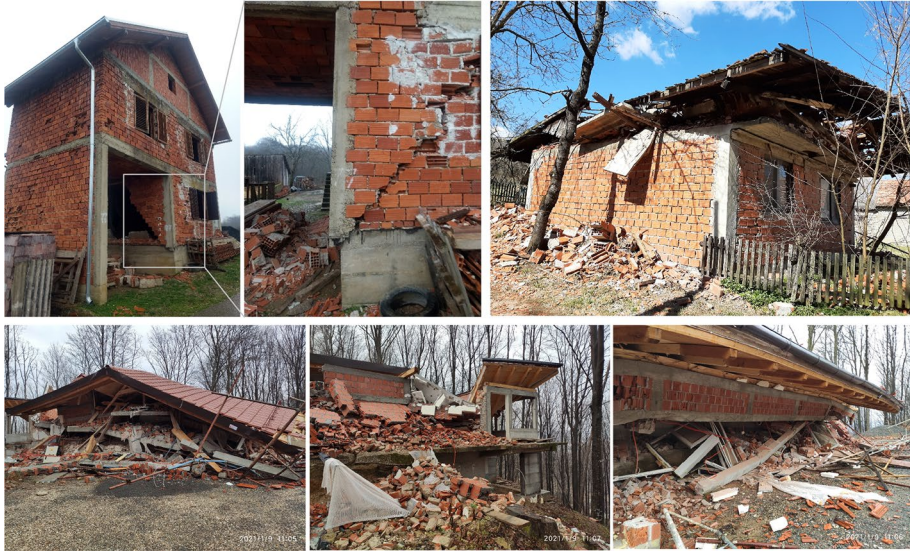
**Fig. 20** Damage to (partially) confined masonry with significant structural deficiencies family houses (CCEE 2022)

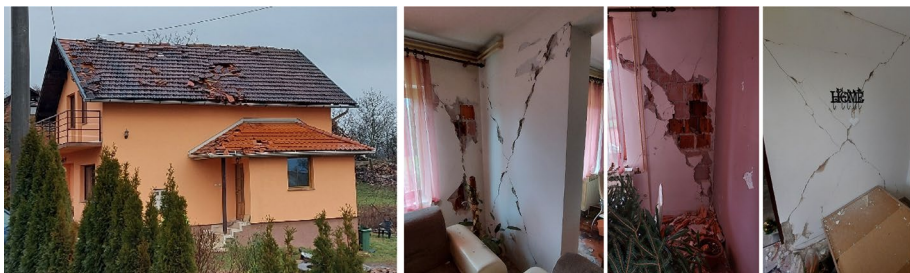
On the other hand, the regular confined masonry buildings suffered mostly light to moderate damage. The most common damage patterns included damage to roofs, overturning of chimneys and gable walls, and damage to partition walls. In addition, moderate structural damage to load-bearing masonry walls was observed less frequently, mainly in the corners of openings or in masonry piers between openings where no vertical confining elements are present (Fig. 21).

**Fig. 21** Damage to confined masonry family houses (CCEE 2022)

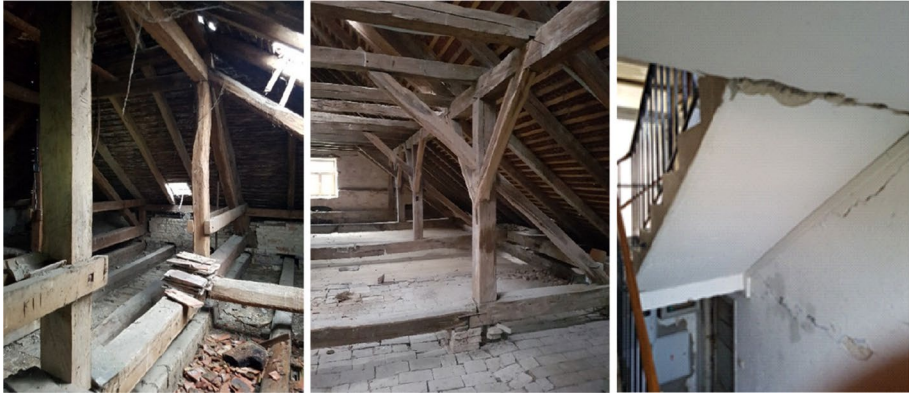
**Fig. 22** Damage to roof structures and staircases (CCEE 2022)

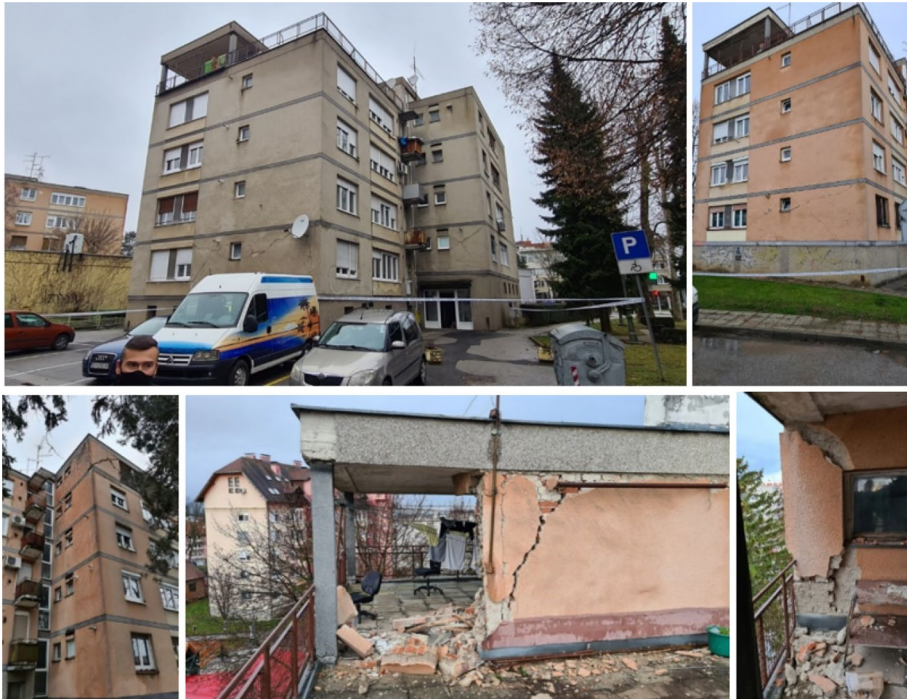
It is interesting to present herein the impacts to a few multi-storey residential masonry buildings in Zaprëšić, a town located more than 60 km from the epicenter (Fig. 23). The causes of the relatively heavy and unexpected damage are still not known. As no damage to foundations or soil failure could have been identified, the high damage could be attributed to inadequate details in the construction and/or to the potential amplification of the seismic shaking as a result of local effects encountered by the seismic waves on their way towards the location. Preliminary results of earthquake simulations for the Petrinja earthquake suggest a potential channeling of the seismic waves in the area, located between the Samobor hills and Medvednica Mt., a phenomenon which increases the shaking intensity (Stipčević et al. 2021). As well, Zaprëšić is situated in the lowlands between Sava and Krapina rivers

**Fig. 23** Damage to multi-storey residential buildings in Zaprešić, located more than 60 km from the epicenter (CCEE 2022)

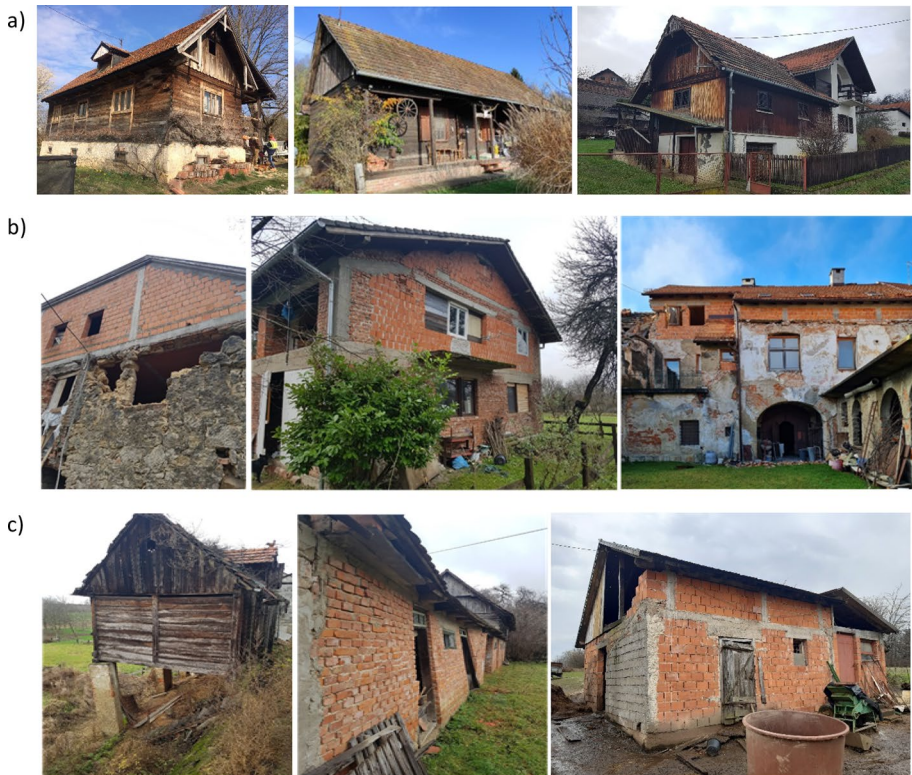
Traditional rural buildings are widespread across the Sisak-Moslavina County. Most of the observed damage was minor confirming their fair to good seismic performance exceeding that of the common URM buildings. The major advantage of these structures is in the light-weight wooden structural elements with joints with capacity to dissipate energy (Fig. 25a). Structural damage was almost inexistent and, when such damage did occur, it was localized mainly to joints between the wooden elements. Nonstructural damage, such

**Fig. 25** Rural buildings: **a** Traditional wooden houses; **b** Buildings of different materials, and **c** agricultural buildings (CCEE 2022)

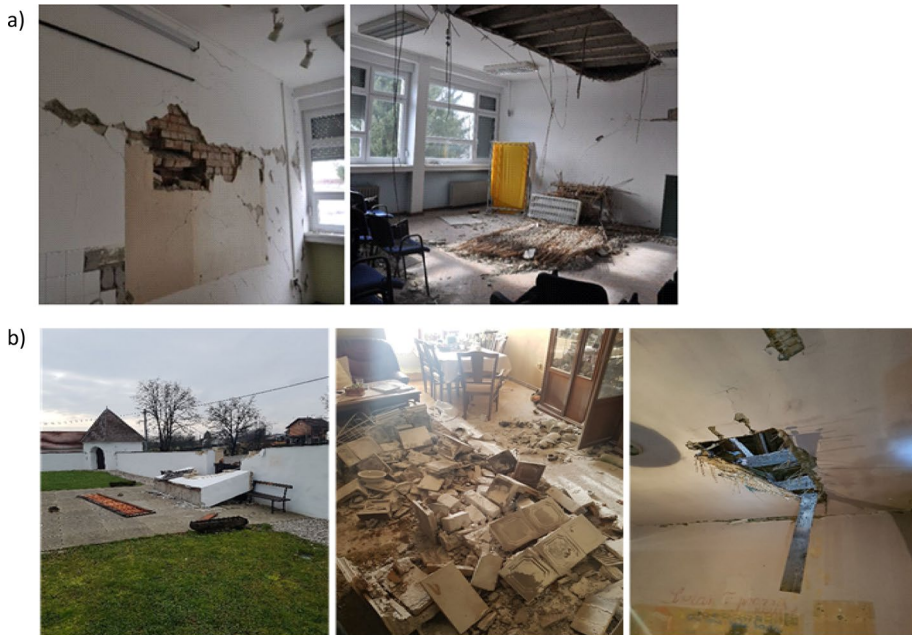
Damage to non-structural elements was by far the most frequent including damage to chimneys, to different parts of the roof, such as cracking and occasional falling of overhangs, cornices and roof tiles, and to various decorative elements. Almost all 'baroque' buildings in the epicenter suffered severe damage in their non-structural elements. These include cornices and significant cracking visible in decorative elements. As well, in many residential buildings, partition walls were damaged due to inadequate thickness and slenderness, or became completely detached from the load-bearing wall and had to be removed to avoid risk of complete collapse (Fig. 26a left).

**Fig. 26** Damage to non-structural elements: **a** failure of partition walls and plaster detachment, **b** toppling of the outer wall, toppling of the heavy tile stove, and hole in the floor structure due to chimney collapse (CCEE 2022)

Cracks and detachment of plaster walls and ceilings (Fig. 26a right) from the inside as well as from the building facade were common in older buildings. More severe damage included the collapse of false ceilings. Damage was also observed to massive non-structural elements such as cantilevered concrete and masonry elements, as well as toppling of outer walls and rarely heavy tile stoves, which in some cases caused further damage (Fig. 26b).
