Source / Izvornik: **Applied sciences (Basel), 2023, 13, 1 - 19**

Post-Earthquake Dynamic Performance of Intact Masonry Building Based on Finite Element Model Updating

As a case study, a building of a high school in Sisak (Figure 1) built in 1935 was taken. The building has four floors: basement, ground floor, and two upper floors. In the central part of the building there is a three-legged staircase with a landing. The foundations are constructed as a reinforced concrete slab. The load-bearing part of structure consists of walls made of solid bricks of 29(39) cm × 15 cm × 6.5 cm, floor slabs and reinforced concrete ribbed floor slabs. The thickness of the load-bearing walls in the basement is 60 cm and 75 cm, and 50 cm and 60 cm on the ground floor and upper floors. The partition walls are 15 cm, 18 cm, 25 cm or 30 cm thick and are made of hollow blocks. The floor slab is 25 cm thick and the reinforced concrete ribbed floor slab has a total height of 33 cm. The clear distance between the ribs is 60 cm, the width of the ribs is 13 cm, and the height is 23 cm. At the entrance of the building on the first and second floors, there is a load-bearing part of the structure that rests o

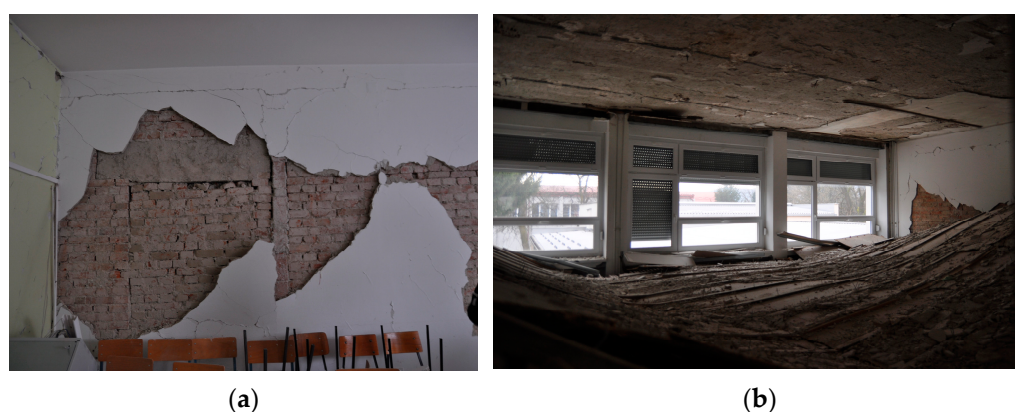
A detailed visual inspection was performed to visually evaluate the structure. During the inspection, some guidelines of the RVS (Rapid Visual Screening) method were applied [36]. The building was inspected by a team of four engineers. The inspection lasted approximately six hours. During the inspection, damage on load bearing and partition walls was observed on the ground floor and first floor. Special attention was paid to crack widths on structural and non-structural elements, separation between structural elements, and displacement of structural components. The cracks were generally diagonal and occurred both in the mortar joints and in the masonry units themselves. Some characteristic and specific damage can be seen in Figure 3. There was frequent evidence of crushing and spalling on many non-structural elements, seen in Figure 4a. Extensive detachment of the surface layer was evident on some parts of the ceiling, seen in Figure 4b. Considering the observation during the visual inspection, the finite element model of the structure in the updating phase is adapted to the found state.

Figure 4. Observed damage on (a) the partition wall and (b) the ceiling.

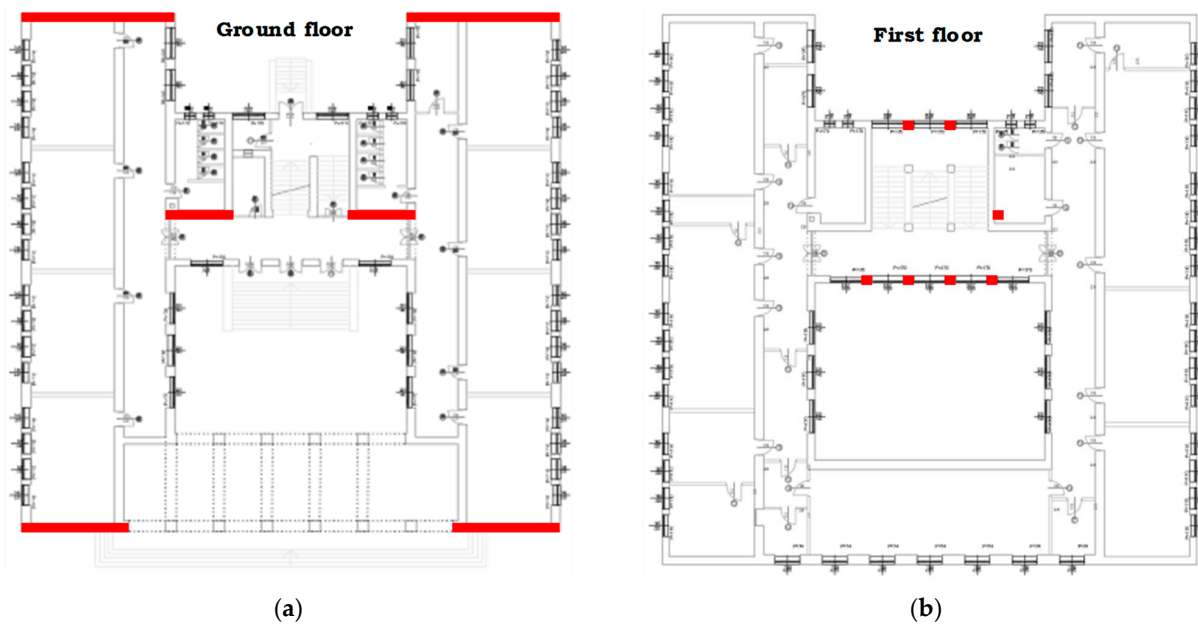
To be able to numerically predict the real structural behavior, the damaged structural elements in this step of analysis are modelled with reduced elasticity modulus. These elements were selected based on a visual inspection and their positions are marked in Figure 11.

Figure 11. The elements of the model with a reduced modulus of elasticity (red bars) at the (a) ground and (b) first floor.
