Zagreb earthquake of 22 March 2020 – preliminary report on seismologic aspects and damage to buildings

Research Paper

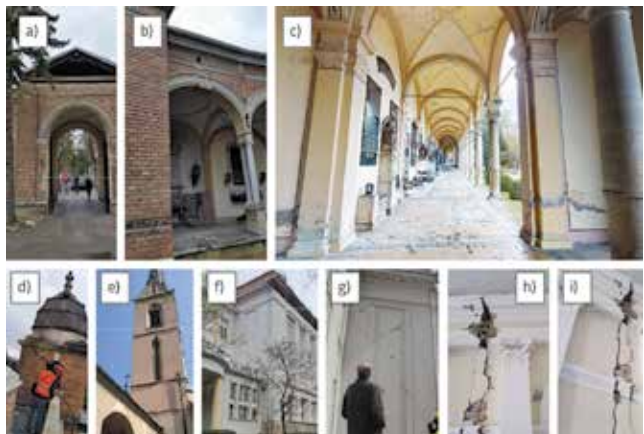
Figure 30. Earthquake damage to some notable buildings: Mirogoj Cemetery (a.-d.), Franciscan Monastery at Kaptol (e), registry office building of the Faculty of Medicine at Šalata (f.-g.), University and Faculty of Law building (h.-i.) [39]
