Potres u Zagrebu od 22. ožujka 2020. - preliminarni izvještaj o seizmološkim istraživanjima i oštećenjima zgrada

Zagreb earthquake of 22 March 2020 – preliminary report on seismologic aspects and damage to buildings

Research Paper

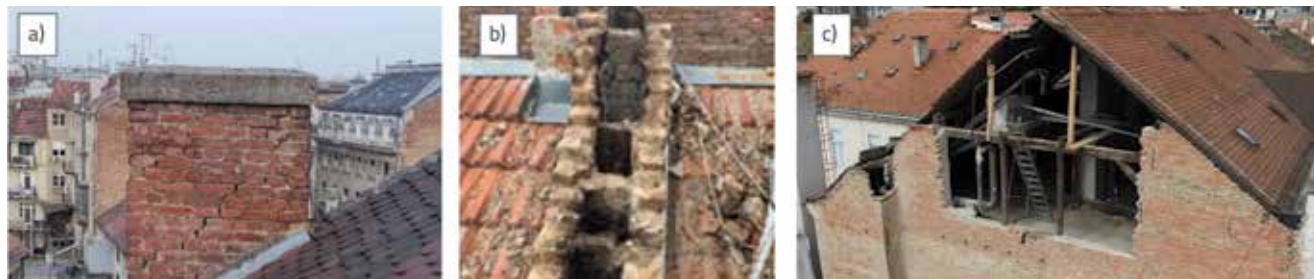
Damage most frequently suffered by old masonry buildings situated in the central part of the city involves collapse of chimneys, gable

Figure 17. Collapse of chimneys and top part of the gable walls (photo courtesy of Mario Todorčić and [39])
