Source / Izvornik: **Građevinar, 2020, 72, 843 - 867**

## Zagreb earthquake of 22 March 2020 – preliminary report on seismologic aspects and damage to buildings

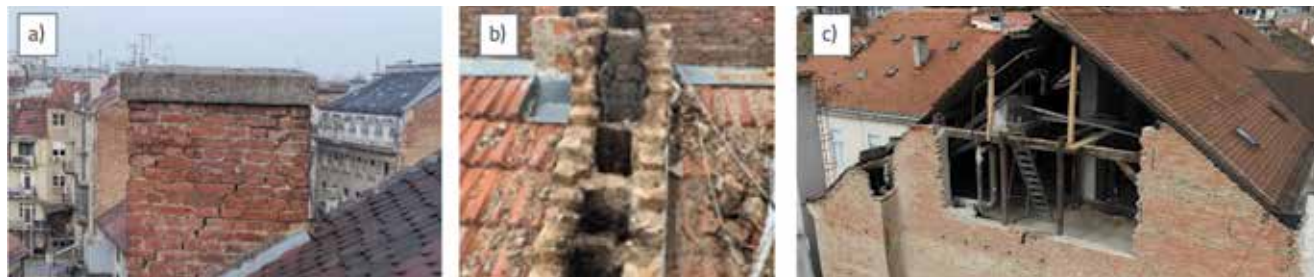
Damage most frequently suffered by old masonry buildings situated in the central part of the city involves collapse of chimneys, gable

Figure 17. Collapse of chimneys and top part of the gable walls (photo courtesy of Mario Todorčić and [39])

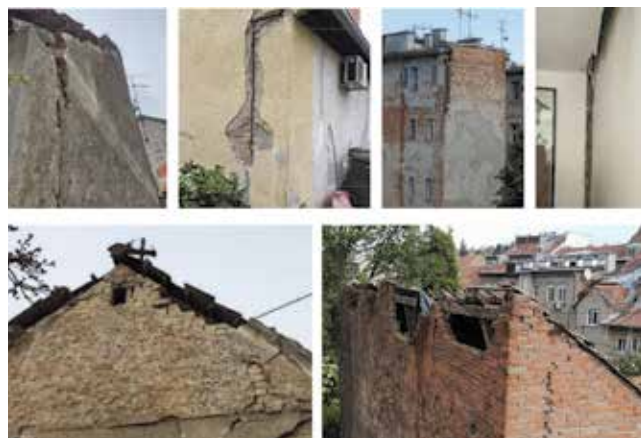
In addition to local collapse of attic gable walls, in more difficult cases the damage involved detachment of gable walls along the entire height or through several floors (Figure 19). The reason is poor connection with walls from the other direction.

Figure 19. Detachment of gable wall and typical cracks in internal part of the building (photos courtesy of Mario Todorčić and [39])

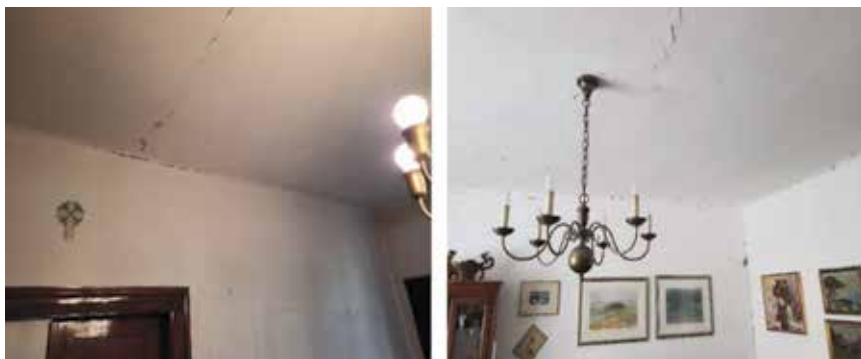
Figure 24. Cracks at ceilings [39]

Small cracks in the direction of joists most often occurred because of displacements due to bending between beams. Such cracks rarely occur due to tensile forces perpendicular to joist. Cracking is often pronounced along the connection between the wall and the floor structure, which is due to relative displacement between these elements. Generally, if the wall does not detach and lean, only the plaster is usually affected, Figure 24.

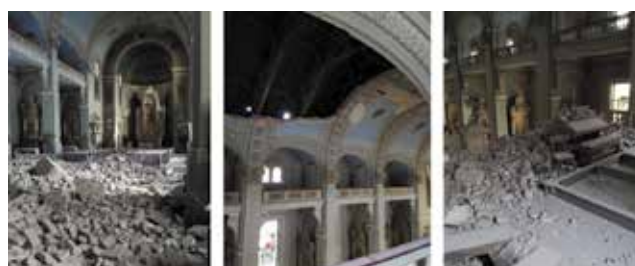
As to cultural heritage buildings, the greatest damage was inflicted on numerous centuries-old churches (cf. Figures 32-34). Out of the total of 43 churches that suffered damage in the city, 30 of them belong to the category of protected cultural monuments. The stone top of the south belltower of Zagreb Cathedral, Croatia's largest sacral building, detached from the base and fell onto and damaged the roof structure of the cathedral. After inspection, it was established that the north belltower also suffered considerable damage, which is why the potentially harmful part had to be removed as it could have fallen onto the cathedral. In addition to the belltower, the balustrade above the apse also collapsed, and great damage was inflicted on facade walls and vaults of this cathedral. Considerable damage to vaults and roofing was also incurred at the cathedral's Archbishop's Palace, where chimneys also collapsed.

**Figure 33. Damage to Basilica of the Sacred Heart of Jesus** (photos courtesy of: Ivan Ćurić)
