Analysis of Tram Traffic-Induced Vibration Influence on Earthquake Damaged Buildings

Keywords: tram track; vibrations; earthquake; masonry structure; vulnerability

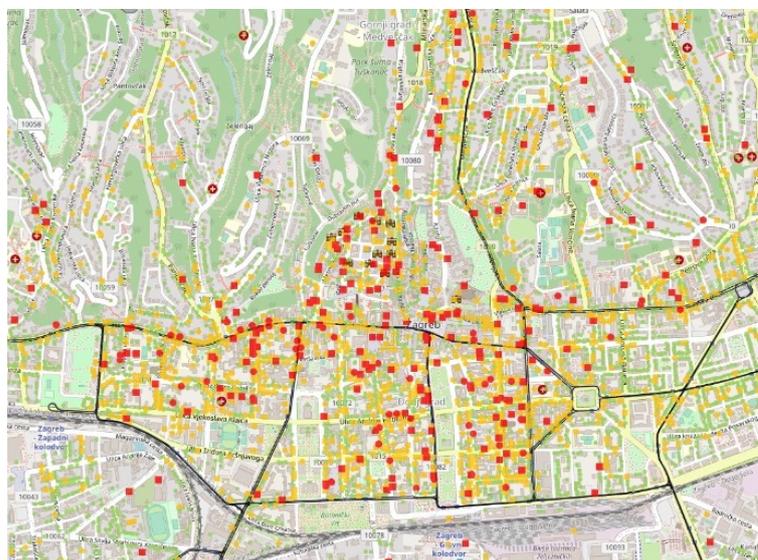
Figure 1. Tram network (black line) and earthquake damage to buildings based on initial inspection (yellow squares—temporarily unusable, red squares—permanently unusable).

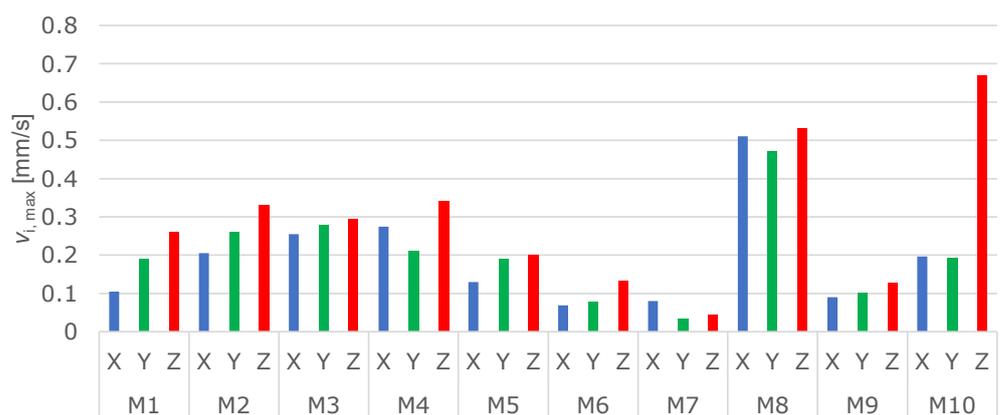
Figure 10. Peak vibration velocities measured in the building at ten measurement positions for the second pass-by of the reference tram.

The vibrations generated at the distant south track (pass-bys 1 and 3) reached 5-to-10-times lower peak values compared to vibrations generated at the north track (pass-bys 2 and 4), which was to be expected due to energy loss with the distance from the source to the receiver. Therefore, pass-bys on track closer to the building façade are further investigated. If the central position of the south façade is observed, vibrations tend to increase with the floor of the building, being the smallest at the basement level (M5) and increasing from the

ground floor to the third floor (M1 to M4). On the third floor, a drop in horizontal vibration level was observed, which is probably due to the stiffer reinforced concrete structure compared to the rest of the building. It is also visible that peak velocities drop with the distance from the track (M1 → M6 → M7) on the same floor. The analysis shows that the highest vibration levels are at the south-east wing connection (M8, ground floor, and M10, third floor of the building). From vibration trends of the passing tram (Figure 9), a distinct peak in the 12th second is visible at the left side of the bogie (PLZ). This peak occurs in a broad spectrum, with the maximum at around 30 Hz. At this position, the tram changes direction (drives in an S curve), which also leads to the deteriorated track geometry when compared to other positions on the building. Additionally, the accelerometer position at the crossing of the south and east bearing walls ensures vibration transfer through the structure.

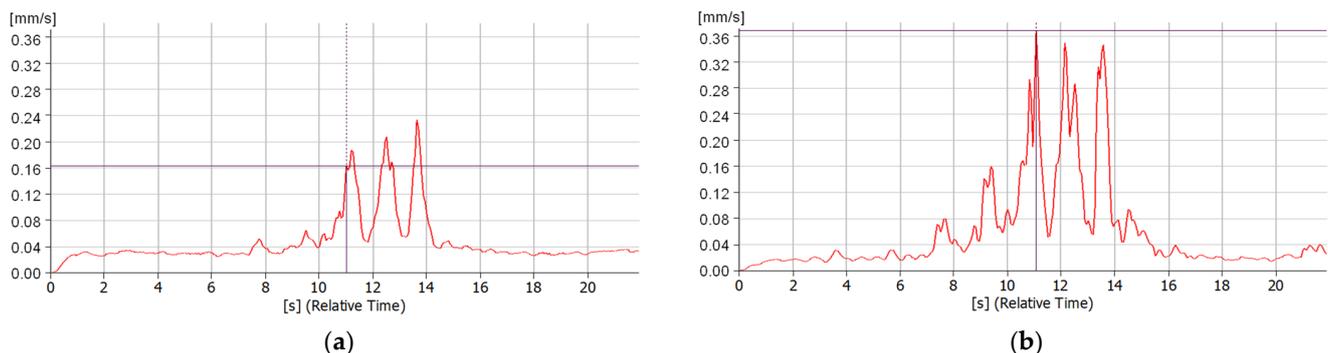
Second pass-by of the reference tram, Figure 11, induced maximum vibrations in terms of PPV when compared to any other observed pass of all trams, and it was therefore used to evaluate the level of long-term vibration exposure. Table 1 gives an overview of available thresholds for assessing the impact of vibrations on structures. According to a standard currently in place in Croatia [19], the long-term vibration exposure of sensitive structures should not exceed 2.5 mm/s of PPV calculated according to Equation (2). The maximum level was recorded in Z direction $-v_{z, \max} = 0.68$ mm/s, well below the allowable limit. If the Swiss standard [18] is considered, PPV calculated according to Equation (1) is 0.724 mm/s, which is also below the recommended value of 1.5 mm/s for vibration-sensitive buildings exposed to long-term vibrations. Therefore, damage occurrence due to tram vibrations has a very low probability.

Figure 11. Vertical (Z) vibration velocity trends at (a) M8 and (b) M10 for the second pass-by of the reference tram.
