Evaluation of tramway overhead line system in city of Osijek

Ivo Haladin^{1*}, Stjepan Lakušić¹, and Ivan Duvnjak²

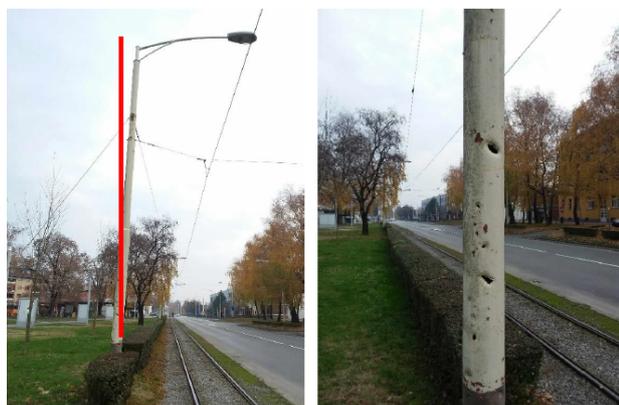
According to analysis, 20 % of columns were characterized as substantially damaged (bent out of vertical axis, corrosion damage, shrapnel damage etc.), as presented in Figure 2; 32 % endangered (minor corrosion or dents); 48 % in good state (not bent, no corrosion or dents).

Fig. 2. Example of substantially damaged columns.

Conducted measurements and further analysis revealed weak spots and sections in overhead line system that are to be replaced or reconstructed due to weakened or damaged support columns (around 20%), worn overhead wire and elevated level of vibrations and shocks on vehicle pantograph. Furthermore recommendations for correction of overhead line alignment in terms of height and stagger have been given for more than 2000 m of track. Priority levels for reconstruction have also been determined.

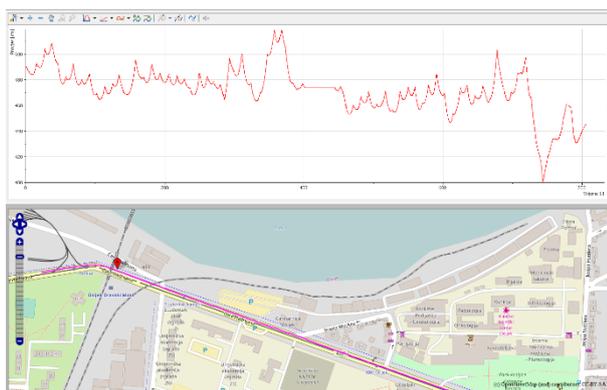
Height difference in respect to travelled distance has also been analysed because it can lead to loss of contact between the pantograph and the wire, Figure 5.

Fig. 5. Substantial height difference of overhead wire (right).

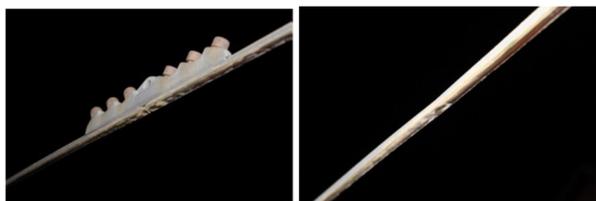
Fig. 10. Inspection of wire joints and potential weak spots.

Such inspection, together with historic data of GPP Osijek maintenance division, revealed 79 joints due to wire breakage, 46 substantially worn spots and other potentially critical points, Figure 10.
