Evaluation of tramway overhead line system in city of Osijek

Abstract. Overhead line system is a vital element of any electrified railway infrastructure. Its performance reflects to all vital parameters such as traction, reliability, availability and safety of railway infrastructure. Operator GPP Osijek runs a 27.5 km long tramway network which plays a key role in transit system of the city of Osijek, Croatia. In 2016 GPP Osijek applied to a tender for acquisition of new rolling stock with 85% EU investment. Mayor requirement prior to rolling stock acquisition was to document, analyse and upgrade current infrastructure (including track structure, electric substations and catenary) to an optimal level. Task of measurement and evaluation of tram track structure and catenary has been appointed to University of Zagreb Faculty of Civil Engineering. Overhead line analysis comprised from several measuring procedures, including supporting columns evaluation, catenary stagger, height, shocks and wear. Such extensive analysis included GPS positioning and on-site evaluation of 1214 supporting columns of overhead line, as well as overhead line measurements using an instrumented tram vehicle o

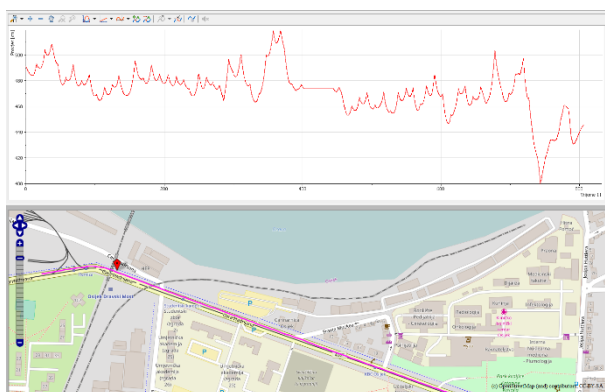
Height difference in respect to travelled distance has also been analysed because it can lead to loss of contact between the pantograph and the wire, Figure 5.

Fig. 5. Substantial height difference of overhead wire (right).

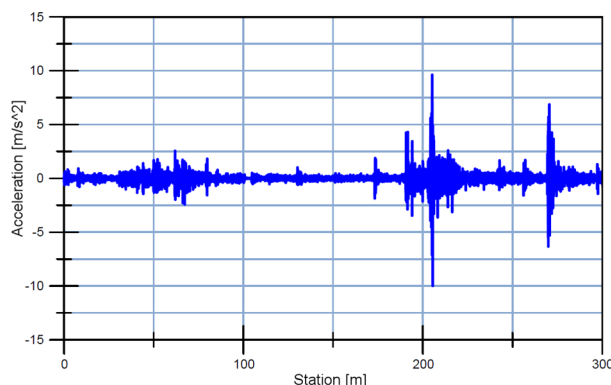
Through vibration analysis different average level of vibrations have been recorded on different track segments as well as individual shock events on the catenary, Figure 6. Such data is important for evaluation of overhead line wear, joints, overlaps and potential weak spots.

Fig. 6. Overhead wire shock time signal sample.

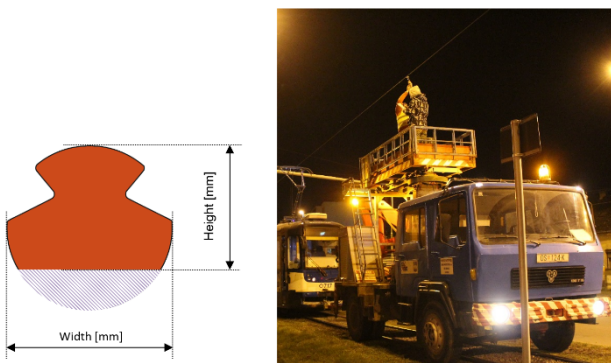
Fig. 9. Measurement of overhead wire wear.

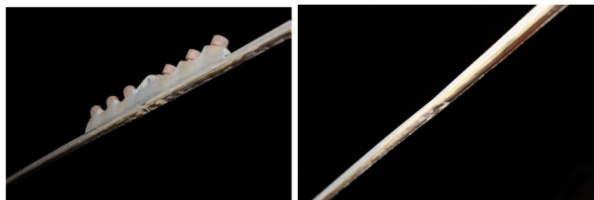
Fig. 10. Inspection of wire joints and potential weak spots.

Such inspection, together with historic data of GPP Osijek maintenance division, revealed 79 joints due to wire breakage, 46 substantially worn spots and other potentially critical points, Figure 10.
