# Case-study of the out-of-plane wall failure of a typical downtown building in Zagreb

*Source / Izvornik:* **1st Croatian Conference on Earthquake Engineering 1CroCEE, 2021, 1557 - 1567**

### 3 Case study: Building in Mrazoviceva street

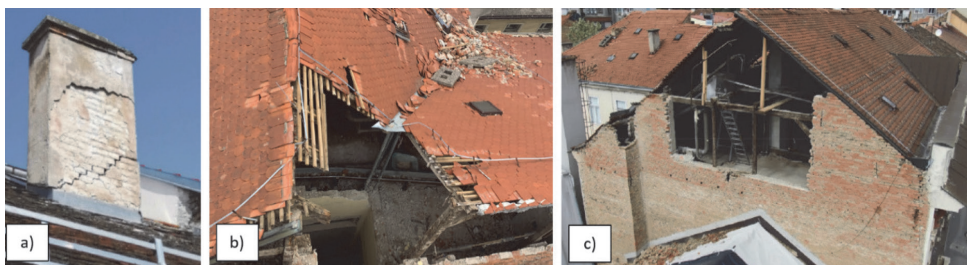
The earthquake that hit Zagreb, the capital city of Croatia, on March 22, 2020 at 6:24 local time was magnitude 5.5, according to Richter. The epicenter was located 7 km north of the Zagreb historic centre. The earthquake, although of moderate magnitude, caused great material damage, especially to the buildings in the historic core of the city. The building fund of the City of Zagreb includes a large number of traditional unreinforced masonry buildings. This kind of buildings are most often consisting of interconnected load-bearing masonry walls and flexible horizontal structures with wooden beam elements. The damage to this type of structures during earthquakes most often occurs due to uneven distribution of seismic forces due to flexible floor structures, inappropriate or non-existent interconnections of elements, and poor contact with the roof and floor structure [1]. Postearthquake survey of buildings in Zagreb showed that the most common damage to this kind of masonry buildings in the city center is associated with local damage to the roof (Figure 1.b.), collapse of attic chimneys (Figure 1.a), and partial or complete collapse of gable attic walls (Figure 1.c) [2].

**Figure 1. a) Collapse of chimneys; b) roof damage; c) collapse of attic gable wall [2]**

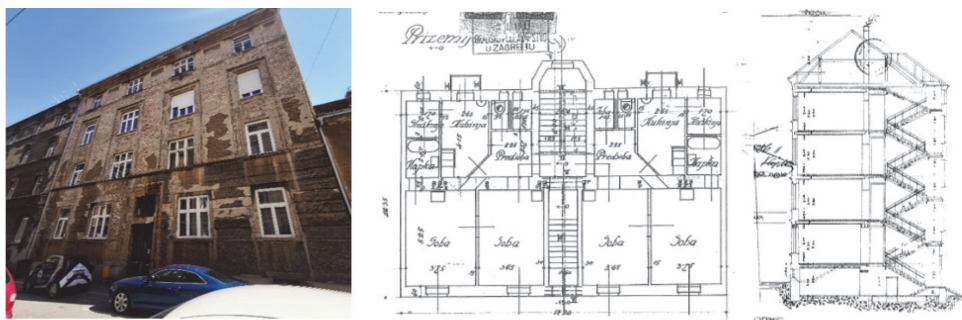
The case-study unreinforced masonry building is built 1911 and it is located in the center of Zagreb. The building is built in block (Figure 4.a). The building has a basement, 4 storeys and the attic. The plan dimensions are 18,20 x 11,35 m (Figure 4.b) and the building height is 17,5 m. The structural system consists of interconnected solid brick walls and floor system are timber joists except for the basement where it consists of concrete slab with steel girders. The load-bearing walls are made of solid brick of the old format (290 × 140 × 65 mm) that are 75, 60, 45 and 30 cm thick. The thickness of the walls narrows with the height of the building. The layout of the walls and the structural system are classic for this period of construction. The post-earthquake survey showed that cracks are mostly present on the non-structural elements, parapets, partition walls, and lintels. Severe damage suffered chimneys and the west gable wall that partially collapsed (Figure 5.a). During inspection, the cracks were observed along the connection of façade wall with floors and perpendicular wall which indicated out-of-plane displacement of the façade wall (Figure 5.c).

Figure 4. a) Case-study building in Mrazoviceva Street; b) Archive architectural drawings

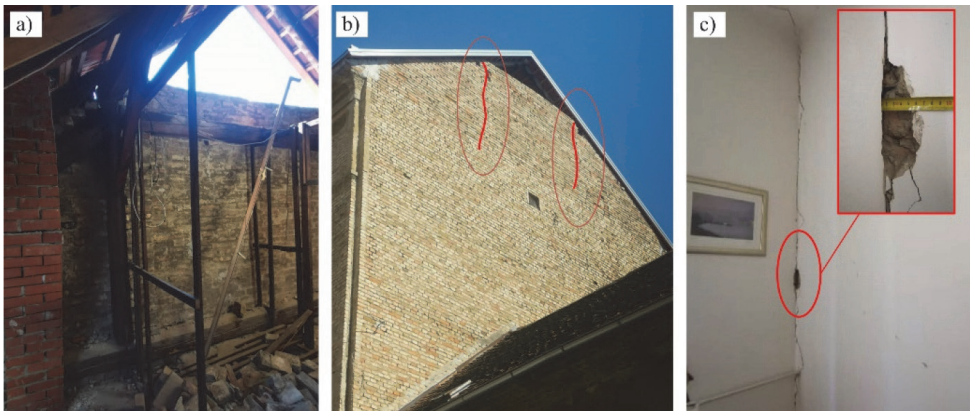
Figure 5. a) Gable wall inside the attic; b) Crack patterns of gable wall; c) Cracks on the connection of facade wall and perpendicular wall

For mechanism 1, only 17 % of the linear model demand and 20 % of the nonlinear model demand is fulfilled. This wall, however, only partially collapsed in the earthquake in March 2020. The model used in the analysis assumes complete separation of the wall from the rest of the structure, but it can be seen from the photographs on Figure 5. a) and b) that in the thirds of the length the wall was thickened with an additional layer of bricks, that certainly helped to prevent complete separation. It should be noted that cracks exist in these parts of wall that are visible from the outside (Figure 5.b). We also emphasize here that the main direction of the earthquake that happened, was approximately parallel to the gable wall plane, which certainly influenced the maximum value of the acceleration that affected this wall. The same wall was analysed in mechanism 2 where it includes the part of the wall on the storey below the attic. In the linear model, there is the fulfilment of 12 % of the demand, while the displacement capacity demand is fulfilled with 47 %. For this wall the connections with perpendicular walls is not completely impaired, so there are some reserves in terms of friction force that is present at the junction of the walls that was not considered in the analysis. The results of street façade wall considered in mechanism 3 showed that the wall should have been most likely activated during earthquake since linear model had fulfilment of 30 %. However, in the nonlinear model, the model had almost complete fulfilment of the demand that was 98 %. This wall, unlike the gable wall, was exposed to a greater acceleration values when considering the main direction of the earthquake. The façade wall on the courtyard side, mechanism 4, have satisfied requirement of the linear model so it was concluded that it was not activated in earthquake, therefore, the nonlinear model was not considered.
