POST-EARTHQUAKE ASSESSMENT AND DOCUMENTATION OF TIMBER ROOFS

ABSTRACT: In 2020 Croatia was struck by two strong earthquakes. Croatian building stock is in big part made of masonry with timber floor and roof structures. Given that masonry structures are highly vulnerable to seismic actions, damage occurred to more than 70.000 buildings. Due to widespread damage, there is a great need for a detailed and more comprehensive post-earthquake damage assessment. This paper briefly presents the post-earthquake damage assessment in the historic parts of Zagreb and the surrounding area after the recent earthquakes in 2020. Special focus is set on traditional timber roofs – traditional roof systems in Croatia, damages to the load-bearing elements due to earthquake excitations, maintenance issues, wrong renovation of the attics, etc. Also, the role of UAVs, photogrammetry and laser scanners in the assessment and preservation of heritage buildings is shown.

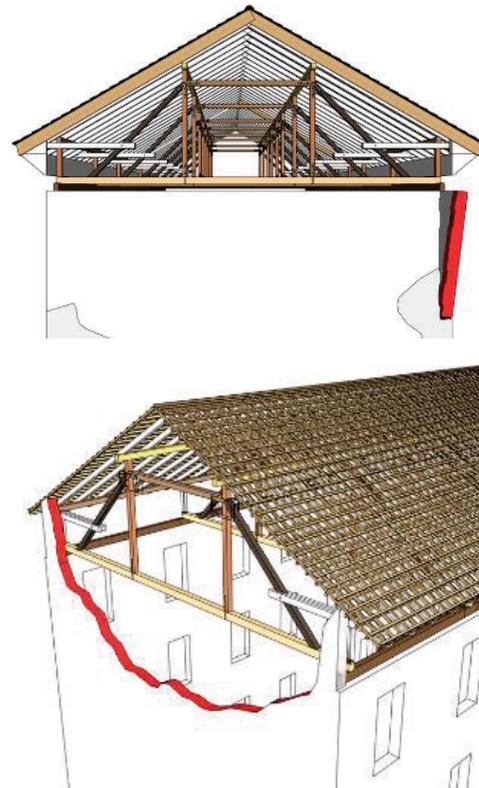
The failure of non-structural elements such as chimneys and decorative elements on facades was observed on almost all buildings in the city center. Failure of gable walls, masonry columns, wall sections between or under windows, vaults, ceilings, staircases, etc. was common. Since the two materials (timber and masonry) have very different properties and masses, the post-earthquake damage was also very different. The two most typical masonry damages, due to the "pushing" of timber elements and the poor connection with masonry walls, are shown in Figures 3 & 4.

Figure 3: Typical damages to masonry walls

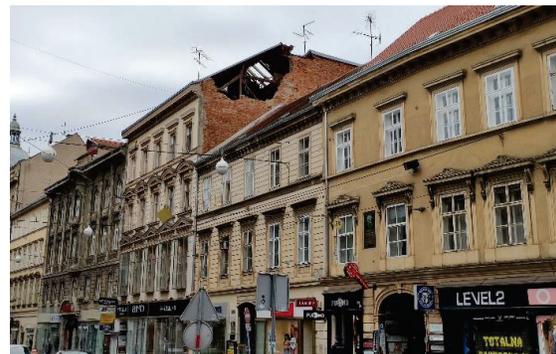
Figure 4: Failure of gable walls (photo credit: M. Stepinac)

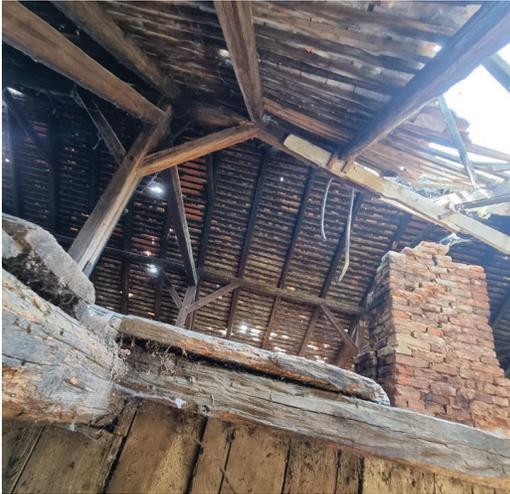
Roof systems often become unstable due to the collapse of individual load-bearing walls beneath them or severe chimney failures (Figure 5 & 6). Post-earthquake inspections showed that many of the chimney failures resulted in direct damage to the roofs. In some locations, the chimneys damaged the supporting roof structure, but in most cases only the rafters broke and the integrity of the roof was maintained (Figures 7 and 8).

Figure 5: Failure of timber elements due to chimney failure (photo credit: R. Gulić)

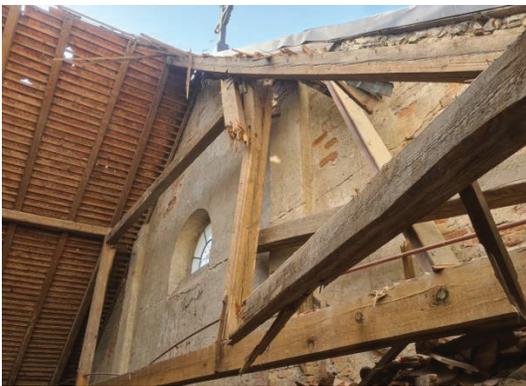
Figure 6: Timber roof collapse – Sisak cathedral (photo credit: Studio Arhing d.o.o.)

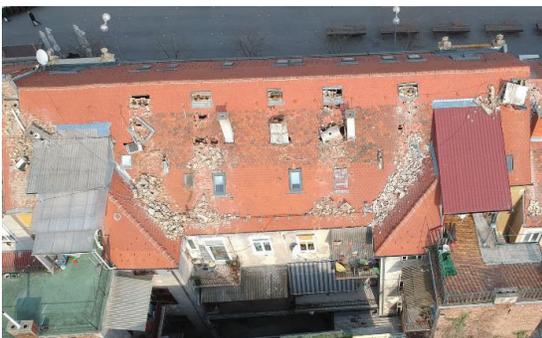
Figure 7: Failure of chimneys (from outside) (photo credit: M. Stepinac)

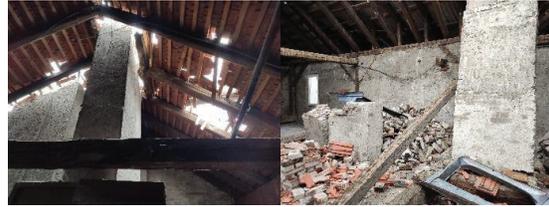
Figure 8: Failure of chimneys (from inside) (photo credit: M. Stepinac)

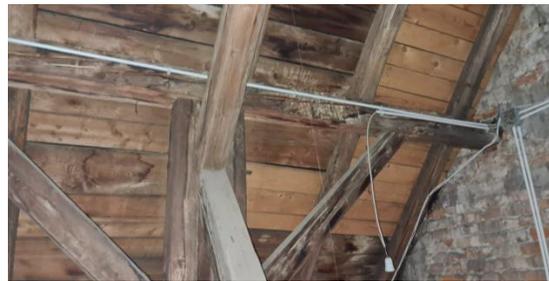
Maintenance was identified as one of the most important aspects that contributed to the condition of buildings after the earthquake. Since a large number of buildings were poorly maintained or not maintained at all, the properties of the masonry deteriorated over the years, and the seismic performance of such buildings was worse [5]. In many cases, water penetration degraded the properties of both masonry and wood elements (Figure 9).

Figure 9: Failure of timber elements due to water leakage and seismic excitations (photo credit: Studio Arhing d.o.o.)

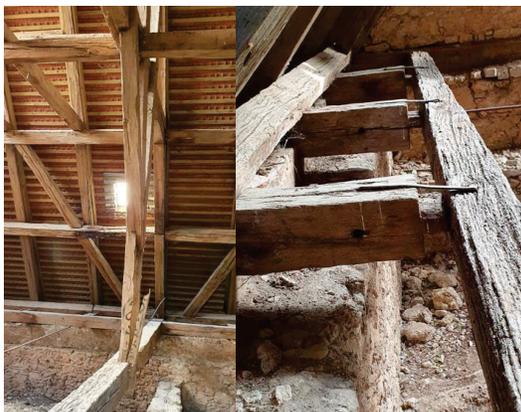
Timber beams on wall parapets along with attic ceiling wooden beams were severely deteriorated due to aforementioned lack of maintenance and due to original defects at the time of construction. The inadequate connections and bad detailing is common and one example is shown in Figure 10. As carpentry joint were used for connections, often, “secondary constructive” screws were missing. Although carpentry joints are considered good in terms of characteristic load combinations, when it comes to dynamic loading with cyclic nature, like earthquake, poor behavior was observed in several cases.

Figure 10: Bad detailing (photo credit: Studio Arhing d.o.o.)

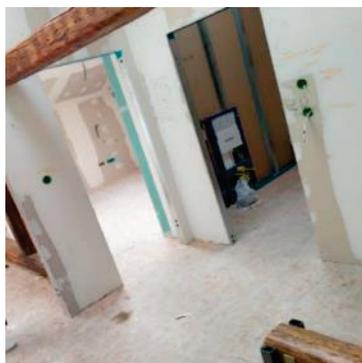
Typical conversions of building spaces convert non-living spaces (e.g., basements, attics, or utility rooms). This room conversion often involved demolition of partition walls, and undesirable intervention in the load-bearing walls is also common. The conversion of the attic for living purposes resulted in numerous changes to the roof structure. Often timber tie elements were cut to insert the door (Figure 11), which significantly changed the basic static system of the roof structure itself. Also, traditional timber structural systems were replaced by masonry or concrete elements as shown in Figure 12.

Figure 11: Improper attic modifications (photo credit: HCPI [4])

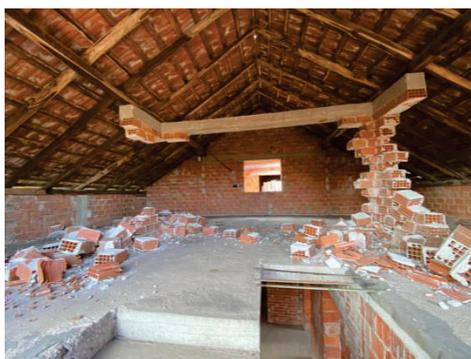
Figure 12: Improper attic modifications (photo credit: HCPI [4])

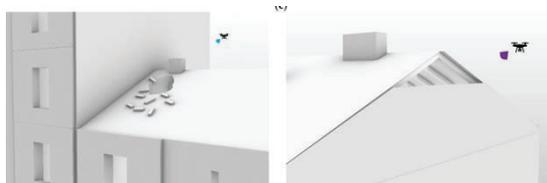
Figure 13: Possible damage on the roof level of a building after an earthquake [16]
