POST-EARTHQUAKE ASSESSMENT AND DOCUMENTATION OF TIMBER ROOFS

ABSTRACT: In 2020 Croatia was struck by two strong earthquakes. Croatian building stock is in big part made of masonry with timber floor and roof structures. Given that masonry structures are highly vulnerable to seismic actions, damage occurred to more than 70.000 buildings. Due to widespread damage, there is a great need for a detailed and more comprehensive post-earthquake damage assessment. This paper briefly presents the post-earthquake damage assessment in the historic parts of Zagreb and the surrounding area after the recent earthquakes in 2020. Special focus is set on traditional timber roofs – traditional roof systems in Croatia, damages to the load-bearing elements due to earthquake excitations, maintenance issues, wrong renovation of the attics, etc. Also, the role of UAVs, photogrammetry and laser scanners in the assessment and preservation of heritage buildings is shown.

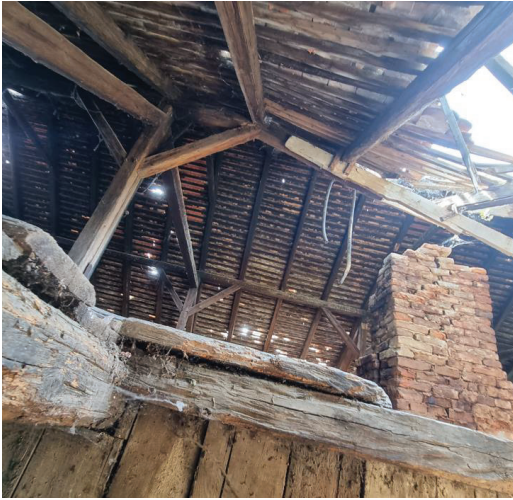
Roof systems often become unstable due to the collapse of individual load-bearing walls beneath them or severe chimney failures (Figure 5 & 6). Post-earthquake inspections showed that many of the chimney failures resulted in direct damage to the roofs. In some locations, the chimneys damaged the supporting roof structure, but in most cases only the rafters broke and the integrity of the roof was maintained (Figures 7 and 8).

Figure 5: Failure of timber elements due to chimney failure (photo credit: R. Gulić)

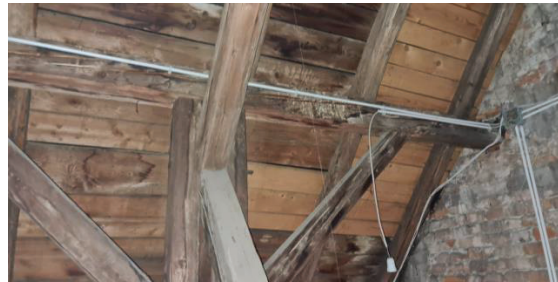
Maintenance was identified as one of the most important aspects that contributed to the condition of buildings after the earthquake. Since a large number of buildings were poorly maintained or not maintained at all, the properties of the masonry deteriorated over the years, and the seismic performance of such buildings was worse [5]. In many cases, water penetration degraded the properties of both masonry and wood elements (Figure 9).

Figure 9: Failure of timber elements due to water leakage and seismic excitations (photo credit: Studio Arhing d.o.o.)

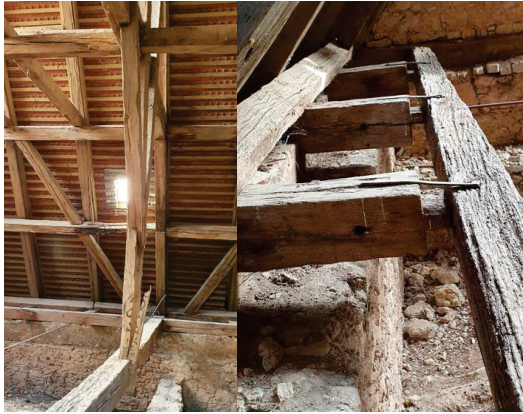
Timber beams on wall parapets along with attic ceiling wooden beams were severely deteriorated due to aforementioned lack of maintenance and due to original defects at the time of construction. The inadequate connections and bad detailing is common and one example is shown in Figure 10. As carpentry joint were used for connections, often, “secondary constructive” screws were missing. Although carpentry joints are considered good in terms of characteristic load combinations, when it comes to dynamic loading with cyclic nature, like earthquake, poor behavior was observed in several cases.

Figure 10: Bad detailing (photo credit: Studio Arhing d.o.o.)

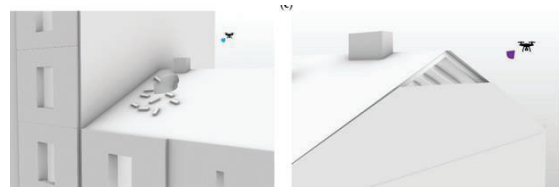
Unmanned aerial vehicles (UAV) have proven very useful during the rapid assessment of roofs, as well as detecting defects/damage in hard-to-reach places. Figure 13 shows a post-earthquake assessment scenario using a UAV. An engineer cannot see what has happened on the higher floors or on the roof of a building during an on-site assessment from the street. With a UAV device the above information can be easily assessed.

Figure 13: Possible damage on the roof level of a building after an earthquake [16]
