# Assessment and Rehabilitation of Culturally Protected Prince Rudolf Infantry Barracks in Zagreb after Major Earthquake

**Abstract:** Recently, Zagreb was struck by a strong earthquake. Damage throughout the city was tremendous due to numerous aged and vulnerable masonry buildings. Many damaged buildings are under a certain level of cultural heritage protection. Hence, reliable assessment and effective rehabilitation are important to preserve cultural significance and mitigate risk for human life. With that in mind, the procedure of a detailed condition assessment of the building under heritage protection is presented. A detailed historical background of the case study building is shown, and observed damage and conducted in situ tests are discussed. The nonlinear static seismic analysis performed in the 3Muri software is extensively elaborated. Four different levels of reconstruction according to new Croatian law are briefly presented. Additionally, several strengthening scenarios are proposed with various strengthening techniques.

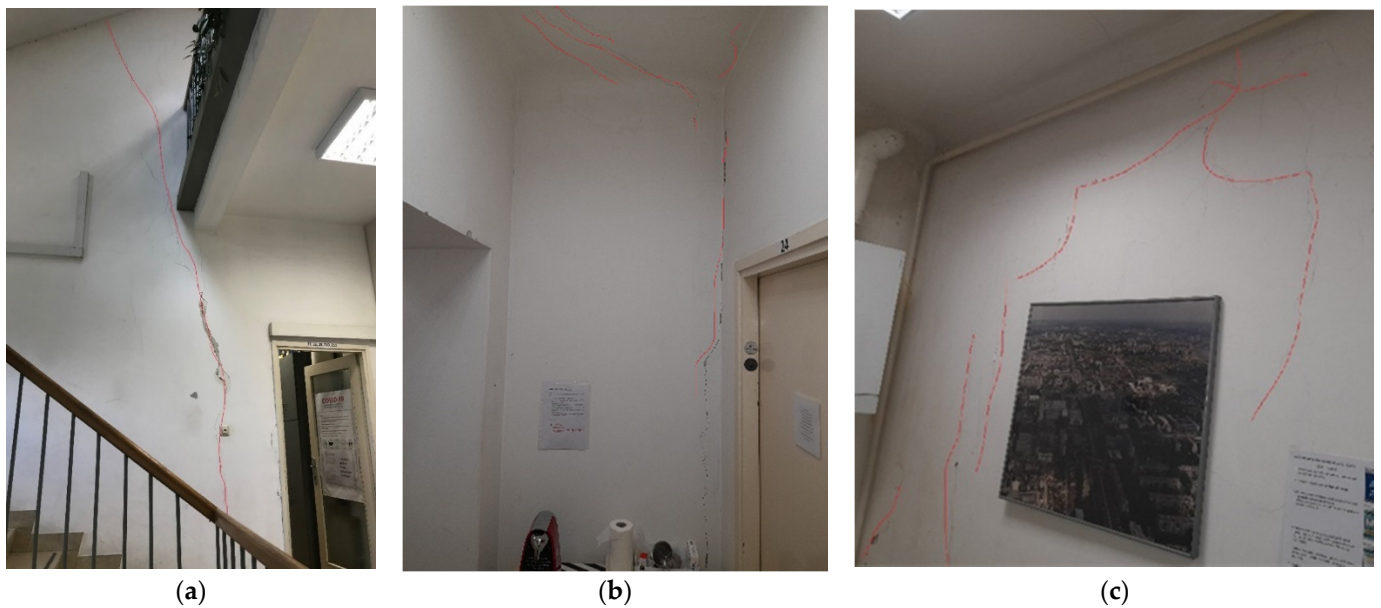
- Several minor cracks were observed on the façades of the building. Due to their slenderness and low vertical load chimneys failed predominantly by shear sliding and overturning. Additionally, roof displacement and collision with chimneys increased failure occurrences.

- On the ground floor, small cracks were noticed at the places of the lintel and at the connections of the walls and ceiling. Lintels are weakened parts of the masonry walls and are therefore vulnerable since the damage is usually concentrated in them.

- On the first floor, major damage was noticed at the connection of partition and load-bearing walls and at the connection of walls and ceilings. Observed damage is not surprising because at the partition and load-bearing wall connections and wall and ceiling connections, there is a discontinuity of material and contact of different materials that have different behavior, and thus, there are different displacements that cause cracking. Often, such cracks do not pose a significant hazard.

- The original staircase has not been preserved, and the existing staircase has minor damage that does not indicate a threat to mechanical resistance and stability.

**Figure 8.** (a) Damage to the stair system; (b) Damage at the connections of load-bearing and partition walls; (c) Slight damage to the load-bearing walls.

This inspection established conservation guidelines for the repair of load-bearing and partition walls, staircases and floor structures. The façade and roof design should be preserved along, with the reparation of existing damage after conducting detailed conservation and restoration research. In addition, this paper analyzed retrofitting strategy as one of the methods to preserve the “outer look” of the building.

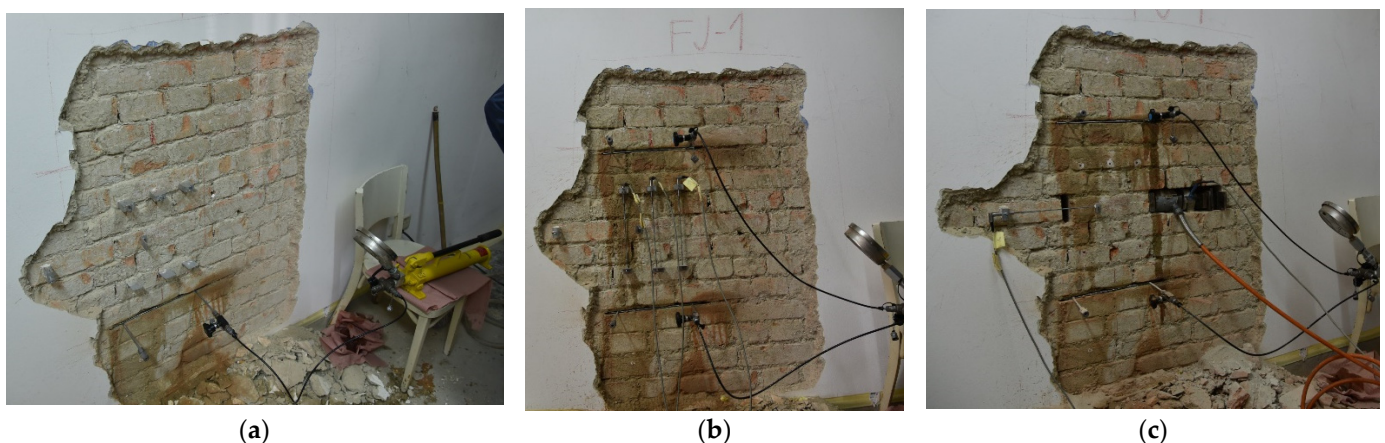
According to the tests (Figure 10), the following values were obtained: compressive stress state in masonry at test location  $\sigma_0 = 0.46 \text{ N/mm}^2$  (used for model calibration regarding weight distribution), modulus of elasticity  $E = 1469.5 \text{ N/mm}^2$  (used for wall stiffness definition), initial shear strength  $f_{v0} = 0.323 \text{ N/mm}^2$  (used for wall shear resistance definition) and coefficient of friction  $\mu = 0.447$ .

**Figure 10.** (a) Connected hydraulic system and flat jack; (b) Determination of stress and deformation dependence of masonry; (c) Testing of shear strength of masonry with control of vertical stress by flat jacks. (photo credit: Luka Lulić).

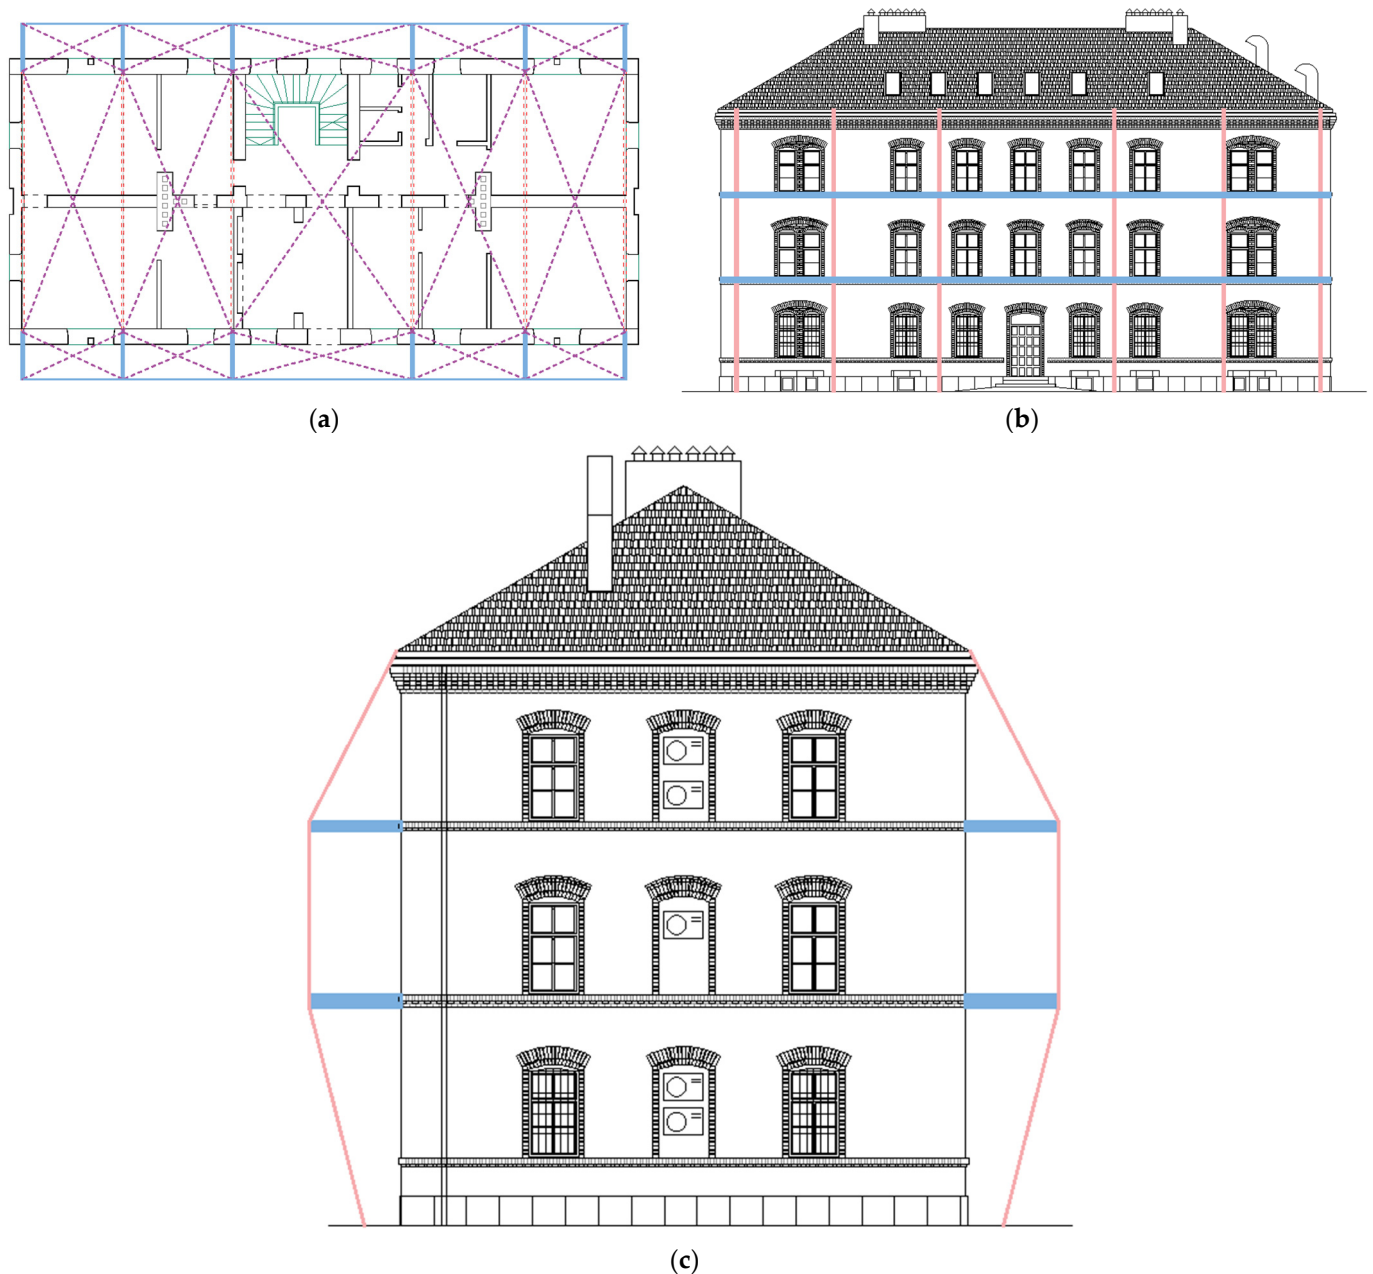
**Figure 24.** Alternative solution for the retrofitting: (a) ground floor plan; (b) longitudinal section; (c) transversal section.

Additionally, this paper analyzed the possibility to perform an equivalent system for an alternative retrofitting strategy to take over horizontal forces. An example of an idea for an equivalent system for taking over horizontal forces can be found in Figure 24. The idea of an equivalent system for taking over horizontal forces consists of using existing steel beams (crossbeams) in the floor structure. New steel beams would be added to the existing steel beams, which would end outside the structure itself. The new steel beams would be externally connected to the steel rope, as shown in Figure 24. Bracing elements could be placed to ensure the common behavior of the whole system and the building and ensure sufficient transverse stiffness.
