# The Assessment and Retrofitting of Cultural Heritage—A Case Study of a Residential Building in Glina

Karlo Ožić<sup>1</sup>, Ivan Markić<sup>2</sup>, Antonela Moretić<sup>1,\*</sup> and Luka Lulić<sup>1</sup>

**Abstract:** The focus of the study is on the renovation of a specific case study, which is a 19th century building under cultural heritage protection. It highlights the particular challenges faced by civil engineers in the structural renovation of buildings that are under heritage protection. Preserving the identity of these buildings limits the available methods for strengthening their seismic capacity. At the beginning, information about the seismic activity and the different post-earthquake evaluation procedures are presented to identify the damage and take appropriate further steps. Then, basic information about the building is given and supported by graphic attachments. In the following, the methods and materials are explained, focusing on in situ testing with the semi-destructive flat-jack method and the analysis of the structure with the nonlinear method implemented in the software. Subsequently, the obtained results are presented and discussed, accompanied by gra

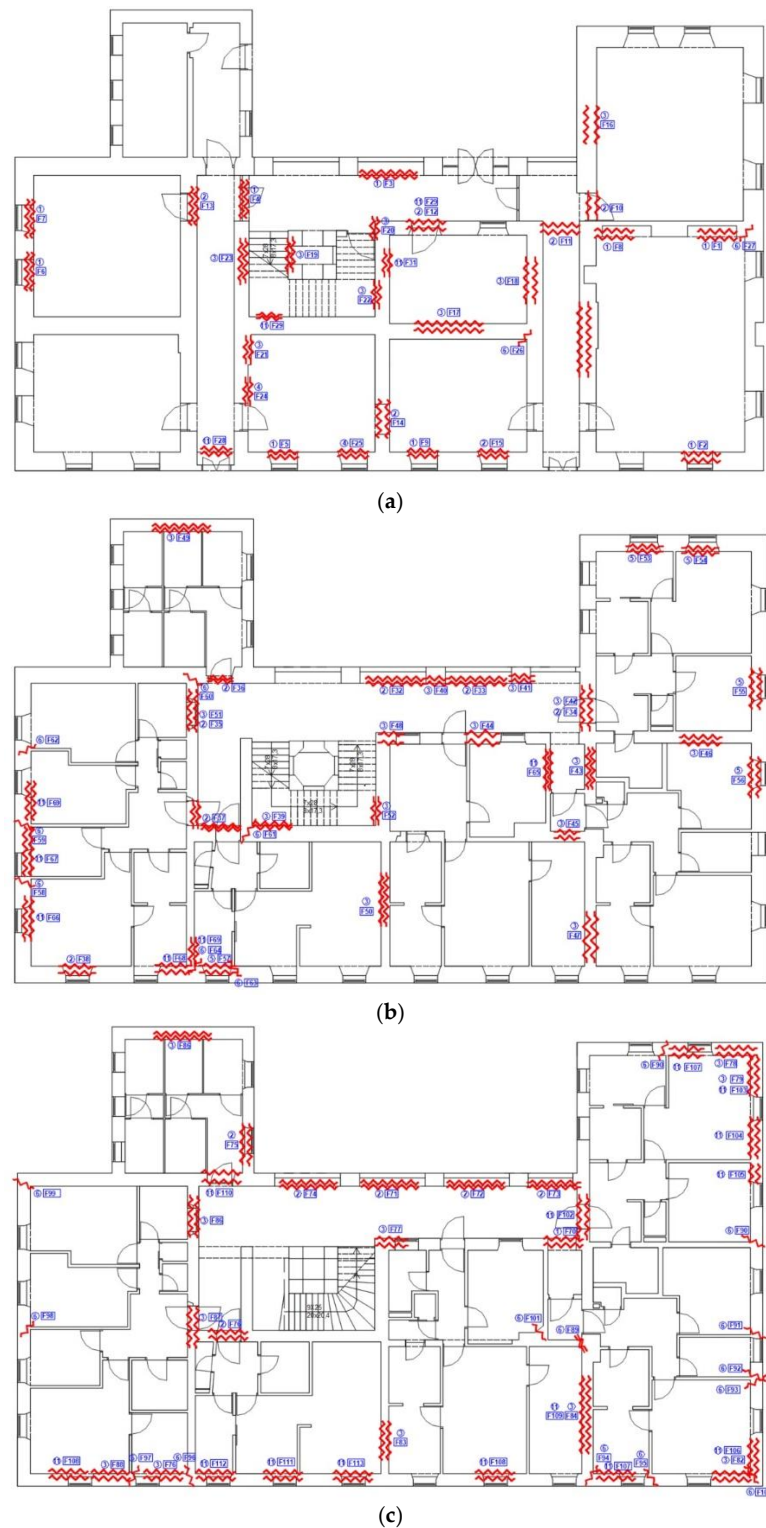
After a rapid inspection, a detailed inspection of the building was carried out in May 2022. All instances of damage, structural and non-structural (Figure 7), were photographed and described in reports on the floors of the building and the individual rooms in which they are located, and proposed measures for their repair were given. A detailed recording of the existing condition was also made for the purpose of creating digital floor plans of the building.

**Figure 7.** Damage patterns (red marks): (a) ground floor, (b) first floor, and (c) second floor.
