Seismic Retrofitting of Dual Structural Systems—A Case Study of an Educational Building in Croatia

Mario Uroš¹

The building of the higher education institution in Petrinja, Croatia, was built in 1963 and underwent energy renovation in 2018. The building consists of the ground, 1st, and 2nd floors; the area on the ground floor is 1294.3 m² and on the upper floors 603.4 m². The total gross floor area of the building is 2501.1 m², while the useful heated area of the building is approximately 2130 m². The building has an irregular T-shaped layout and consists of three volumes connected into one whole (Figure 3). In the northwest–southeast direction (hereafter X-dir), there are two volumes that have only the ground floor. The volume marked as V1 is 3.84 m high, while the volume V2 in the southeastern part of the building is 5.52 m high and consists of a one large hall. The central volume V3 of the building is arranged in a northeast–southwest direction (hereafter Y-dir) and has three stories with a total height of 11.52 m.

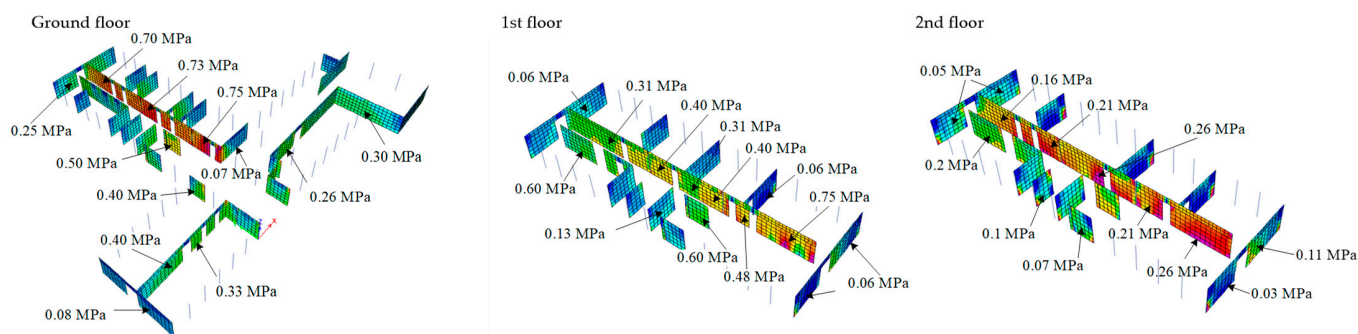
Figure 11 shows normal stresses of masonry walls. As can be seen, the stress in the walls of the ground floor is up to 0.75 MPa on the central longitudinal brick wall, which is about 22% of the compressive strength of the walls.

Figure 11. Normal stresses in masonry walls due to permanent loads.
