The December 2020 magnitude (Mw) 6.4 Petrinja earthquake, Croatia: seismological aspects, emergency response and impacts

Source / Izvornik: **Bulletin of earthquake engineering, 2023, 21, 5767 - 5808**

Keywords Physical damage · Masonry buildings · Emergency response · Post-earthquake survey · Social impacts

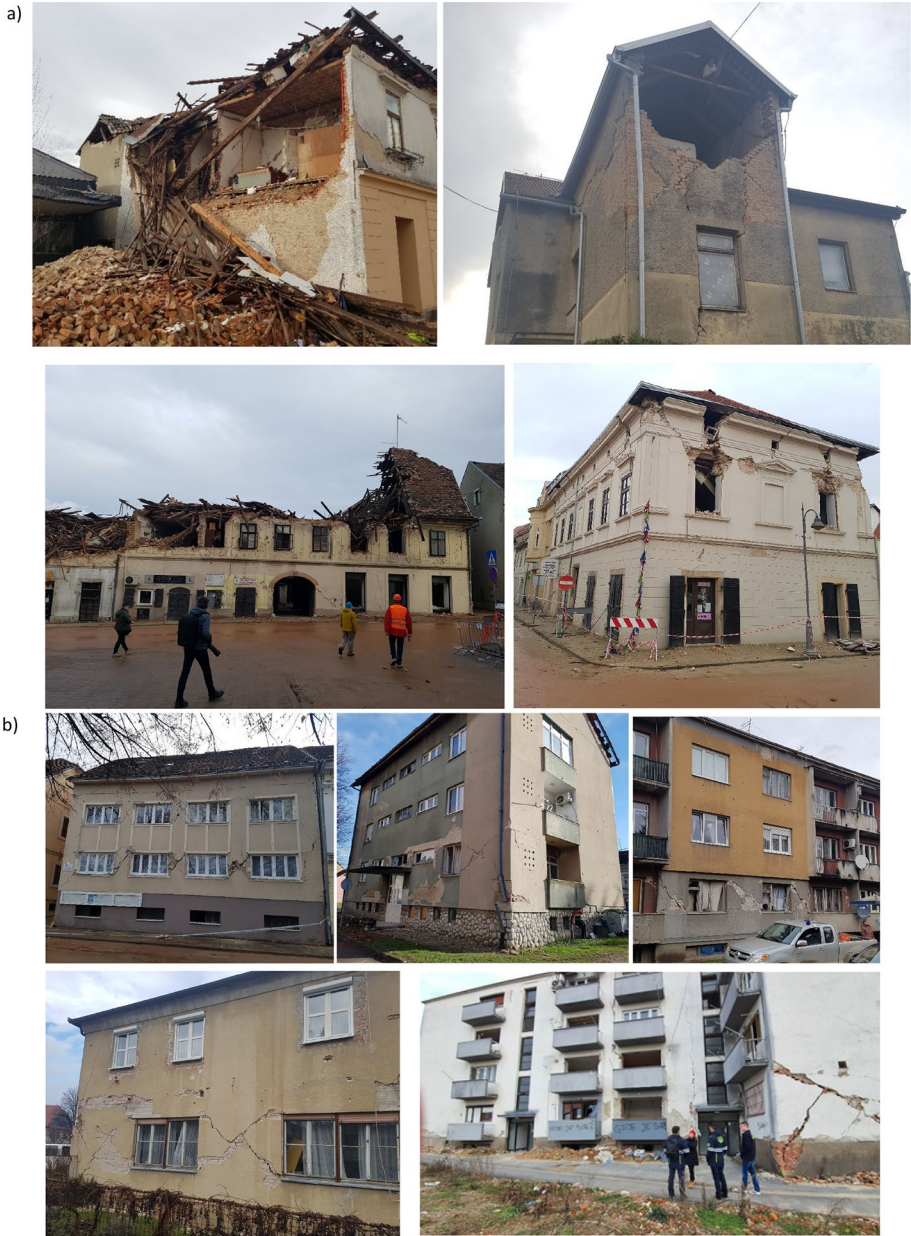
On the other hand, exceedance of the in-plane bearing capacity in load-bearing walls was observed in masonry buildings confined with rigid floor structures that contributed to the box-like behavior. The shear mechanism in the bearing walls is manifested with typical diagonal cracks accompanied by cracking at joints owing to the poor quality of the mortar. The extent of damage concentrated on the ground floor indicates that the first mode dominates the dynamic response (Fig. 17b). Despite the relatively low lateral load capacity of masonry buildings, this confirms their moderate ductility due to the strong nonlinear behavior that includes stiffness changes due to cracking. The introduction of adequate diaphragm interconnecting the load-bearing elements, where installed, provided a favorable load distribution resulting in increasing of the building's global resistance to seismic loading. Although details of the connection between the confining

Fig. 17 Damage to unreinforced masonry buildings: **a** out-of-plane failure mechanisms, **b** in-plane failure mechanisms (CCEE 2022)

floor structure and the bearing walls are still not precisely known, field observations showed that, in such cases, the minimum requirement to prevent failure due to an out-of-plane mechanism has been met.
