The December 2020 magnitude (Mw) 6.4 Petrinja earthquake, Croatia: seismological aspects, emergency response and impacts

Source / Izvornik: **Bulletin of earthquake engineering, 2023, 21, 5767 - 5808**

The December 2020 magnitude (M_w) 6.4 Petrinja earthquake, Croatia: seismological aspects, emergency response and impacts

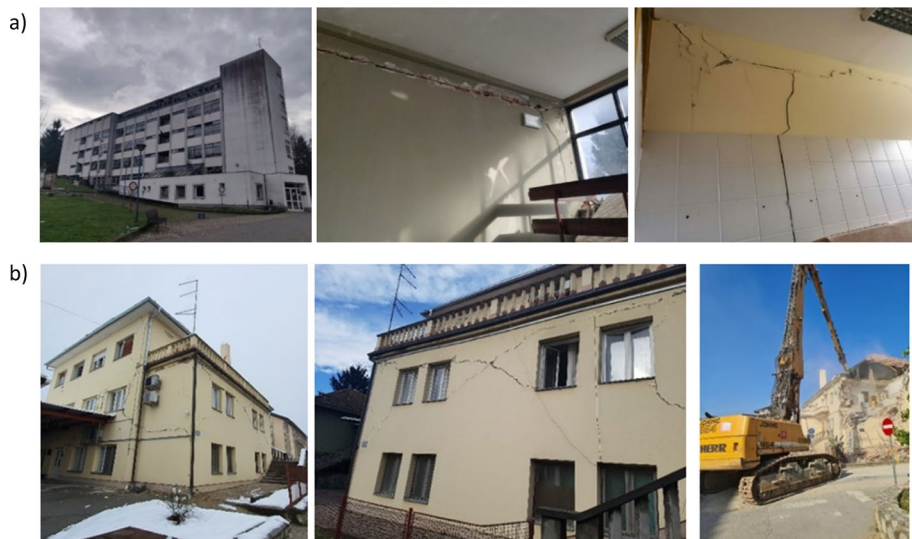
The Special hospital for chronic diseases in Petrinja was moderately damaged and was evaluated as temporarily unusable pending a detailed engineering inspection. Damage to gable and partition walls is given in Fig. 10a. Another important health care facility in

Fig. 10 Petrinja, damage to buildings in the health sector: **a** Special hospital for chronic diseases and **b** Health center in Petrinja (photos: private collection of authors and courtesy of Tina Nikolić, Joning d.o.o.)

Petrinja, the Community Health center also suffered heavy damage (Fig. 10b). Most of the load-bearing walls were significantly damaged and the chimneys collapsed. The building has a reinforced concrete ribbed slab which prevented the development of out-of-plane failure mechanisms. Partition walls were severely damaged and a number of them collapsed. Following a detailed inspection, it was decided to demolish the building.

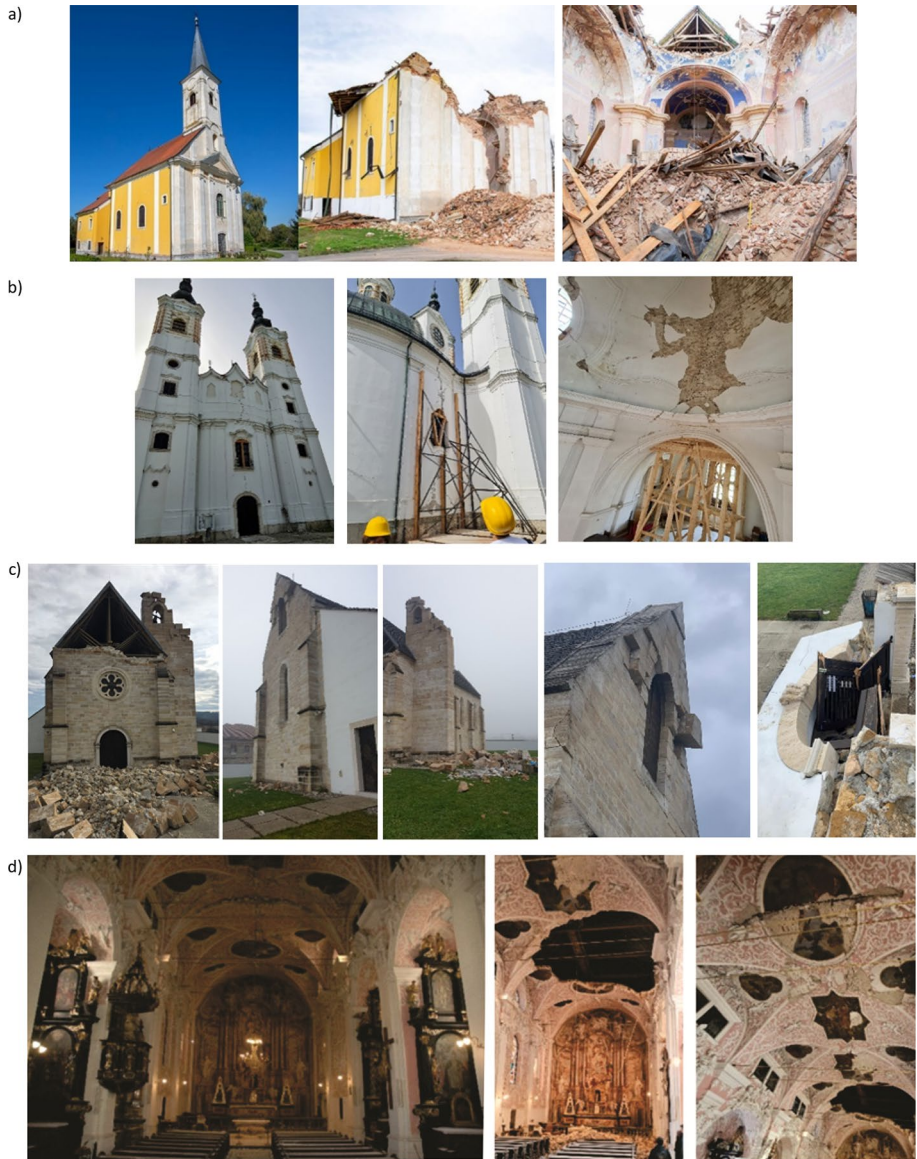
Figure 14a shows the church of St. Nicholas and St. Vid in Žažina, which suffered considerable structural damage caused by collapse of the bell tower. Part of the roof of the main nave also collapsed as did the vaults supporting the roof structure. Unfortunately, the organist of the parish lost his life under the rubble in this church. One of the most valuable and beautiful Baroque churches in continental Croatia is certainly the parish church of St. Mary Magdalene in Sela near Sisak (Fig. 14b). Both towers of the church, the entrance portal, the lintels and walls, and the dome were severely damaged. Urgent protective measures were therefore implemented including the erection of supporting scaffolding to alleviate any threat of collapse of arches and external walls, and stabilization of both towers. The third example shown here is the parish church of the Assumption of the Virgin Mary in Gora. This church was destroyed and rebuilt several times over the centuries. The last facsimile reconstruction of this early Gothic Templar church of carved stone blocks was completed in 2015 without any modern materials and techniques. The authentic reconstruction work was based on extensive archaeological and conservation-restoration research (Miletić and Valjato Fabris 2014). However, the project obviously lacked awareness of the seismic risks, and the new church sustained extensive damage, the tower collapsed together with several arches and part of the roof structure (Fig. 14c).

Due to the significant number of damaged buildings following the March 2020 Zagreb earthquake and insufficient time and resources, a large portion of those buildings remained without proper preventive measures and reconstruction. When the December 2020 Petrinja earthquake hit the region, it caused additional damage to structures already damaged by the previous earthquake. An example of such progressive damage is the church of St. Catherine in the Upper Town Zagreb, whose vaults extensively damaged during the previous earthquake collapsed together with parts of the ceiling (Fig. 14d).

Fig. 14 Damage to sacral buildings: **a** Church of St. Nicholas and St. Vid in Žažina, **b** Church of St. Mary Magdalene in Sela, **c** Church of the Assumption of the Virgin Mary in Gora, and **d** Church of St. Catherine in Zagreb after Zagreb earthquake (left) and after Petrinja earthquake (center and right) (photos: courtesy of Sisak archdiocese 2021; CCEE 2022; and Martina Vujanović, 2022)
