Post-Earthquake Dynamic Performance of Intact Masonry Building Based on Finite Element Model Updating

Ivan Duvnjak *, Suzana Ereiz, Marina Frančić Smrkić

As a case study, a building of a high school in Sisak (Figure 1) built in 1935 was taken. The building has four floors: basement, ground floor, and two upper floors. In the central part of the building there is a three-legged staircase with a landing. The foundations are constructed as a reinforced concrete slab. The load-bearing part of structure consists of walls made of solid bricks of 29(39) cm × 15 cm × 6.5 cm, floor slabs and reinforced concrete ribbed floor slabs. The thickness of the load-bearing walls in the basement is 60 cm and 75 cm, and 50 cm and 60 cm on the ground floor and upper floors. The partition walls are 15 cm, 18 cm, 25 cm or 30 cm thick and are made of hollow blocks. The floor slab is 25 cm thick and the reinforced concrete ribbed floor slab has a total height of 33 cm. The clear distance between the ribs is 60 cm, the width of the ribs is 13 cm, and the height is 23 cm. At the entrance of the building on the first and second floors, there is a load-bearing part of the structure that rests on columns with

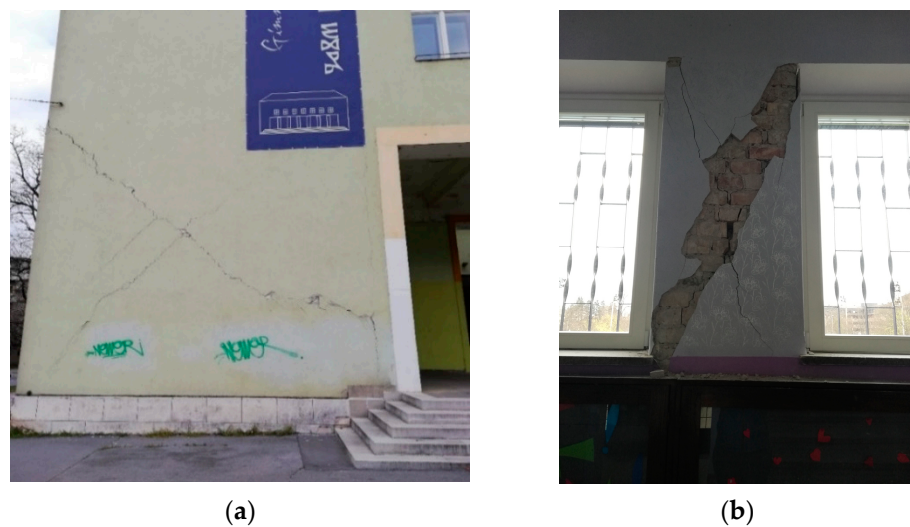
Figure 3. Observed characteristic damages on (a) the load bearing walls (b) the walls between the openings.

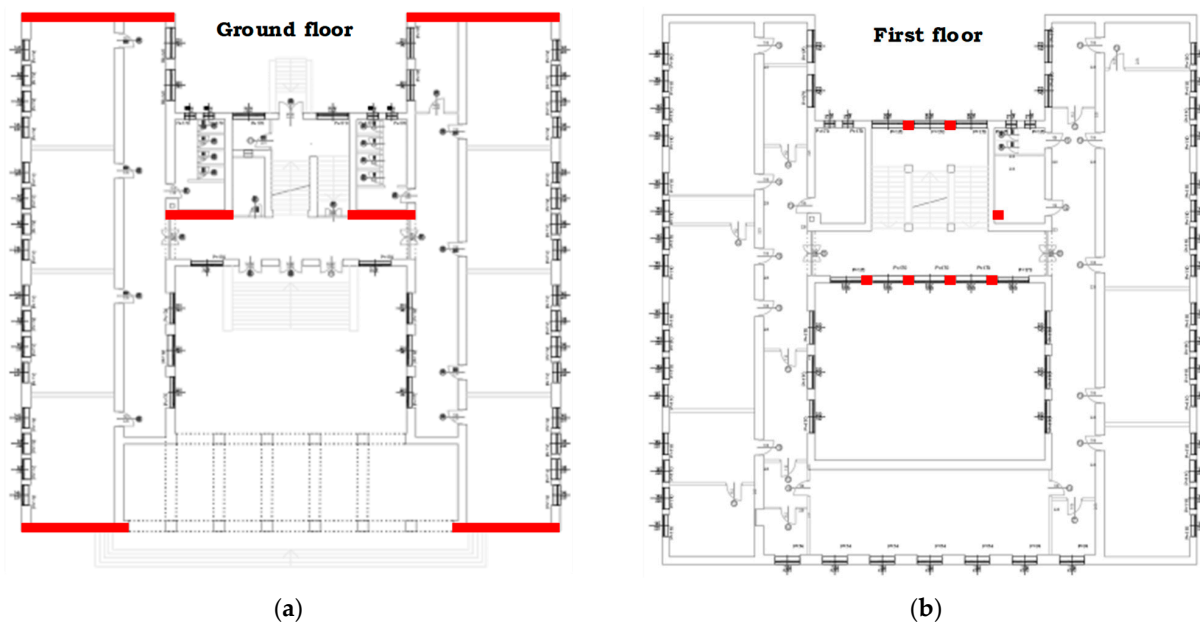
To be able to numerically predict the real structural behavior, the damaged structural elements in this step of analysis are modelled with reduced elasticity modulus. These elements were selected based on a visual inspection and their positions are marked in Figure 11.

Based on the analysis (Figure 12) of the elasticity modulus reduction for the damage construction elements (E_{red}), a decrease in the first natural frequency (f_1^{num}) can be noticed. However, by imitating the damaged parts of the structure with finite elements with a reduced modulus of elasticity, satisfactory results were not achieved. Regardless of the fact that the previous iteration and analysis did not provide satisfactory results (matching values of numerically predicted and experimentally measured natural frequencies), in the next iteration, the simulation of damages in the specified load-bearing walls is retained.

Figure 11. The elements of the model with a reduced modulus of elasticity (red bars) at the (a) ground and (b) first floor.

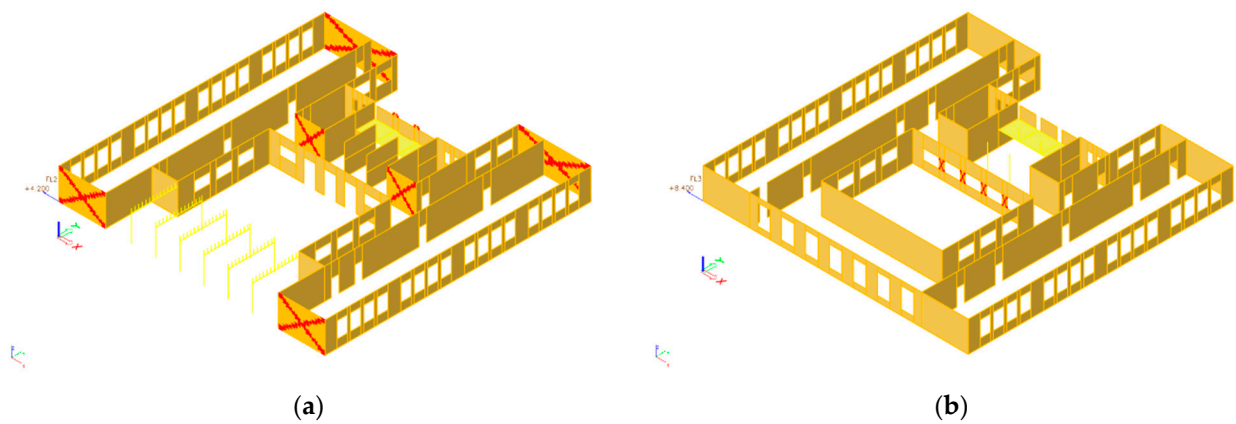
Since the behavior of the structure obtained by experimental testing was not achieved with the previously analyzed updated numerical models, the numerical analysis was carried out on the new model (Model 4). The new model is developed in such a way that the finite elements of the initial numerical model, whose locations correspond to the location of the diagonal cracks determined by visual inspection (Figure 13), were associated with a modulus of elasticity close to 0 (in order to avoid errors in calculation).

Figure 13. The finite elements of the model with a reduced modulus of elasticity at the (a) ground and (b) first floor.
