Potres u Zagrebu od 22. ožujka 2020. - preliminarni izvještaj o seizmološkim istraživanjima i oštećenjima zgrada

Zagreb earthquake of 22 March 2020 – preliminary report on seismologic aspects and damage to buildings

Research Paper

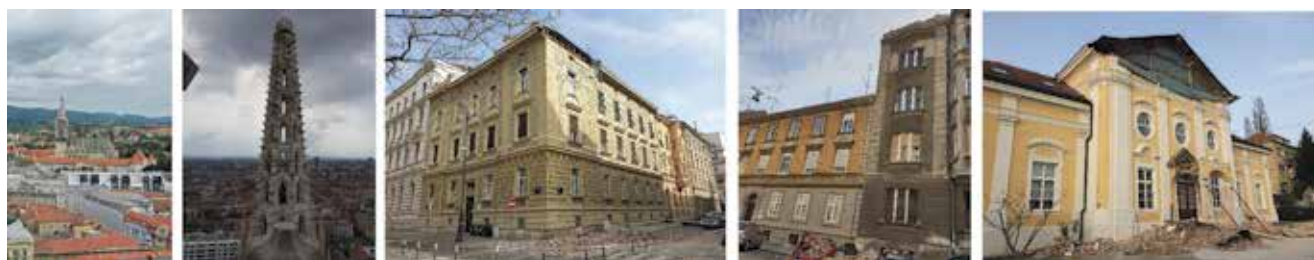
Figure 1. Earthquake effects in historic centre of the city (photos courtesy of: AIR-RMLD d.o.o. www.air-rmld.com, Filip Foretić, Karlo Jandrić)

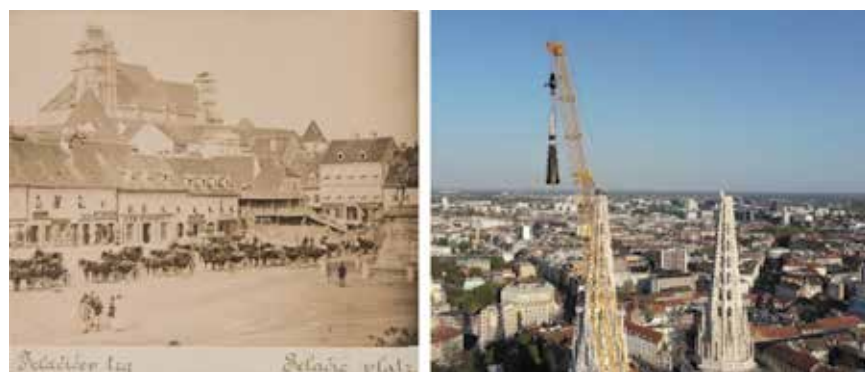
Figure 3. Zagreb Cathedral – tower removal: a) after the 1880 earthquake (source: Museum of the City of Zagreb), b) after the 2020 earthquake (source: Ministry of Defence of the Republic of Croatia)

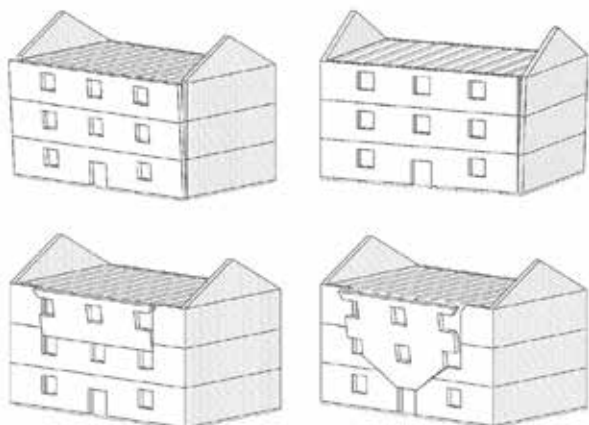
Traditional masonry buildings were most often built as systems of interconnected load bearing walls with timber floor structures. In case of an earthquake, they are mostly damaged because of uneven distribution of stiffness, inadequate or nonexistent interconnections, and poor contact with roof and floor structures (they are very flexible and so walls may deflect out of their plane). An obvious deficiency is the lack of confining elements (vertical and horizontal tie beams), poor bearing capacity in their own plane, and insufficient bearing capacity of roof and floor structures, which causes additional damage. Because of long service life of buildings, poor maintenance, and lack of facade at some external walls (such as gable walls), the material deteriorates quite rapidly thus increasing inhomogeneity of walls and loss of binding material.

Figure 16. Out of plane inclination of walls

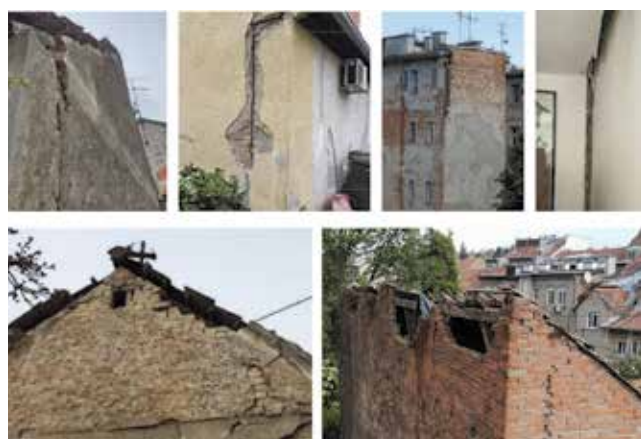
In addition to local collapse of attic gable walls, in more difficult cases the damage involved detachment of gable walls along the entire height or through several floors (Figure 19). The reason is poor connection with walls from the other direction.

Figure 19. Detachment of gable wall and typical cracks in internal part of the building (photos courtesy of Mario Todorčić and [39])

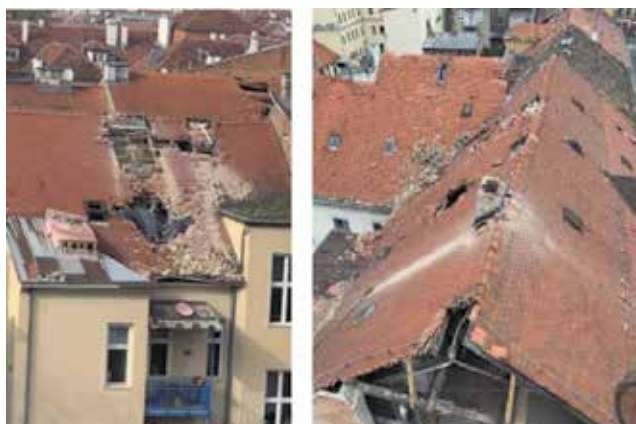
We have pointed out that the most frequent cause of damage to roof structure is the collapse of chimneys, gable walls and other unsupported elements above the roof plane. This is mostly local damage to the roof structure (Figure 20). However, it should be noted that roof structures are usually not adequately stabilised, and due to lack of maintenance and old-age they are additionally unsafe and cannot restrain chimneys and attic gable walls [38]. In some cases, involving flexible roof structures, permanent displacements of the entire roof structure were registered, which is extremely dangerous and requires full reconstruction.

Figure 20. Roof structure damage (photos courtesy of Mario Todorčić)

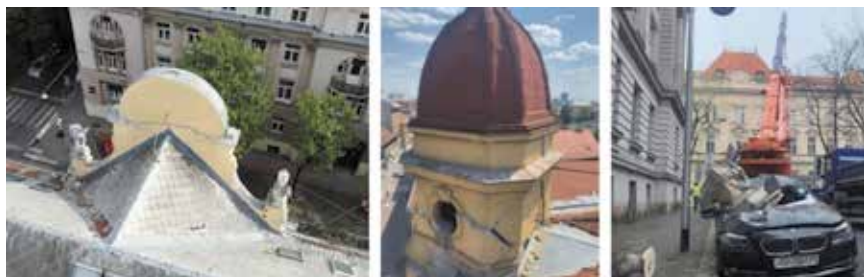
Elements of building heritage, such as roof domes, portals, cornices on facades, and decorative sculptures, have also suffered considerable damage (Figure 21). These elements represented and still represent considerable hazard in case of an earthquake event [38]. As these elements are mostly made of brick or concrete, they may inflict considerable damage when falling from large height. It is interesting to note that Andrija Mohorovičić stated already at the beginning of the twentieth century that these elements should either be properly stabilised or altogether removed precisely because they could present danger in case of an earthquake.

Figure 21. Damage of decorative elements (photos courtesy of Mario Todorčić and [39])

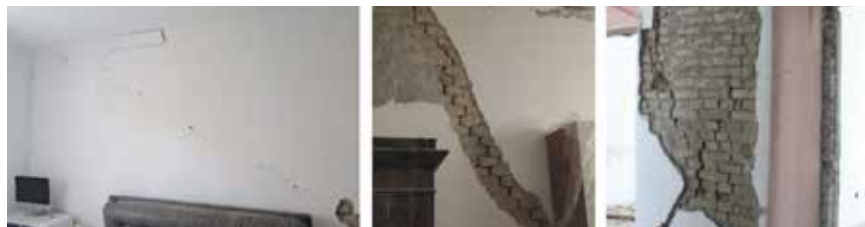
Figure 22. Diagonal cracks in load bearing walls [39]

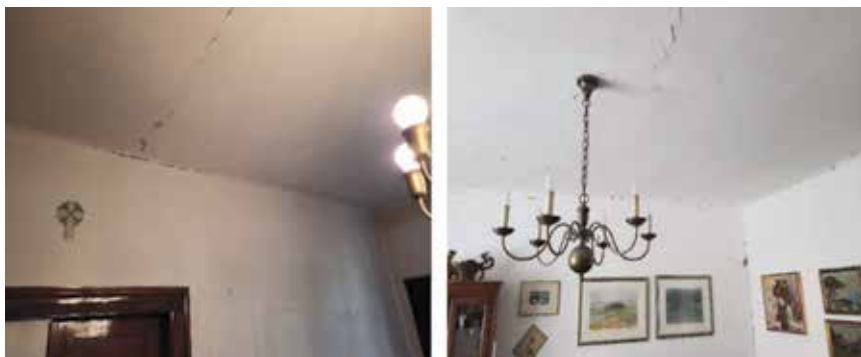
Figure 24. Cracks at ceilings [39]

Small cracks in the direction of joists most often occurred because of displacements due to bending between beams. Such cracks rarely occur due to tensile forces perpendicular to joist. Cracking is often pronounced along the connection between the wall and the floor structure, which is due to relative displacement between these elements. Generally, if the wall does not detach and lean, only the plaster is usually affected, Figure 24.

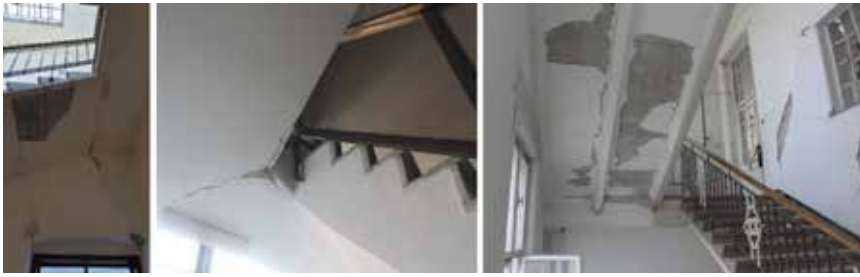
Figure 25. Cases of staircase damage [39]

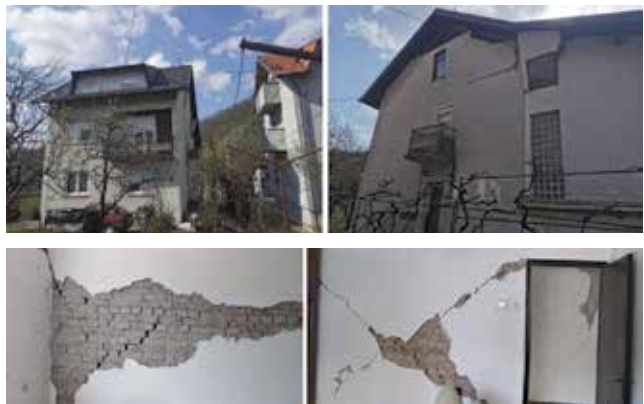
Figures 28 and 29 show frequent damage to houses near the epicentral area. As already pointed out, these are mostly masonry houses without tie beams, but various mixed systems were also encountered because old single storey houses were often subsequently raised by adding a floor.

Figure 29. Damage to houses at LB Dankovec, CD Gornja Dubrava (photo courtesy of Luka Božić and [39])

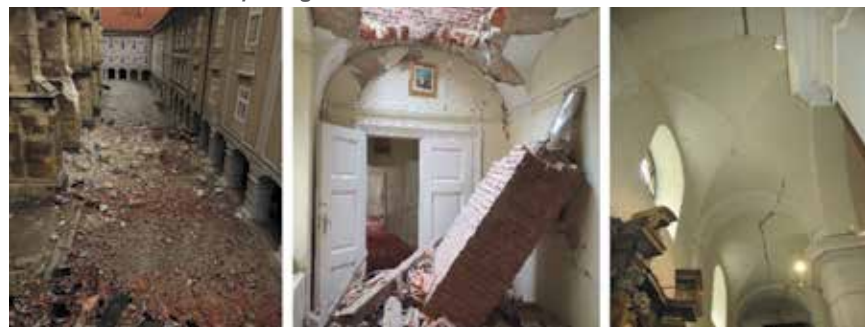
Figure 32. Damage to the cathedral's parish house and the St Mary's Church (source: Ministry of Culture of the Republic of Croatia and [39])

As to cultural heritage buildings, the greatest damage was inflicted on numerous centuries-old churches (cf. Figures 32-34). Out of the total of 43 churches that suffered damage in the city, 30 of them belong to the category of protected cultural monuments. The stone top of the south belltower of Zagreb Cathedral, Croatia's largest sacral building, detached from the base and fell onto and damaged the roof structure of the cathedral. After inspection, it was established that the north belltower also suffered considerable damage, which is why the potentially harmful part had to be removed as it could have fallen onto the cathedral. In addition to the belltower, the balustrade above the apse also collapsed, and great damage was inflicted on facade walls and vaults of this cathedral. Considerable damage to vaults and roofing was also incurred at the cathedral's Archbishop's Palace, where chimneys also collapsed.

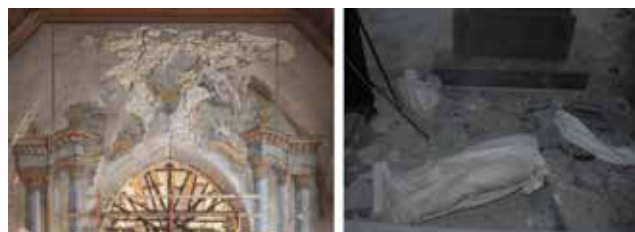
Figure 34. Damage to Church of the Assumption of the Blessed Virgin Mary at Remete and damage to a statue in St. Catherine of Alexandria Church (source: Ministry of Culture of the Republic of Croatia)

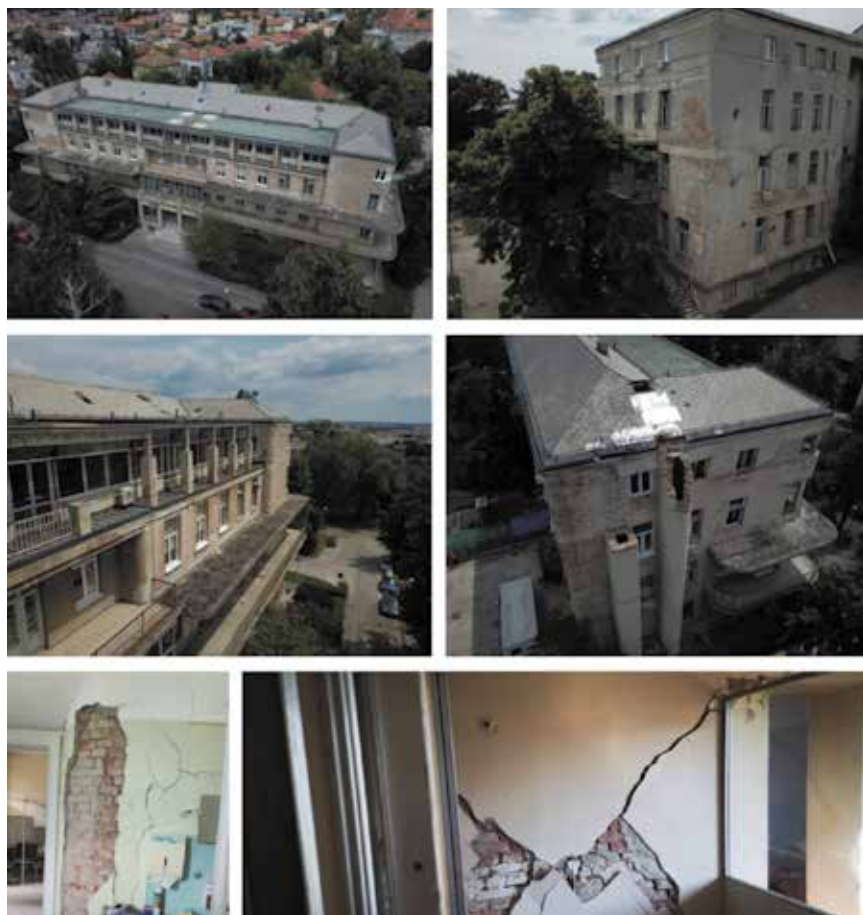
The building of Orthopaedics Clinic at Šalata was built in 1931. It is of elongated rectangular form in plan, and is composed of the central part with the main entrance, and the west and east wings that are symmetric to one another. The building measures 17 x 60 meters in plan. Basement walls are built of concrete, while walls above the ground level are built of solid brick of old format. They differ in thickness and run in longitudinal and transverse directions, interconnected with reinforced concrete floor structures. The clinic consists of the basement, the ground floor, and three floors above it. Partition walls are also built of solid brick. Even before the earthquake, the building was poorly maintained, as evidenced by brick facade walls, which were severely exposed to atmospheric influences, as much of the plaster had fallen off. Tops of both chimneys at the west side of the building collapsed as a result of the earthquake (Figure 37). One chimney separated by approximately ten centimetres from the facade wall, viewed from the roof level, and it now represents a considerable hazard for hospital staff and patients. Urgent removal or reinforcement at the RC slab levels was recommended. The inspection has revealed significant damage to many load-bearing and partition walls. The damage is especially pronounced in east wing walls, where it spreads all the way from the ground floor to the attic. Mostly affected are transverse walls where pronounced diagonal cracks, spreading across most of the walls, were observed. At the central part of the building, load-bearing walls are less damaged. Cracks observed at some locations point to shear failure of walls. Partition walls made of solid brick are generally quite damaged with pronounced diagonal cracks.

Figure 37. View of damage to building of Orthopaedics Clinic
