Zagreb earthquake of 22 March 2020 – preliminary report on seismologic aspects and damage to buildings

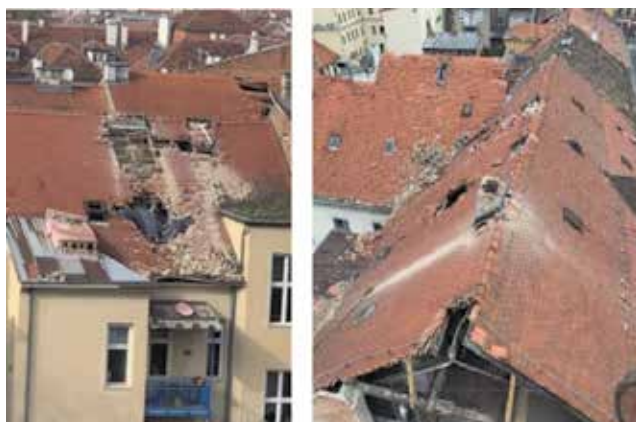
We have pointed out that the most frequent cause of damage to roof structure is the collapse of chimneys, gable walls and other unsupported elements above the roof plane. This is mostly local damage to the roof structure (Figure 20). However, it should be noted that roof structures are usually not adequately stabilised, and due to lack of maintenance and old-age they are additionally unsafe and cannot restrain chimneys and attic gable walls [38]. In some cases, involving flexible roof structures, permanent displacements of the entire roof structure were registered, which is extremely dangerous and requires full reconstruction.

Figure 20. Roof structure damage (photos courtesy of Mario Todorčić)
