Potres u Zagrebu od 22. ožujka 2020. - preliminarni izvještaj o seizmološkim istraživanjima i oštećenjima zgrada

Zagreb earthquake of 22 March 2020 – preliminary report on seismologic aspects and damage to buildings

Research Paper

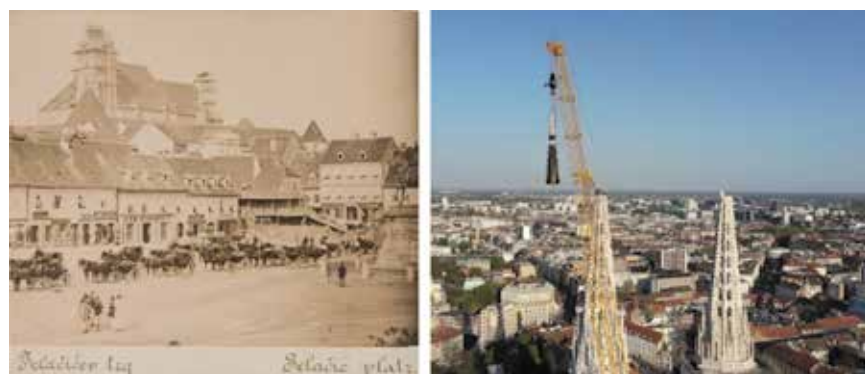
Figure 3. Zagreb Cathedral – tower removal: a) after the 1880 earthquake (source: Museum of the City of Zagreb), b) after the 2020 earthquake (source: Ministry of Defence of the Republic of Croatia)

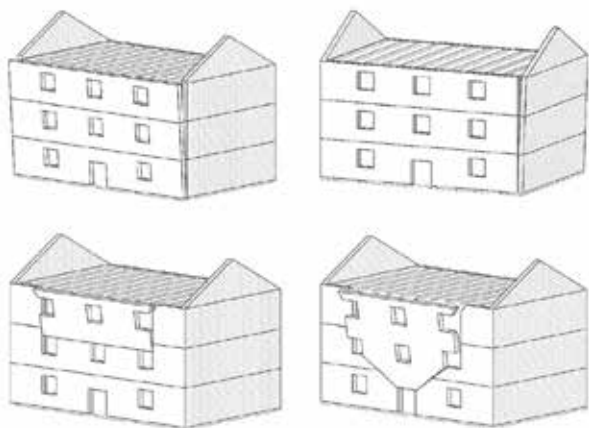
Traditional masonry buildings were most often built as systems of interconnected load bearing walls with timber floor structures. In case of an earthquake, they are mostly damaged because of uneven distribution of stiffness, inadequate or nonexistent interconnections, and poor contact with roof and floor structures (they are very flexible and so walls may deflect out of their plane). An obvious deficiency is the lack of confining elements (vertical and horizontal tie beams), poor bearing capacity in their own plane, and insufficient bearing capacity of roof and floor structures, which causes additional damage. Because of long service life of buildings, poor maintenance, and lack of facade at some external walls (such as gable walls), the material deteriorates quite rapidly thus increasing inhomogeneity of walls and loss of binding material.

Figure 16. Out of plane inclination of walls

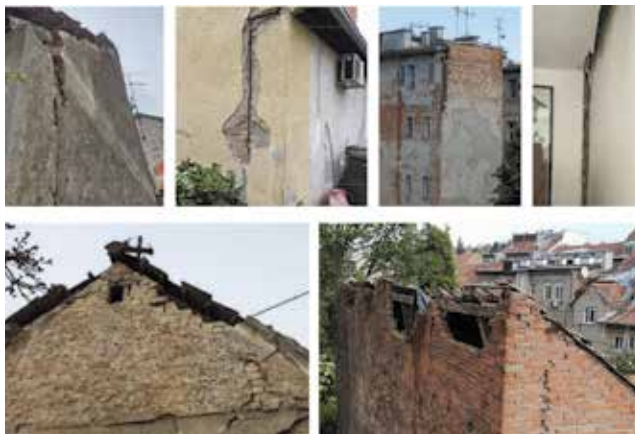
In addition to local collapse of attic gable walls, in more difficult cases the damage involved detachment of gable walls along the entire height or through several floors (Figure 19). The reason is poor connection with walls from the other direction.

Figure 19. Detachment of gable wall and typical cracks in internal part of the building (photos courtesy of Mario Todorčić and [39])

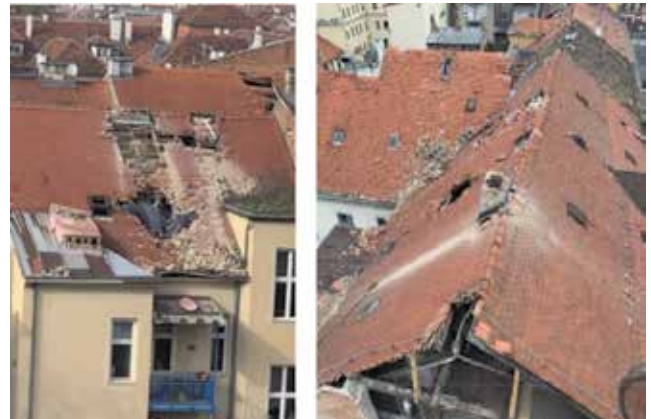
We have pointed out that the most frequent cause of damage to roof structure is the collapse of chimneys, gable walls and other unsupported elements above the roof plane. This is mostly local damage to the roof structure (Figure 20). However, it should be noted that roof structures are usually not adequately stabilised, and due to lack of maintenance and old-age they are additionally unsafe and cannot restrain chimneys and attic gable walls [38]. In some cases, involving flexible roof structures, permanent displacements of the entire roof structure were registered, which is extremely dangerous and requires full reconstruction.

Figure 20. Roof structure damage (photos courtesy of Mario Todorčić)

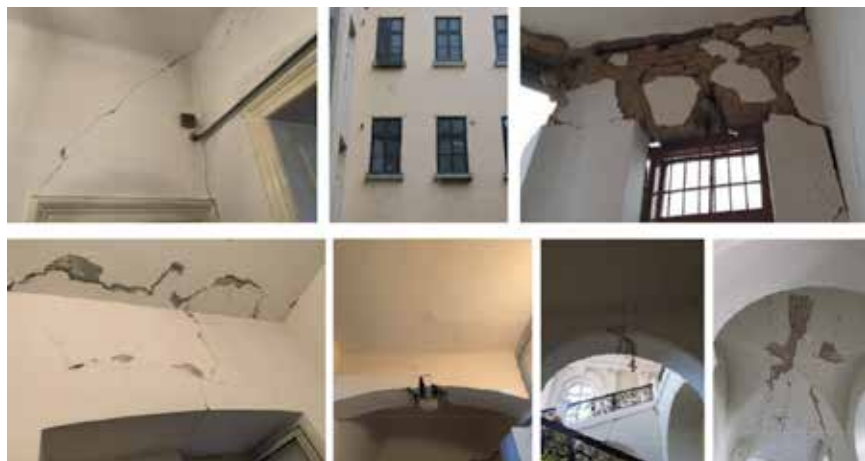
Figure 23. Lintel damage: diagonal and vertical cracks [39]

Lintel cracking is one of the most frequent forms of damage (Figure 23). It is typical for masonry and reinforced-concrete buildings. Diagonal cracks at lintels can very often be seen even in recently built buildings. If cracks are not

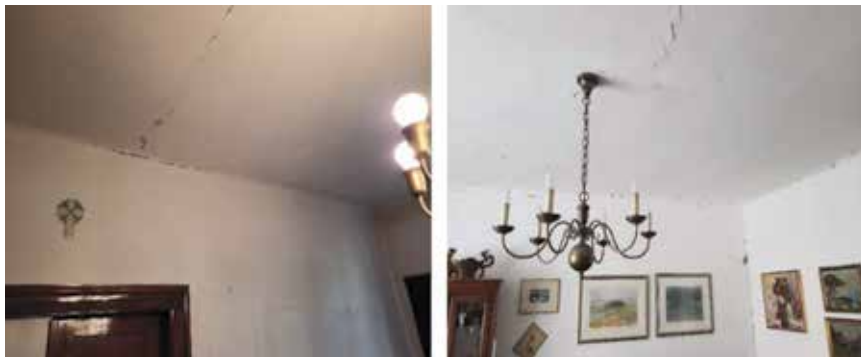
Figure 24. Cracks at ceilings [39]

Small cracks in the direction of joists most often occurred because of displacements due to bending between beams. Such cracks rarely occur due to tensile forces perpendicular to joist. Cracking is often pronounced along the connection between the wall and the floor structure, which is due to relative displacement between these elements. Generally, if the wall does not detach and lean, only the plaster is usually affected, Figure 24.

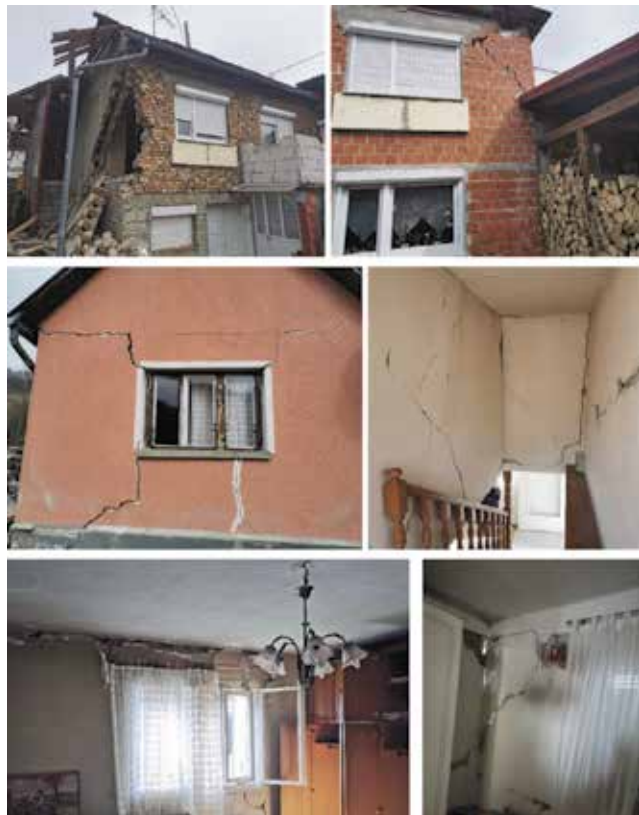
Figures 28 and 29 show frequent damage to houses near the epicentral area. As already pointed out, these are mostly masonry houses without tie beams, but various mixed systems were also encountered because old single storey houses were often subsequently raised by adding a floor.

Figure 28. Damage to houses at LB Vidovec, CD Podsljeme (photo courtesy of Luka Božić and [39])

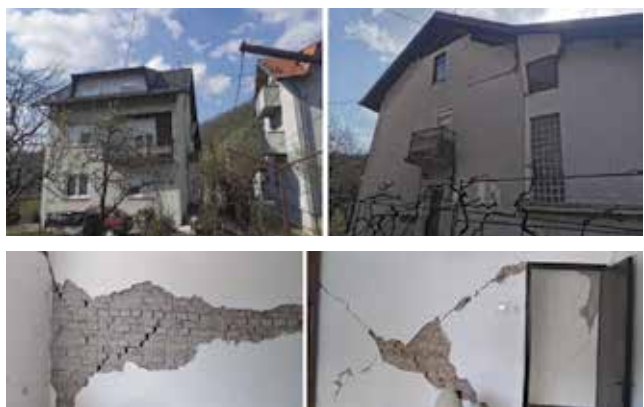
Figure 29. Damage to houses at LB Dankovec, CD Gornja Dubrava (photo courtesy of Luka Božić and [39])

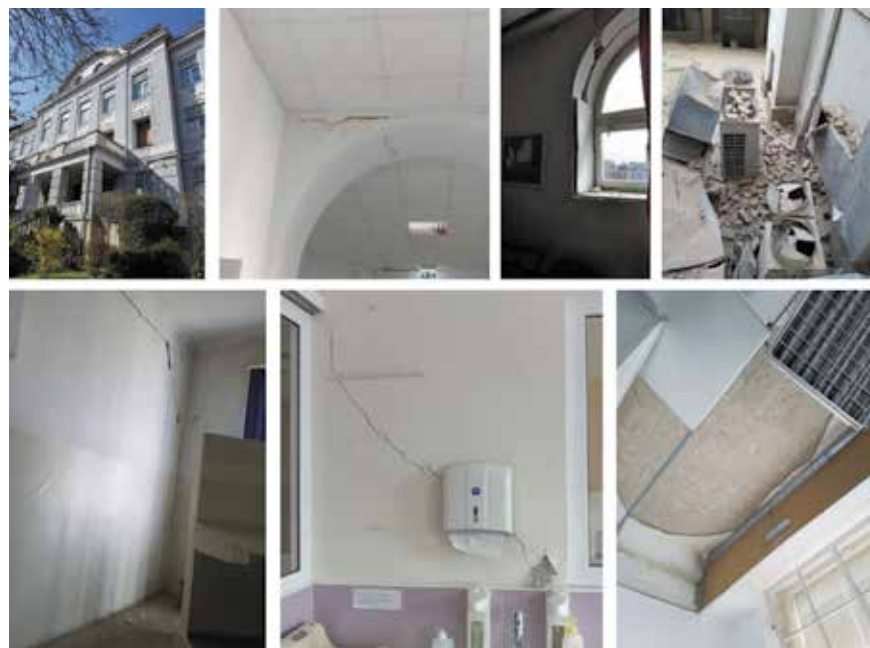
Zagreb residents will remember a long time distressing scenes of pregnant women and babies that were urgently evacuated after the earthquake from the hospital building. Rapid visual inspection of the building’s structure was conducted immediately after the earthquake. The main old building was inspected, as it is in the most critical, considering that it dates back to the early twentieth century. It is irregular in plan, and it comprises masonry walls of solid brick of old format. The building comprises the basement, the ground floor, two floors above it, and the attic. Floor structures in room areas are timber joists, while masonry vaults are used in corridors. Some chimneys collapsed in the earthquake so that the heating system had to be shut down, the gas supply turned off and he hot water supply cut-off. The inspection has revealed damage to staircases that lie along the edges of the east and west parts of the building. Over time, some improper changes and reconstructions were made, which cracked, although this cracking did not affect the overall load bearing capacity of the building. Besides these damages, cracking of the attic overhang and of the cornice was detected, which could imperil the area in front of the main entrance in case of another earthquake, and so the recommendation was given to limit the access to hospital from the front side, and to use the alternative entrance. The system of cracks spreading along the entire building was identified, but these cracks do not pose danger to the bearing capacity and serviceability of the building. Diagonal cracks were observed at

Figure 36. Damage to the Old building of Clinic for Women’s Health and Obstetrics in Petrova
