# Potres u Zagrebu od 22. ožujka 2020. - preliminarni izvještaj o seizmološkim istraživanjima i oštećenjima zgrada

Source / Izvornik: **Građevinar, 2020, 72, 843 - 867**

## Zagreb earthquake of 22 March 2020 – preliminary report on seismologic aspects and damage to buildings

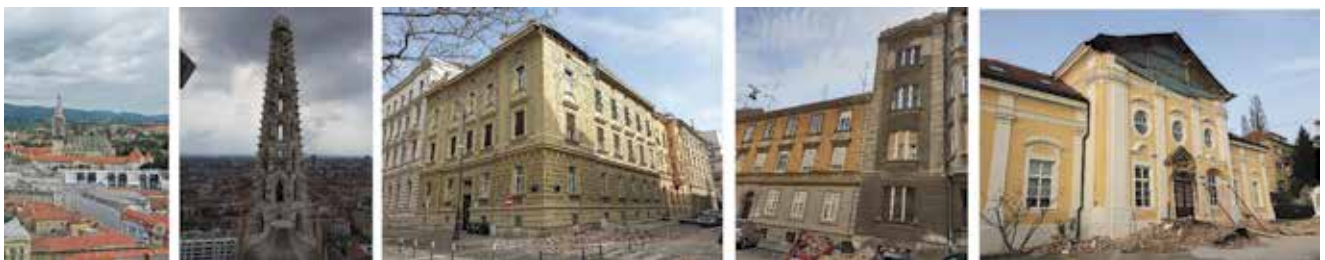
Figure 1. Earthquake effects in historic centre of the city (photos courtesy of: AIR-RMLD d.o.o. [www.air-rmld.com](http://www.air-rmld.com), Filip Foretić, Karlo Jandrić)

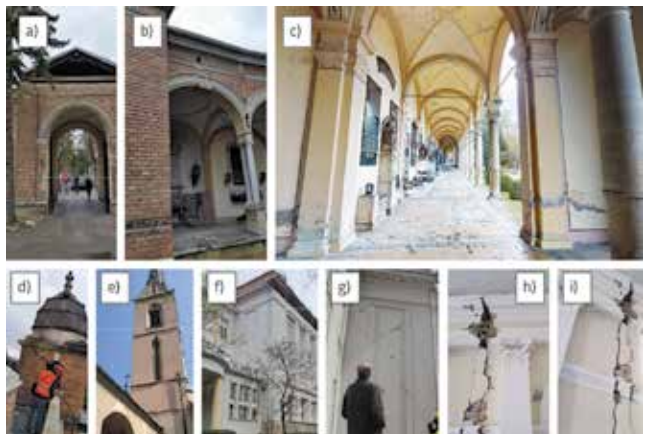
Figure 30. Earthquake damage to some notable buildings: Mirogoj Cemetery (a.-d.), Franciscan Monastery at Kaptol (e), registry office building of the Faculty of Medicine at Šalata (f.-g.), University and Faculty of Law building (h.-i.) [39]

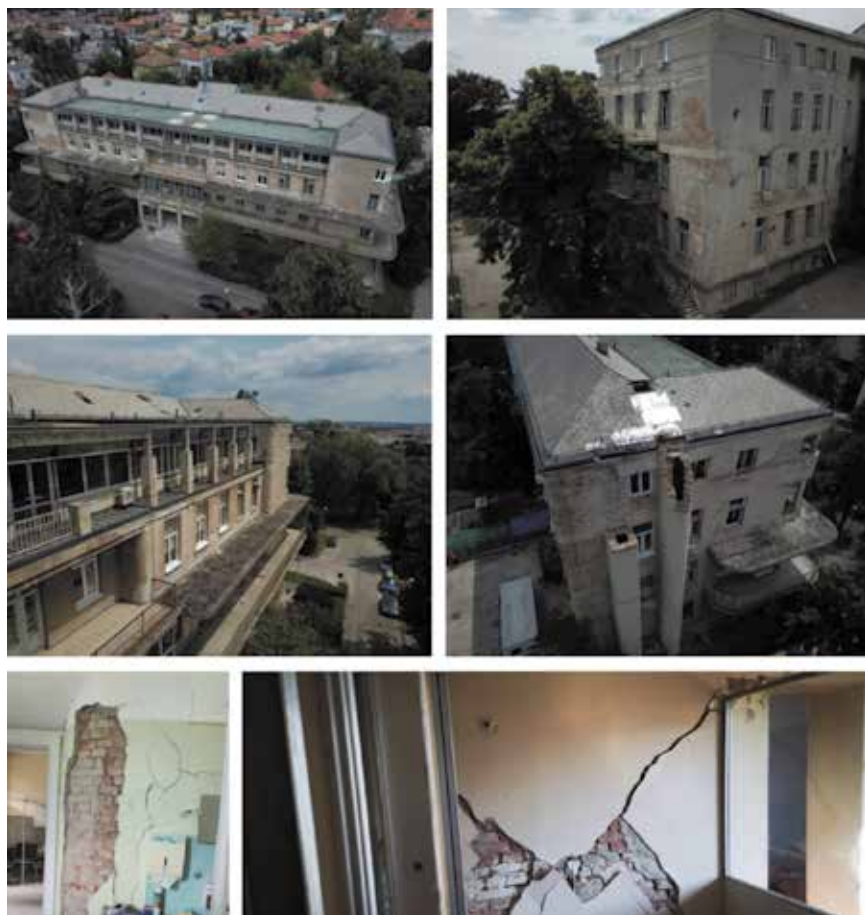
The building of Orthopaedics Clinic at Šalata was built in 1931. It is of elongated rectangular form in plan, and is composed of the central part with the main entrance, and the west and east wings that are symmetric to one another. The building measures 17 x 60 meters in plan. Basement walls are built of concrete, while walls above the ground level are built of solid brick of old format. They differ in thickness and run in longitudinal and transverse directions, interconnected with reinforced concrete floor structures. The clinic consists of the basement, the ground floor, and three floors above it. Partition walls are also built of solid brick. Even before the earthquake, the building was poorly maintained, as evidenced by brick facade walls, which were severely exposed to atmospheric influences, as much of the plaster had fallen off. Tops of both chimneys at the west side of the building collapsed as a result of the earthquake (Figure 37). One chimney separated by approximately ten centimetres from the facade wall, viewed from the roof level, and it now represents a considerable hazard for hospital staff and patients. Urgent removal or reinforcement at the RC slab levels was recommended. The inspection has revealed significant damage to many load-bearing and partition walls. The damage is especially pronounced in east wing walls, where it spreads all the way from the ground floor to the attic. Mostly affected are transverse walls where pronounced diagonal cracks, spreading across most of the walls, were observed. At the central part of the building, load-bearing walls are less damaged. Cracks observed at some locations point to shear failure of walls. Partition walls made of solid brick are generally quite damaged with pronounced diagonal cracks.

Figure 37. View of damage to building of Orthopaedics Clinic
