# Potres u Zagrebu od 22. ožujka 2020. - preliminarni izvještaj o seizmološkim istraživanjima i oštećenjima zgrada

Source / Izvornik: **Građevinar, 2020, 72, 843 - 867**

## Zagreb earthquake of 22 March 2020 – preliminary report on seismologic aspects and damage to buildings

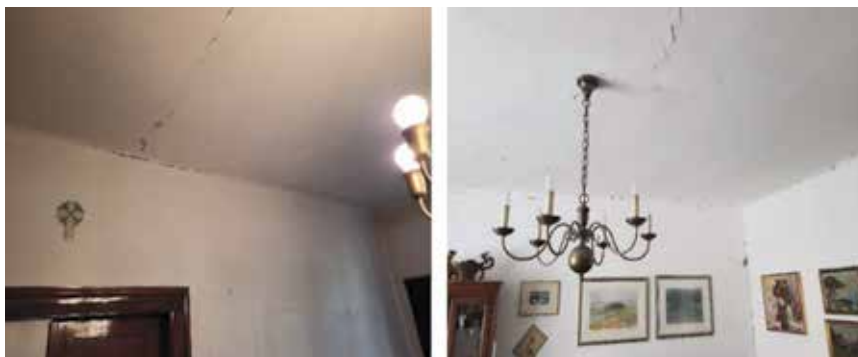
Figure 24. Cracks at ceilings [39]

Small cracks in the direction of joists most often occurred because of displacements due to bending between beams. Such cracks rarely occur due to tensile forces perpendicular to joist. Cracking is often pronounced along the connection between the wall and the floor structure, which is due to relative displacement between these elements. Generally, if the wall does not detach and lean, only the plaster is usually affected, Figure 24.
