Potres u Zagrebu od 22. ožujka 2020. - preliminarni izvještaj o seizmološkim istraživanjima i oštećenjima zgrada

Zagreb earthquake of 22 March 2020 – preliminary report on seismologic aspects and damage to buildings

Research Paper

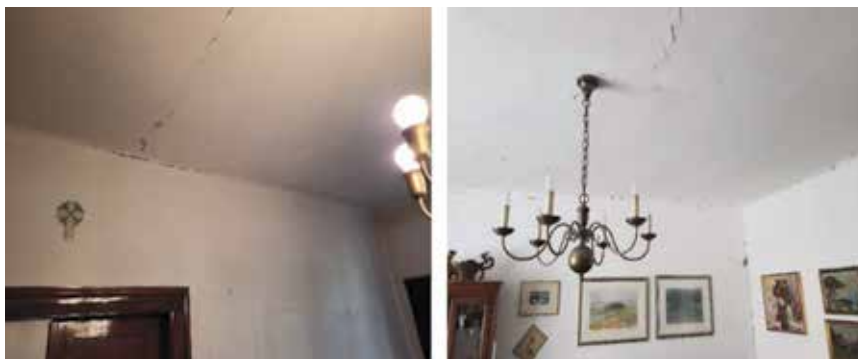
Figure 24. Cracks at ceilings [39]

Small cracks in the direction of joists most often occurred because of displacements due to bending between beams. Such cracks rarely occur due to tensile forces perpendicular to joist. Cracking is often pronounced along the connection between the wall and the floor structure, which is due to relative displacement between these elements. Generally, if the wall does not detach and lean, only the plaster is usually affected, Figure 24.

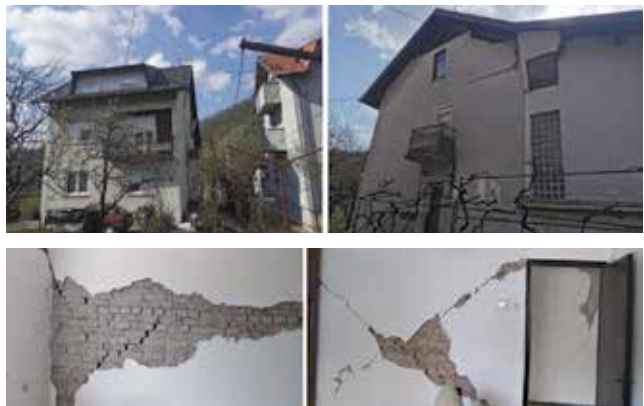
Figures 28 and 29 show frequent damage to houses near the epicentral area. As already pointed out, these are mostly masonry houses without tie beams, but various mixed systems were also encountered because old single storey houses were often subsequently raised by adding a floor.

Figure 29. Damage to houses at LB Dankovec, CD Gornja Dubrava (photo courtesy of Luka Božić and [39])

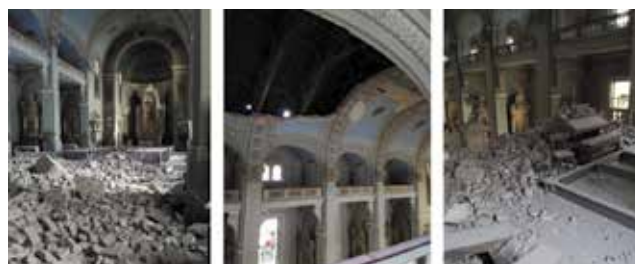
As to cultural heritage buildings, the greatest damage was inflicted on numerous centuries-old churches (cf. Figures 32-34). Out of the total of 43 churches that suffered damage in the city, 30 of them belong to the category of protected cultural monuments. The stone top of the south belltower of Zagreb Cathedral, Croatia's largest sacral building, detached from the base and fell onto and damaged the roof structure of the cathedral. After inspection, it was established that the north belltower also suffered considerable damage, which is why the potentially harmful part had to be removed as it could have fallen onto the cathedral. In addition to the belltower, the balustrade above the apse also collapsed, and great damage was inflicted on facade walls and vaults of this cathedral. Considerable damage to vaults and roofing was also incurred at the cathedral's Archbishop's Palace, where chimneys also collapsed.

Figure 33. Damage to Basilica of the Sacred Heart of Jesus (photos courtesy of: Ivan Ćurić)
