Analysis of Tram Traffic-Induced Vibration Influence on Earthquake Damaged Buildings

Ivo Haladin ^{1,*}, Marijan Bogut ² and Stjepan Lakušić ¹¹ Faculty of Civil Engineering, University of Zagreb, 10000 Zagreb, Croatia; stjepan.lakusic@grad.unizg.hr² Končar—Electrical Engineering Institute Inc., 10000 Zagreb, Croatia; bogut@koncar-institut.hr

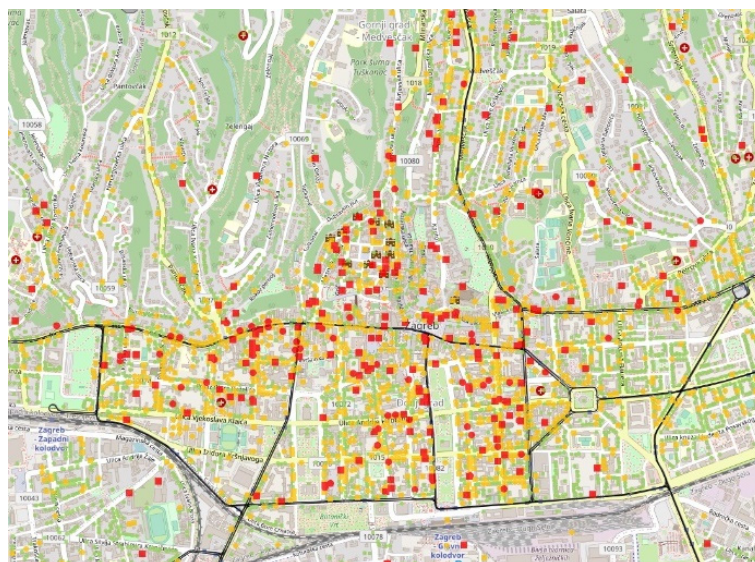
Figure 1. Tram network (black line) and earthquake damage to buildings based on initial inspection (yellow squares—temporarily unusable, red squares—permanently unusable).
