Analysis of Tram Traffic-Induced Vibration Influence on Earthquake Damaged Buildings

Source / Izvornik: **Buildings, 2021, 11**

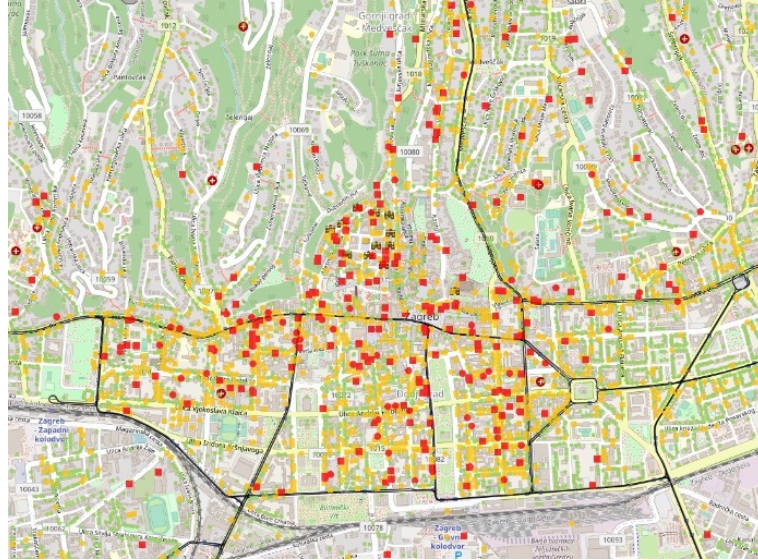
Figure 1. Tram network (black line) and earthquake damage to buildings based on initial inspection (yellow squares—temporarily unusable, red squares—permanently unusable).

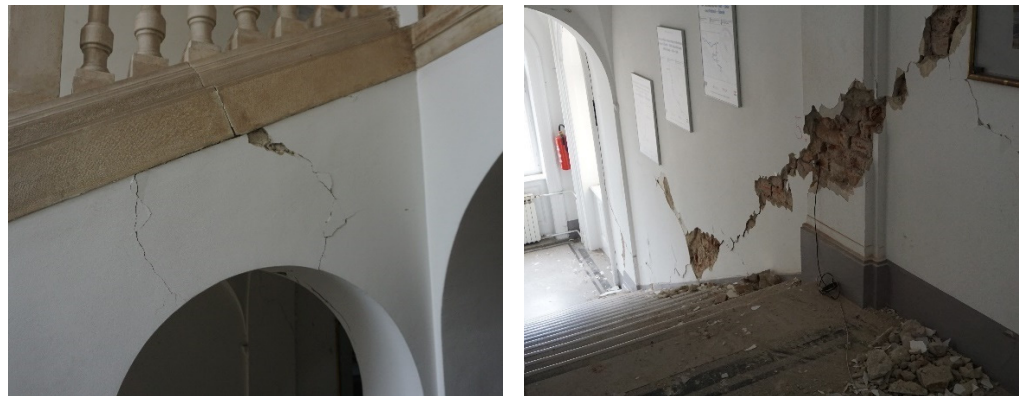
As a result of the M5.5 earthquake that hit Zagreb, the building suffered considerable damage at the level of the central staircase, partition walls, and load-bearing walls on higher floors of the building, Figure 4. The south wing was marked as temporarily unusable (PN2) according to the rapid post-earthquake assessment described in [27], while the east and west wings were marked as usable (U2) with minor damage. The building is also situated in the immediate vicinity of the tram track passing through Mihanovićeve street. The centreline of the closer track is situated only 5 m away from the facade of the building. Since the south wing, closest to the track, was completely evacuated after the earthquake, with the permission of HŽI, it served as an optimum location for performing an initial investigation of the influence of tram vibrations on the earthquake-damaged building.

Figure 4. Damage to the central staircase in the HŽI head-office building.

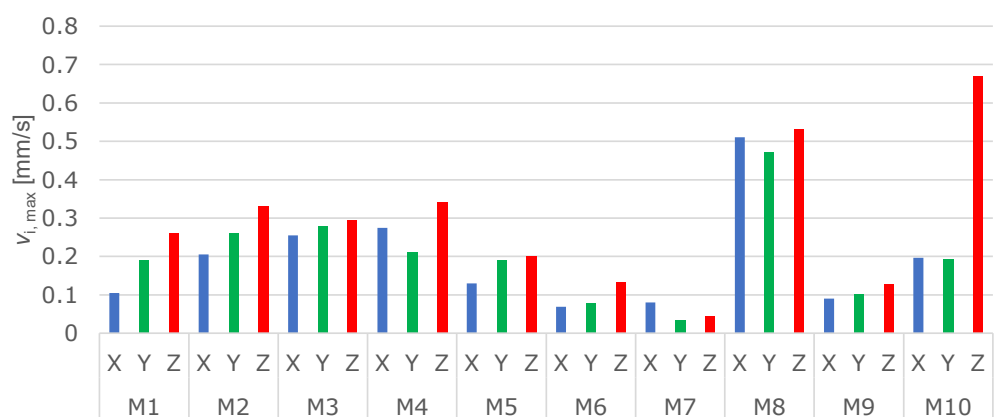
Figure 10. Peak vibration velocities measured in the building at ten measurement positions for the second pass-by of the reference tram.

The vibrations generated at the distant south track (pass-bys 1 and 3) reached 5-to-10-times lower peak values compared to vibrations generated at the north track (pass-bys 2 and 4), which was to be expected due to energy loss with the distance from the source to the receiver. Therefore, pass-bys on track closer to the building façade are further investigated. If the central position of the south façade is observed, vibrations tend to increase with the floor of the building, being the smallest at the basement level (M5) and increasing from the

ground floor to the third floor (M1 to M4). On the third floor, a drop in horizontal vibration level was observed, which is probably due to the stiffer reinforced concrete structure compared to the rest of the building. It is also visible that peak velocities drop with the distance from the track (M1 → M6 → M7) on the same floor. The analysis shows that the highest vibration levels are at the south-east wing connection (M8, ground floor, and M10, third floor of the building). From vibration trends of the passing tram (Figure 9), a distinct peak in the 12th second is visible at the left side of the bogie (PLZ). This peak occurs in a broad spectrum, with the maximum at around 30 Hz. At this position, the tram changes direction (drives in an S curve), which also leads to the deteriorated track geometry when compared to other positions on the building. Additionally, the accelerometer position at the crossing of the south and east bearing walls ensures vibration transfer through the structure.

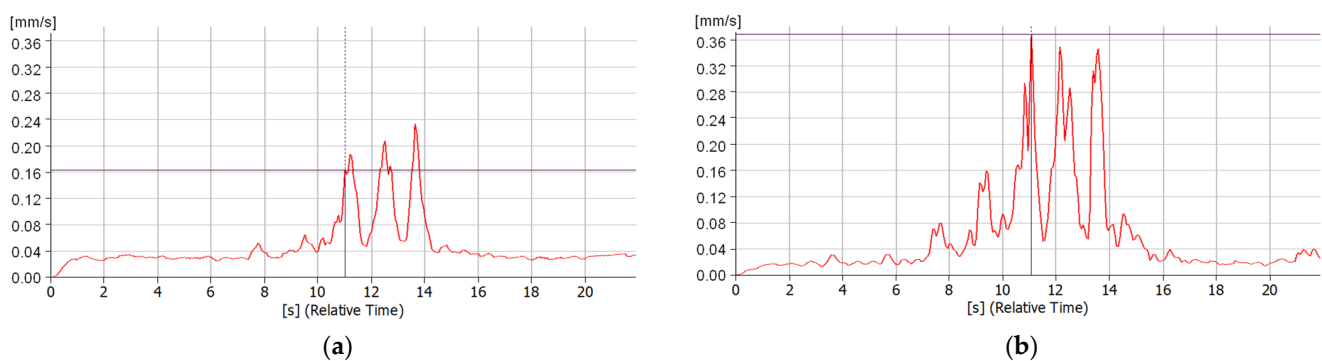
Second pass-by of the reference tram, Figure 11, induced maximum vibrations in terms of PPV when compared to any other observed pass of all trams, and it was therefore used to evaluate the level of long-term vibration exposure. Table 1 gives an overview of available thresholds for assessing the impact of vibrations on structures. According to a standard currently in place in Croatia [19], the long-term vibration exposure of sensitive structures should not exceed 2.5 mm/s of PPV calculated according to Equation (2). The maximum level was recorded in Z direction $-v_{z, \max} = 0.68$ mm/s, well below the allowable limit. If the Swiss standard [18] is considered, PPV calculated according to Equation (1) is 0.724 mm/s, which is also below the recommended value of 1.5 mm/s for vibration-sensitive buildings exposed to long-term vibrations. Therefore, damage occurrence due to tram vibrations has a very low probability.

Figure 11. Vertical (Z) vibration velocity trends at (a) M8 and (b) M10 for the second pass-by of the reference tram.

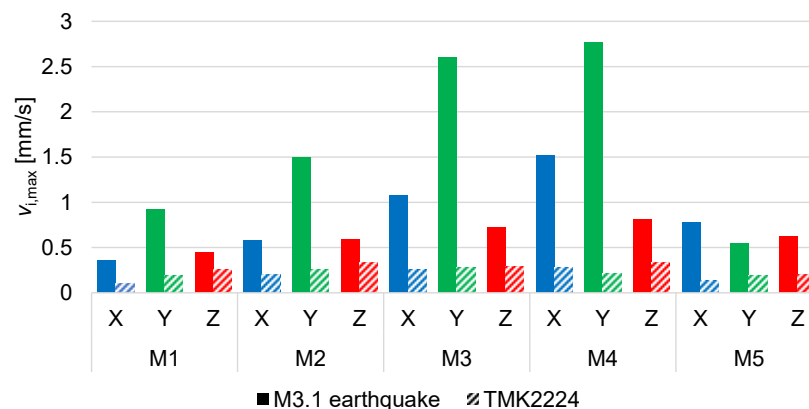
If the 3.1 (ML) response is analysed in terms of PPV according to [19], a direct comparison to the acquired tram response can be made. The results presented for M1 to M5 clearly indicate how even small-intensity earthquake-triggered vibrations are considered harmful for historic masonry structures, Figure 16, while maximum tram vibrations trigger a much smaller response.

Figure 16. Comparison of peak vibration velocities generated by M3.1 earthquake and pass-by of TMK2224 vehicle.
