Analysis of Tram Traffic-Induced Vibration Influence on Earthquake Damaged Buildings

Keywords: tram track; vibrations; earthquake; masonry structure; vulnerability

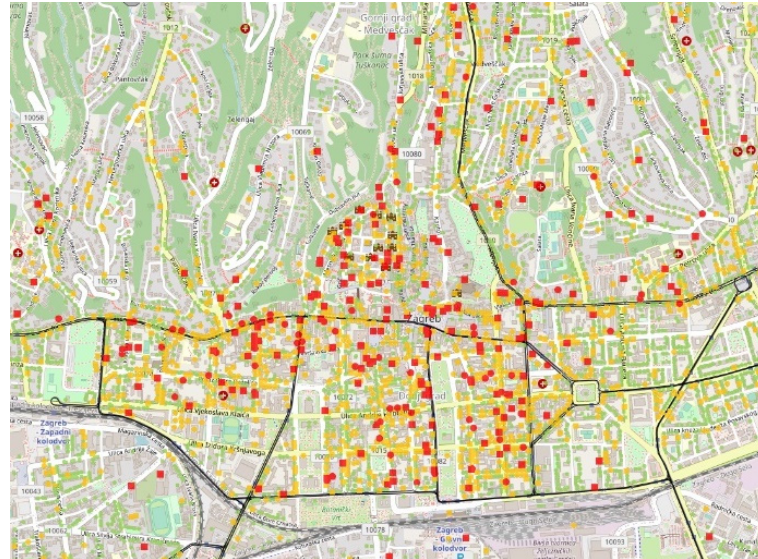
Figure 1. Tram network (black line) and earthquake damage to buildings based on initial inspection (yellow squares—temporarily unusable, red squares—permanently unusable).
