Evaluation of tramway overhead line system in city of Osijek

Ivo Haladin^{1*}, Stjepan Lakušić¹, and Ivan Duvnjak²

Abstract. Overhead line system is a vital element of any electrified railway infrastructure. Its performance reflects to all vital parameters such as traction, reliability, availability and safety of railway infrastructure. Operator GPP Osijek runs a 27.5 km long tramway network which plays a key role in transit system of the city of Osijek, Croatia. In 2016 GPP Osijek applied to a tender for acquisition of new rolling stock with 85% EU investment. Mayor requirement prior to rolling stock acquisition was to document, analyse and upgrade current infrastructure (including track structure, electric substations and catenary) to an optimal level. Task of measurement and evaluation of tram track structure and catenary has been appointed to University of Zagreb Faculty of Civil Engineering. Overhead line analysis comprised from several measuring procedures, including supporting columns evaluation, catenary stagger, height, shocks and wear. Such extensive analysis included GPS positioning and on-site evaluation of 1214 supporting columns of overhead line, as well as overhead

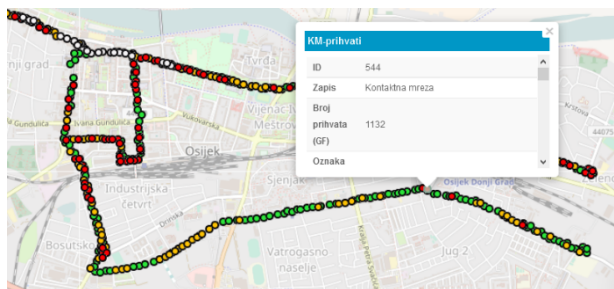
Fig. 1. Acquired GIS dataset of 1214 analysed supports.

According to analysis, 20 % of columns were characterized as substantially damaged (bent out of vertical axis, corrosion damage, shrapnel damage etc.), as presented in Figure 2; 32 % endangered (minor corrosion or dents); 48 % in good state (not bent, no corrosion or dents).

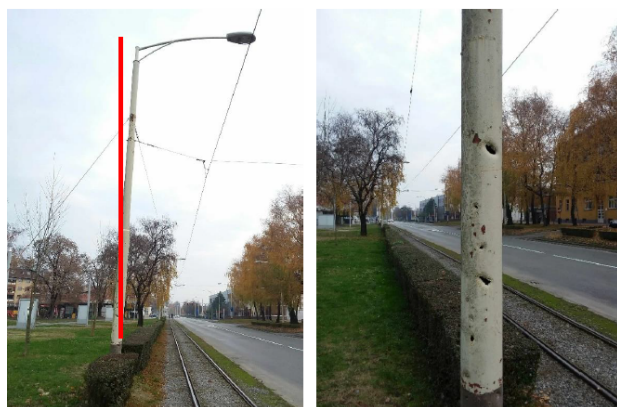
Fig. 2. Example of substantially damaged columns.

Conducted measurements and further analysis revealed weak spots and sections in overhead line system that are to be replaced or reconstructed due to weakened or damaged support columns (around 20%), worn overhead wire and elevated level of vibrations and shocks on vehicle pantograph. Furthermore recommendations for correction of overhead line alignment in terms of height and stagger have been given for more than 2000 m of track. Priority levels for reconstruction have also been determined.

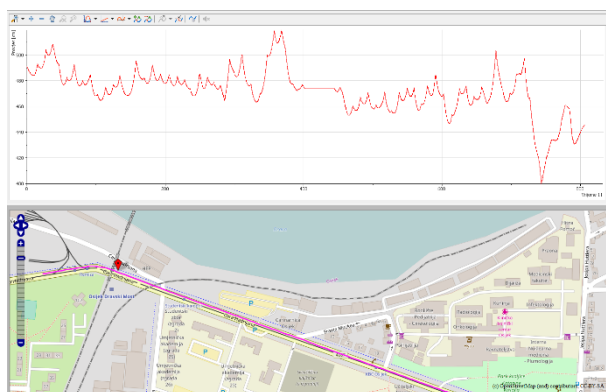
Height difference in respect to travelled distance has also been analysed because it can lead to loss of contact between the pantograph and the wire, Figure 5.

Fig. 5. Substantial height difference of overhead wire (right).

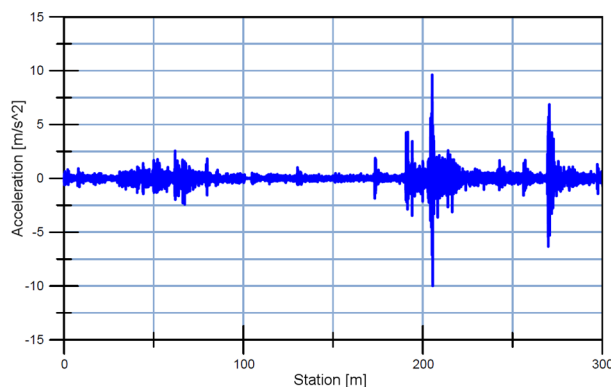
Through vibration analysis different average level of vibrations have been recorded on different track segments as well as individual shock events on the catenary, Figure 6. Such data is important for evaluation of overhead line wear, joints, overlaps and potential weak spots.

Fig. 6. Overhead wire shock time signal sample.

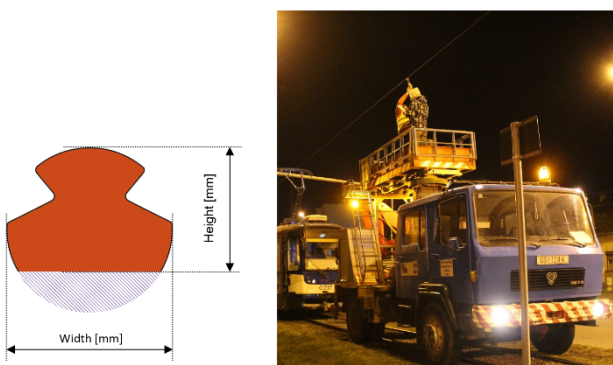
Using an overhead line inspection vehicle, the overhead wire has been checked for wear on different cross-section (Figure 9) as well as for wire defects and joints (Figure 10). Such measurements were conducted to assess the overall state of the contact wire on different subsections of the network.

Fig. 9. Measurement of overhead wire wear.

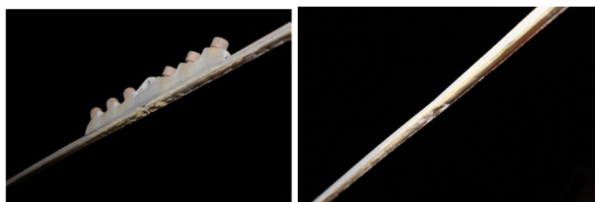
Fig. 10. Inspection of wire joints and potential weak spots.

Such inspection, together with historic data of GPP Osijek maintenance division, revealed 79 joints due to wire breakage, 46 substantially worn spots and other potentially critical points, Figure 10.
