Evaluation of tramway overhead line system in city of Osijek

Abstract. Overhead line system is a vital element of any electrified railway infrastructure. Its performance reflects to all vital parameters such as traction, reliability, availability and safety of railway infrastructure. Operator GPP Osijek runs a 27.5 km long tramway network which plays a key role in transit system of the city of Osijek, Croatia. In 2016 GPP Osijek applied to a tender for acquisition of new rolling stock with 85% EU investment. Mayor requirement prior to rolling stock acquisition was to document, analyse and upgrade current infrastructure (including track structure, electric substations and catenary) to an optimal level. Task of measurement and evaluation of tram track structure and catenary has been appointed to University of Zagreb Faculty of Civil Engineering. Overhead line analysis comprised from several measuring procedures, including supporting columns evaluation, catenary stagger, height, shocks and wear. Such extensive analysis included GPS positioning and on-site evaluation of 1214 supporting columns of overhead line, as well as overhead line measurements using an instrumented tram vehicle o

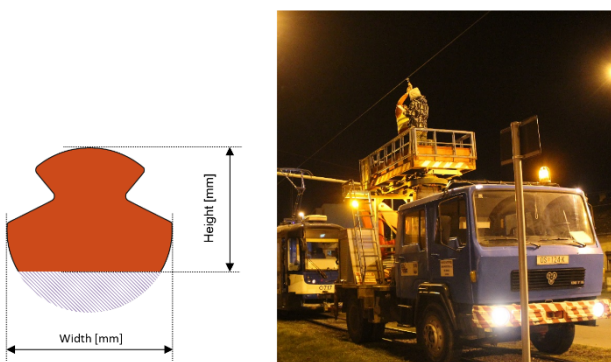
Using an overhead line inspection vehicle, the overhead wire has been checked for wear on different cross-section (Figure 9) as well as for wire defects and joints (Figure 10). Such measurements were conducted to assess the overall state of the contact wire on different subsections of the network.

Fig. 9. Measurement of overhead wire wear.

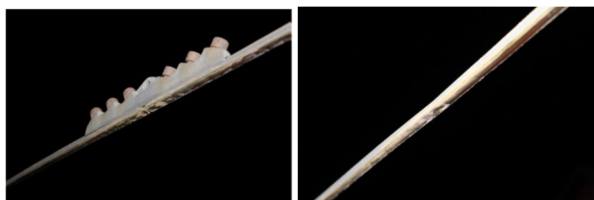
Fig. 10. Inspection of wire joints and potential weak spots.

Such inspection, together with historic data of GPP Osijek maintenance division, revealed 79 joints due to wire breakage, 46 substantially worn spots and other potentially critical points, Figure 10.

Conducted measurements and further analysis revealed weak spots and sections in overhead line system that are to be replaced or reconstructed due to weakened or damaged support columns (around 20%), worn overhead wire and elevated level of vibrations and shocks on vehicle pantograph. Furthermore recommendations for correction of overhead line alignment in terms of height and stagger have been given for more than 2000 m of track. Priority levels for reconstruction have also been determined.
