Case-study of the out-of-plane wall failure of a typical downtown building in Zagreb

3 Case study: Building in Mrazoviceva street

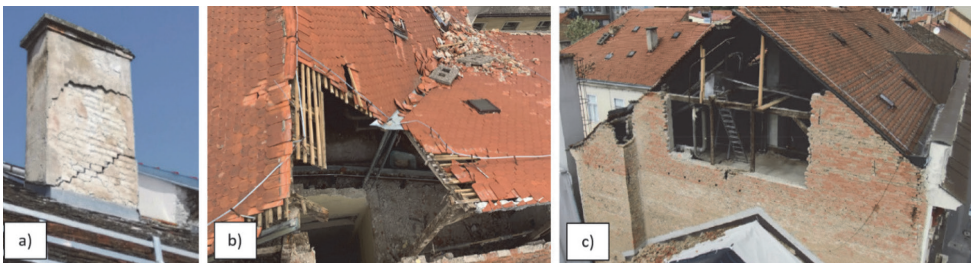
The earthquake that hit Zagreb, the capital city of Croatia, on March 22, 2020 at 6:24 local time was magnitude 5.5, according to Richter. The epicenter was located 7 km north of the Zagreb historic centre. The earthquake, although of moderate magnitude, caused great material damage, especially to the buildings in the historic core of the city. The building fund of the City of Zagreb includes a large number of traditional unreinforced masonry buildings. This kind of buildings are most often consisting of interconnected load-bearing masonry walls and flexible horizontal structures with wooden beam elements. The damage to this type of structures during earthquakes most often occurs due to uneven distribution of seismic forces due to flexible floor structures, inappropriate or non-existent interconnections of elements, and poor contact with the roof and floor structure [1]. Postearthquake survey of buildings in Zagreb showed that the most common damage to this kind of masonry buildings in the city center is associated with local damage to the roof (Figure 1.b.), collapse of attic chimneys (Figure 1.a), and partial or complete collapse of gable attic walls (Figure 1.c) [2].

Figure 1. a) Collapse of chimneys; b) roof damage; c) collapse of attic gable wall [2]

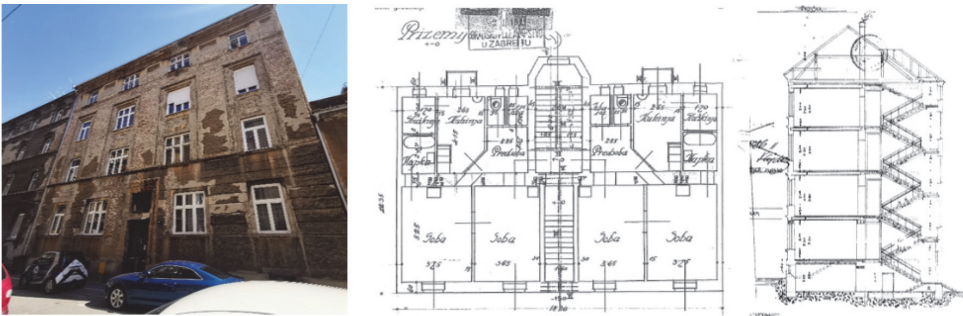
The case-study unreinforced masonry building is built 1911 and it is located in the center of Zagreb. The building is built in block (Figure 4.a). The building has a basement, 4 storeys and the attic. The plan dimensions are 18,20 x 11,35 m (Figure 4.b) and the building height is 17,5 m. The structural system consists of interconnected solid brick walls and floor system are timber joists except for the basement where it consists of concrete slab with steel girders. The load-bearing walls are made of solid brick of the old format (290 × 140 × 65 mm) that are 75, 60, 45 and 30 cm thick. The thickness of the walls narrows with the height of the building. The layout of the walls and the structural system are classic for this period of construction. The post-earthquake survey showed that cracks are mostly present on the non-structural elements, parapets, partition walls, and lintels. Severe damage suffered chimneys and the west gable wall that partially collapsed (Figure 5.a). During inspection, the cracks were observed along the connection of façade wall with floors and perpendicular wall which indicated out-of-plane displacement of the façade wall (Figure 5.c).

Figure 4. a) Case-study building in Mrazoviceva Street; b) Archive architectural drawings

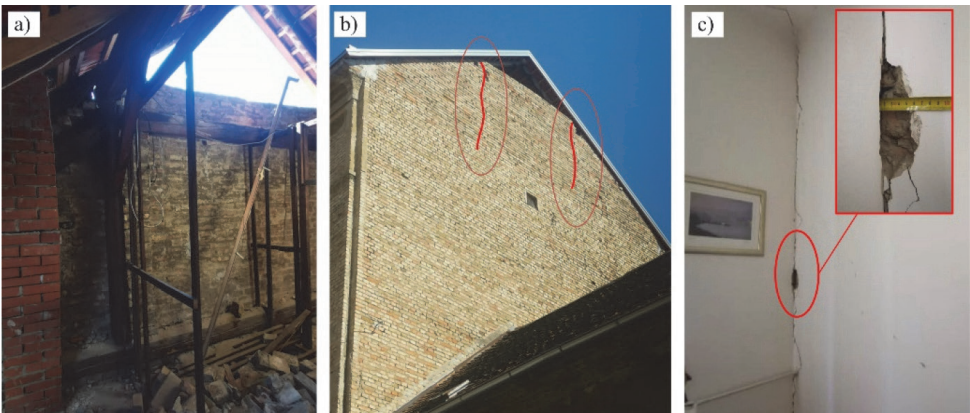
Figure 5. a) Gable wall inside the attic; b) Crack patterns of gable wall; c) Cracks on the connection of facade wall and perpendicular wall

For mechanism 1, only 17 % of the linear model demand and 20 % of the nonlinear model demand is fulfilled. This wall, however, only partially collapsed in the earthquake in March 2020. The model used in the analysis assumes complete separation of the wall from the rest of the structure, but it can be seen from the photographs on Figure 5. a) and b) that in the thirds of the length the wall was thickened with an additional layer of bricks, that certainly helped to prevent complete separation. It should be noted that cracks exist in these parts of wall that are visible from the outside (Figure 5.b). We also emphasize here that the main direction of the earthquake that happened, was approximately parallel to the gable wall plane, which certainly influenced the maximum value of the acceleration that affected this wall. The same wall was analysed in mechanism 2 where it includes the part of the wall on the storey below the attic. In the linear model, there is the fulfilment of 12 % of the demand, while the displacement capacity demand is fulfilled with 47 %. For this wall the connections with perpendicular walls is not completely impaired, so there are some reserves in terms of friction force that is present at the junction of the walls that was not considered in the analysis. The results of street façade wall considered in mechanism 3 showed that the wall should have been most likely activated during earthquake since linear model had fulfilment of 30 %. However, in the nonlinear model, the model had almost complete fulfilment of the demand that was 98 %. This wall, unlike the gable wall, was exposed to a greater acceleration values when considering the main direction of the earthquake. The façade wall on the courtyard side, mechanism 4, have satisfied requirement of the linear model so it was concluded that it was not activated in earthquake, therefore, the nonlinear model was not considered.
