Case-study of the out-of-plane wall failure of a typical downtown building in Zagreb

Matea Sruk¹, Marija Demšić², Maja Baniček³

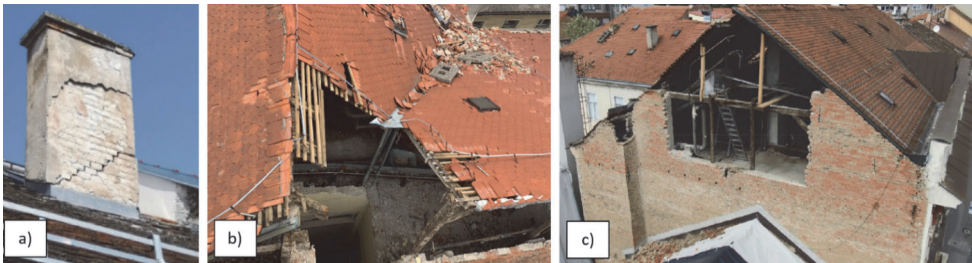
The earthquake that hit Zagreb, the capital city of Croatia, on March 22, 2020 at 6:24 local time was magnitude 5.5, according to Richter. The epicenter was located 7 km north of the Zagreb historic centre. The earthquake, although of moderate magnitude, caused great material damage, especially to the buildings in the historic core of the city. The building fund of the City of Zagreb includes a large number of traditional unreinforced masonry buildings. This kind of buildings are most often consisting of interconnected load-bearing masonry walls and flexible horizontal structures with wooden beam elements. The damage to this type of structures during earthquakes most often occurs due to uneven distribution of seismic forces due to flexible floor structures, inappropriate or non-existent interconnections of elements, and poor contact with the roof and floor structure [1]. Postearthquake survey of buildings in Zagreb showed that the most common damage to this kind of masonry buildings in the city center is associated with local damage to the roof (Figure 1.b.), collapse of attic chimneys (Figure 1.a), and partial or complete collapse of gable attic walls (Figure 1.c) [2].

Figure 1. a) Collapse of chimneys; b) roof damage; c) collapse of attic gable wall [2]

In addition to the damage of the gable walls and roof, the damage to the walls due to exceedance of in-plane bearing capacity in its own plane is also observed. It manifested as diagonal cracks in the partitional and load-bearing walls, and as cracks of the lintels. The cracks were also evidenced along the connections of perpendicular walls that can seriously endanger structural integrity by making walls susceptible to the out-of-plane failure.

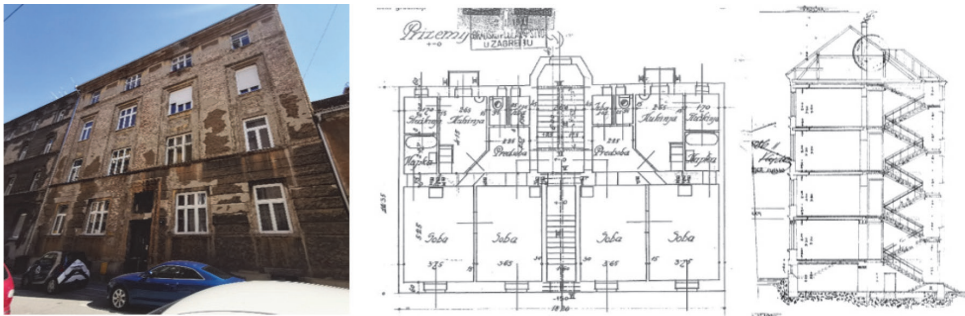
The case-study unreinforced masonry building is built 1911 and it is located in the center of Zagreb. The building is built in block (Figure 4.a). The building has a basement, 4 storeys and the attic. The plan dimensions are 18,20 x 11,35 m (Figure 4.b) and the building height is 17,5 m. The structural system consists of interconnected solid brick walls and floor system are timber joists except for the basement where it consists of concrete slab with steel girders. The load-bearing walls are made of solid brick of the old format (290 × 140 × 65 mm) that are 75, 60, 45 and 30 cm thick. The thickness of the walls narrows with the height of the building. The layout of the walls and the structural system are classic for this period of construction. The post-earthquake survey showed that cracks are mostly present on the non-structural elements, parapets, partition walls, and lintels. Severe damage suffered chimneys and the west gable wall that partially collapsed (Figure 5.a). During inspection, the cracks were observed along the connection of façade wall with floors and perpendicular wall which indicated out-of-plane displacement of the façade wall (Figure 5.c).

Figure 4. a) Case-study building in Mrazoviceva Street; b) Archive architectural drawings

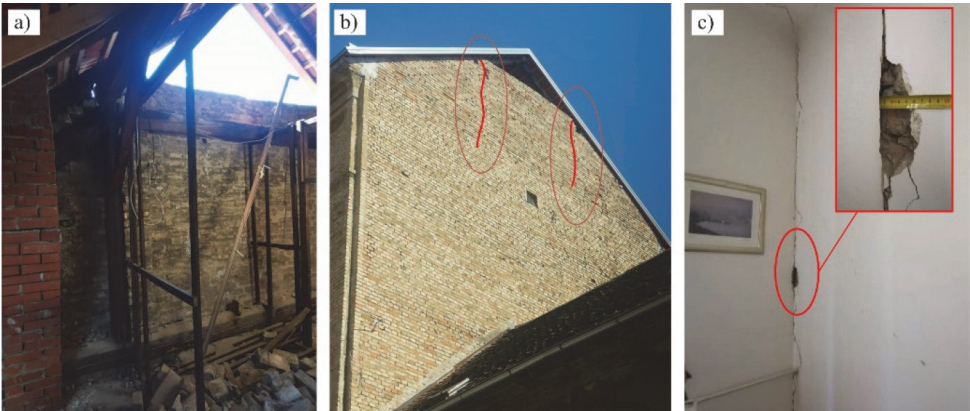
Figure 5. a) Gable wall inside the attic; b) Crack patterns of gable wall; c) Cracks on the connection of facade wall and perpendicular wall

For mechanism 1, only 17 % of the linear model demand and 20 % of the nonlinear model demand is fulfilled. This wall, however, only partially collapsed in the earthquake in March 2020. The model used in the analysis assumes complete separation of the wall from the rest of the structure, but it can be seen from the photographs on Figure 5. a) and b) that in the thirds of the length the wall was thickened with an additional layer of bricks, that certainly helped to prevent complete separation. It should be noted that cracks exist in these parts of wall that are visible from the outside (Figure 5.b). We also emphasize here that the main direction of the earthquake that happened, was approximately parallel to the gable wall plane, which certainly influenced the maximum value of the acceleration that affected this wall. The same wall was analysed in mechanism 2 where it includes the part of the wall on the storey below the attic. In the linear model, there is the fulfilment of 12 % of the demand, while the displacement capacity demand is fulfilled with 47 %. For this wall the connections with perpendicular walls is not completely impaired, so there are some reserves in terms of friction force that is present at the junction of the walls that was not considered in the analysis. The results of street façade wall considered in mechanism 3 showed that the wall should have been most likely activated during earthquake since linear model had fulfilment of 30 %. However, in the nonlinear model, the model had almost complete fulfilment of the demand that was 98 %. This wall, unlike the gable wall, was exposed to a greater acceleration values when considering the main direction of the earthquake. The façade wall on the courtyard side, mechanism 4, have satisfied requirement of the linear model so it was concluded that it was not activated in earthquake, therefore, the nonlinear model was not considered.

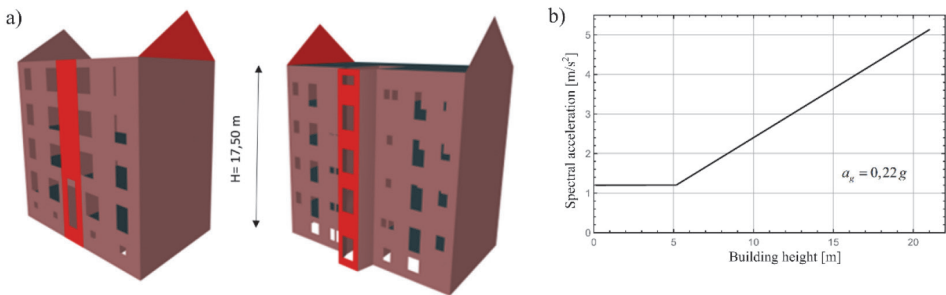
Figure 6.a) shows a three-dimensional view of selected walls that are analysed. All walls were modelled as single rigid block since there is no strengthening elements in the levels of floors that could lead two body motion. For all mechanisms, the plan of virtual displacement is determined for the unit value of control node displacement. This point is also used as control point in the nonlinear analysis. Detail numerical model of the build-

Figure 6. a) 3D view of the analyzed mechanism; b) Acceleration level requirement

This paper showed a case-study of out-of-plane seismic behaviour of unreinforced masonry walls by different methods of local analysis. The linear analysis proved to be more conservative than the nonlinear analysis. It was showed that all considered walls except the façade wall on the courtyard side can be activated due to peak ground acceleration of $0,22g$. The gable wall that partially collapsed in the earthquake is the most vulnerable to out-of-plane failure that was confirmed by linear and nonlinear procedure.

Out-of-plane wall failure is the primary analysis when considering unreinforced masonry buildings, especially when it comes to the buildings that are damaged in an earthquake. If the verifications done by linear or nonlinear procedure is not fulfilled the results of the global structural response become unreliable. Although most of technical guidelines, including Croatian regulations, does not require these verifications, so the engineers must take into account the structural retrofitting measures which prevent the activation of local mechanisms and ensure a global structural response during earthquakes.
