Source / Izvornik: **1st Croatian Conference on Earthquake Engineering 1CroCEE, 2021, 655 - 660**

## Damage assessment after the Zagreb earthquake – the case study of the educational building

Luka Lulić<sup>1</sup>, Tvrtko Renić<sup>2</sup>, Michele Škofić<sup>3</sup>, Ivan Hafner<sup>4</sup>, Tomislav Kišiček<sup>5</sup>, Mislav Stepinac<sup>6</sup>

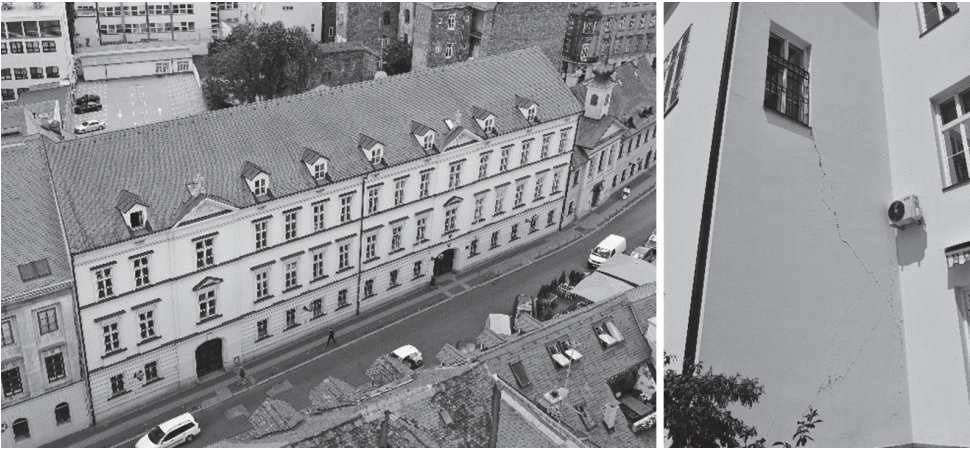
Masonry buildings account for a big part of housing in Croatia [3]. Hence, initial assessments are essential to inform the tenants about their damaged homes' usability and safety. The rapid assessments began only a few hours after the main earthquake. Damage classification in rapid assessments was made in accordance with the modified EMS-98 scale [4]. The educational building shown in Fig.2 and Fig.3 is an old unreinforced masonry building located in the old town of Zagreb. Its floor heights range from 3.2 to 4 m, and wall thicknesses range from 28 to 70 cm. It was one of the structures assessed by the ARES project team. In the initial assessment, it was classified as temporary unusable due to observed damage. A detailed inspection was required - the building has moderate damage without likely collapse. The load-bearing capacity is partially impaired, and it was not recommended to stay in the building. After some time, a more detailed evaluation was done, and the building's damage and possible behavior were analyzed.

**Figure 2. Educational building and damage by the earthquake**

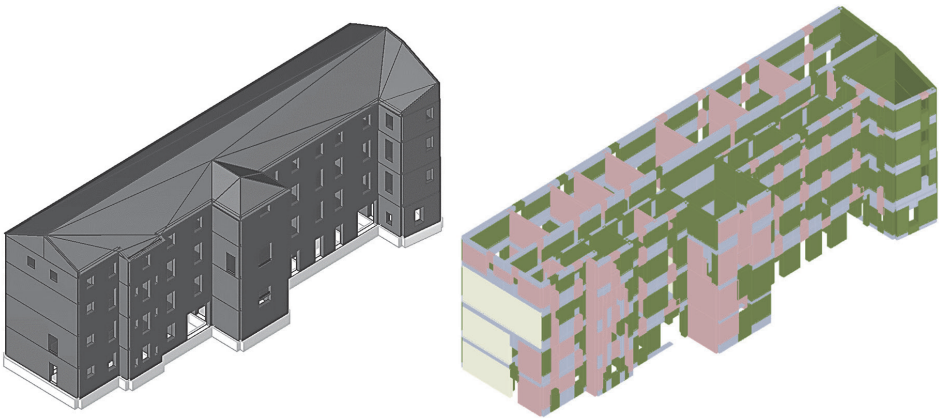
As shown in Fig.4, the numerical model was made in software 3muri, which uses the equivalent frame method and non-linear static (pushover) analysis to characterize the building's seismic response through a capacity curve. Non-linear static (pushover) analysis combines constant gravity loads with monotonically increasing horizontal loads. Two different horizontal load distribution patterns along the height of the building are used. Modal distribution follows the first mode shape for each direction obtained from

**Figure 4. Numerical model and the basic results from the 3muri software**

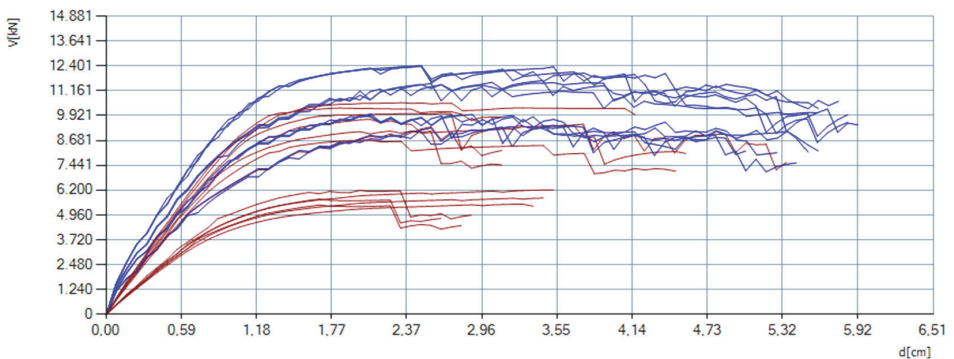
The results are as expected, where the building's behavior is in accordance with wall distribution. The obtained capacity curves can be seen in Fig.5, and target displacement determination is graphically explained in Fig.6.

**Figure 5. Capacity curves for x-direction (blue) and y-direction (red)**

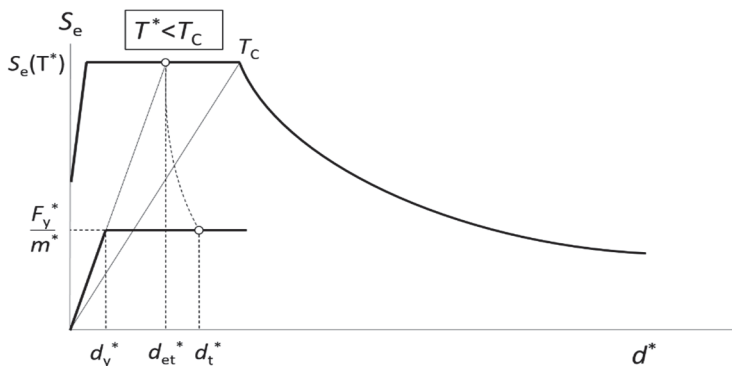
**Figure 6. Target displacement determination for short periods**

Real damage also corresponds with the damage distribution previewed in 3muri. Comparison between displacement capacity and the displacement demand shows us that modern, more demanding regulations (i.e. Eurocode 8 standard) are not satisfied. Hence, the next logical step after assessing the building's behavior in an earthquake is its strengthening. In repairing and rebuilding this building and the city itself, principles of build back better should be adopted, e.g. using sustainable materials and innovative concepts [7, 8, 9] or ensuring energy efficiency [10].

Contemporary materials such as FRP and TRM are among the most compatible strengthening options for masonry and cultural heritage, which is advised not to be strengthened with irreversible and invasive methods such as concrete jacketing. An insightful comparison between different design codes for masonry strengthening with FRP and TRM is discussed and showed in an example in [11].
