POST-EARTHQUAKE ASSESSMENT AND DOCUMENTATION OF TIMBER ROOFS

ABSTRACT: In 2020 Croatia was struck by two strong earthquakes. Croatian building stock is in big part made of masonry with timber floor and roof structures. Given that masonry structures are highly vulnerable to seismic actions, damage occurred to more than 70.000 buildings. Due to widespread damage, there is a great need for a detailed and more comprehensive post-earthquake damage assessment. This paper briefly presents the post-earthquake damage assessment in the historic parts of Zagreb and the surrounding area after the recent earthquakes in 2020. Special focus is set on traditional timber roofs – traditional roof systems in Croatia, damages to the load-bearing elements due to earthquake excitations, maintenance issues, wrong renovation of the attics, etc. Also, the role of UAVs, photogrammetry and laser scanners in the assessment and preservation of heritage buildings is shown.

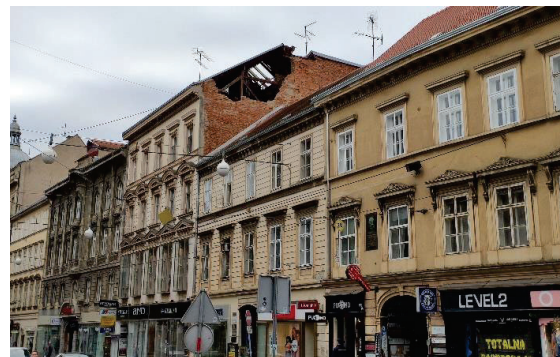
The failure of non-structural elements such as chimneys and decorative elements on facades was observed on almost all buildings in the city center. Failure of gable walls, masonry columns, wall sections between or under windows, vaults, ceilings, staircases, etc. was common. Since the two materials (timber and masonry) have very different properties and masses, the post-earthquake damage was also very different. The two most typical masonry damages, due to the "pushing" of timber elements and the poor connection with masonry walls, are shown in Figures 3 & 4.

Figure 4: Failure of gable walls (photo credit: M. Stepinac)

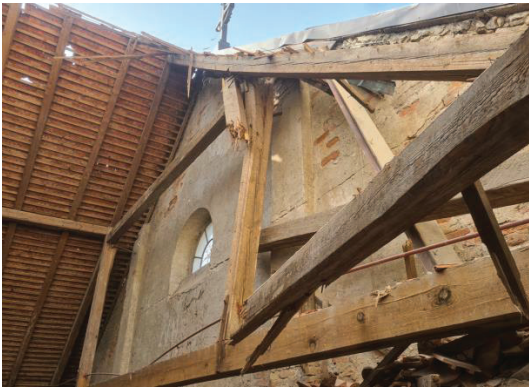
Roof systems often become unstable due to the collapse of individual load-bearing walls beneath them or severe chimney failures (Figure 5 & 6). Post-earthquake inspections showed that many of the chimney failures resulted in direct damage to the roofs. In some locations, the chimneys damaged the supporting roof structure, but in most cases only the rafters broke and the integrity of the roof was maintained (Figures 7 and 8).

Figure 6: Timber roof collapse – Sisak cathedral (photo credit: Studio Arhing d.o.o.)

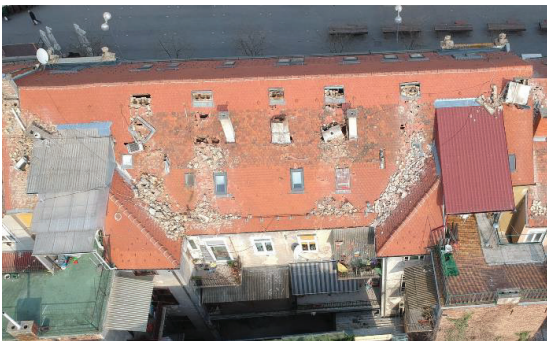
Figure 7: Failure of chimneys (from outside) (photo credit: M. Stepinac)

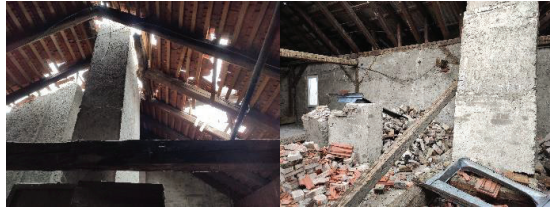
Figure 8: Failure of chimneys (from inside) (photo credit: M. Stepinac)

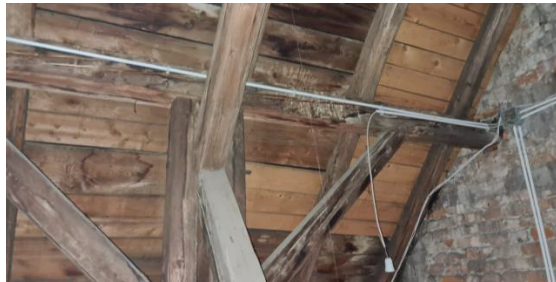
Maintenance was identified as one of the most important aspects that contributed to the condition of buildings after the earthquake. Since a large number of buildings were poorly maintained or not maintained at all, the properties of the masonry deteriorated over the years, and the seismic performance of such buildings was worse [5]. In many cases, water penetration degraded the properties of both masonry and wood elements (Figure 9).

Figure 9: Failure of timber elements due to water leakage and seismic excitations (photo credit: Studio Arhing d.o.o.)

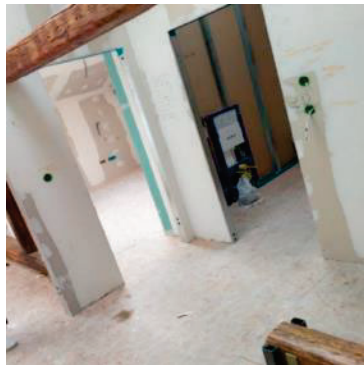
Typical conversions of building spaces convert non-living spaces (e.g., basements, attics, or utility rooms). This room conversion often involved demolition of partition walls, and undesirable intervention in the load-bearing walls is also common. The conversion of the attic for living purposes resulted in numerous changes to the roof structure. Often timber tie elements were cut to insert the door (Figure 11), which significantly changed the basic static system of the roof structure itself. Also, traditional timber structural systems were replaced by masonry or concrete elements as shown in Figure 12.

Figure 11: Improper attic modifications (photo credit: HCPI [4])

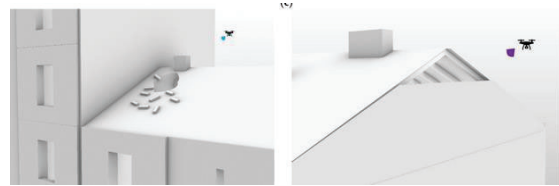
Unmanned aerial vehicles (UAV) have proven very useful during the rapid assessment of roofs, as well as detecting defects/damage in hard-to-reach places. Figure 13 shows a post-earthquake assessment scenario using a UAV. An engineer cannot see what has happened on the higher floors or on the roof of a building during an on-site assessment from the street. With a UAV device the above information can be easily assessed.

Figure 13: Possible damage on the roof level of a building after an earthquake [16]
