POST-EARTHQUAKE ASSESSMENT AND DOCUMENTATION OF TIMBER ROOFS

Mislav Stepinac¹, David Andić², Juraj Pojatina³

ABSTRACT: In 2020 Croatia was struck by two strong earthquakes. Croatian building stock is in big part made of masonry with timber floor and roof structures. Given that masonry structures are highly vulnerable to seismic actions, damage occurred to more than 70.000 buildings. Due to widespread damage, there is a great need for a detailed and more comprehensive post-earthquake damage assessment. This paper briefly presents the post-earthquake damage assessment in the historic parts of Zagreb and the surrounding area after the recent earthquakes in 2020. Special focus is set on traditional timber roofs – traditional roof systems in Croatia, damages to the load-bearing elements due to earthquake excitations, maintenance issues, wrong renovation of the attics, etc. Also, the role of UAVs, photogrammetry and laser scanners in the assessment and preservation of heritage buildings is shown.

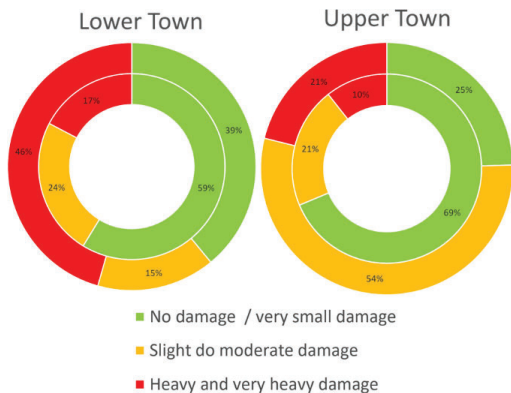
The damage methodology for the roof elements and structure was divided into five damage levels: no damage, very minor damage, moderate damage, significant damage, severe damage. Figure 2 shows the extent of damage to roofing and wooden roof structures in the historic districts of Zagreb. In Donji Grad (Lower Town), the buildings are larger in plan than in Gornji Grad (Upper Town); therefore, the structural systems are also different. In the Upper Town, single-family houses and villas predominate, while in the Lower Town, multi-family houses with mostly 7 to 9 housing units are the most common buildings. According to the engineers' decision, the total number of severely damaged roofs was 274 in the Lower Town and 189 in the Upper Town. Damage to roofing was found on 598 buildings in the Lower Town and 516 buildings in the Upper Town [4,13].

Figure 2: Statistical data about damage to roofs (inner circle: damaged roof systems, outer circle: damaged roof coverings)

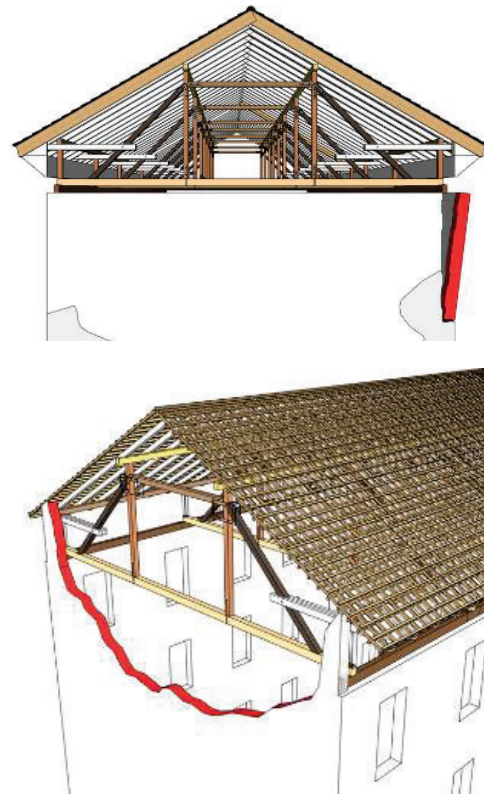
The failure of non-structural elements such as chimneys and decorative elements on facades was observed on almost all buildings in the city center. Failure of gable walls, masonry columns, wall sections between or under windows, vaults, ceilings, staircases, etc. was common. Since the two materials (timber and masonry) have very different properties and masses, the post-earthquake damage was also very different. The two most typical masonry damages, due to the "pushing" of timber elements and the poor connection with masonry walls, are shown in Figures 3 & 4.

Figure 3: Typical damages to masonry walls

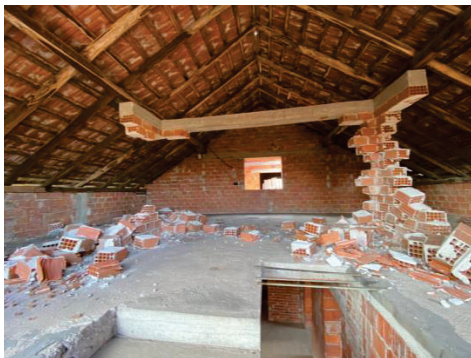
Typical conversions of building spaces convert non-living spaces (e.g., basements, attics, or utility rooms). This room conversion often involved demolition of partition walls, and undesirable intervention in the load-bearing walls is also common. The conversion of the attic for living purposes resulted in numerous changes to the roof structure. Often timber tie elements were cut to insert the door (Figure 11), which significantly changed the basic static system of the roof structure itself. Also, traditional timber structural systems were replaced by masonry or concrete elements as shown in Figure 12.

Figure 12: Improper attic modifications (photo credit: HCPI [4])
