Assessment and Rehabilitation of Culturally Protected Prince Rudolf Infantry Barracks in Zagreb after Major Earthquake

Abstract: Recently, Zagreb was struck by a strong earthquake. Damage throughout the city was tremendous due to numerous aged and vulnerable masonry buildings. Many damaged buildings are under a certain level of cultural heritage protection. Hence, reliable assessment and effective rehabilitation are important to preserve cultural significance and mitigate risk for human life. With that in mind, the procedure of a detailed condition assessment of the building under heritage protection is presented. A detailed historical background of the case study building is shown, and observed damage and conducted in situ tests are discussed. The nonlinear static seismic analysis performed in the 3Muri software is extensively elaborated. Four different levels of reconstruction according to new Croatian law are briefly presented. Additionally, several strengthening scenarios are proposed with various strengthening techniques.

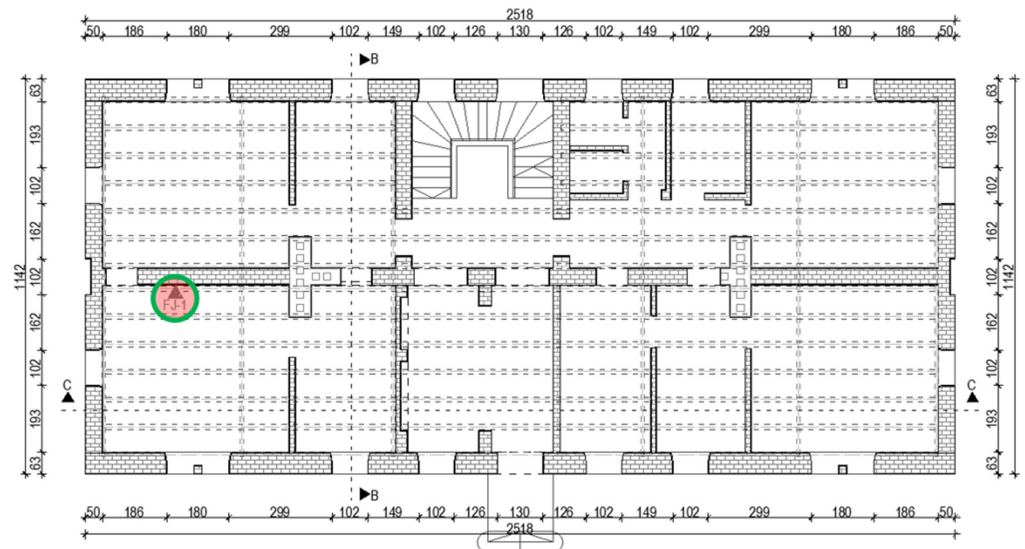
The flat-jack method determined the vertical stress, the modulus of elasticity and the masonry's shear strength. The test was conducted on the ground and first floors on the same wall (Figure 9).

Figure 9. Ground floor plan with a marked test site.

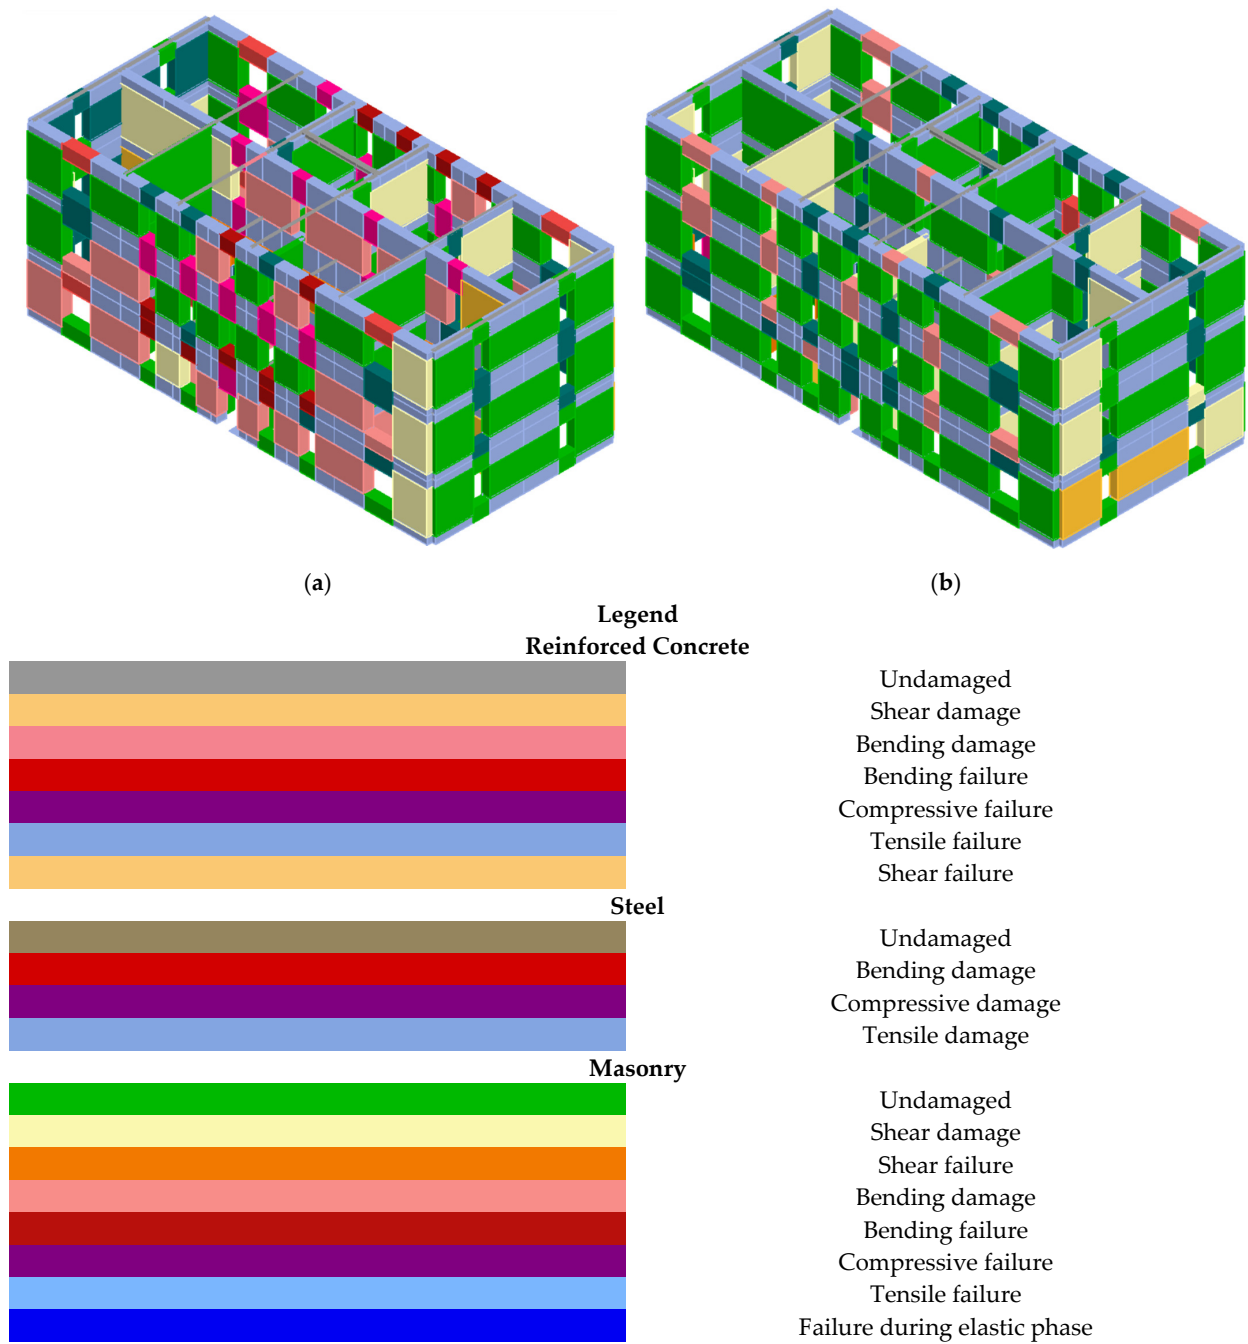
The pushover analysis was performed for all three distributions of lateral load without random eccentricity. Finally, the capacity/demand ratio obtained according to the simplified calculations and the values of the safety indices for critical analyses obtained using the 3Muri software were compared, as shown in Table 5. According to the regulation, the safety index is the ratio of peak ground acceleration for which the structure reaches a certain limit state, i.e., capacity and peak ground acceleration (PGA), i.e., demand. PGA for a return period of 95 years was used, and it has a value of 0.13 g. The limit state of significant damage (SD) was observed.

Figure 18. Three-dimensional (3D) model with damage for the near-collapse limit state: (a) *x*-direction; (b) *y*-direction.

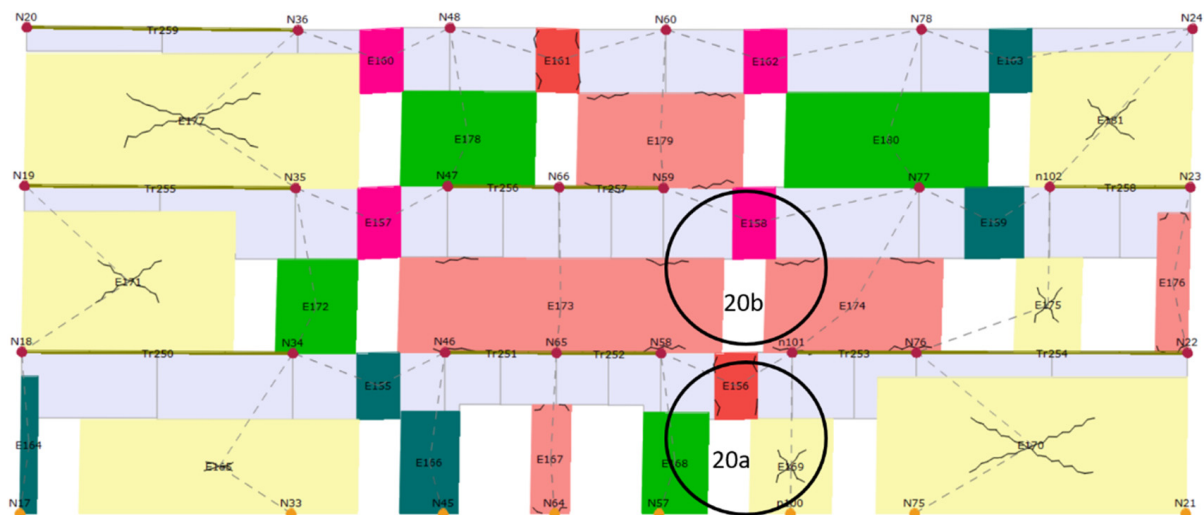
To compare the actual damage and the damage obtained using the 3Muri software, a uniform lateral load distribution was selected. It is assumed that the peak ground acceleration of the earthquake in Zagreb in 2020 was about 0.18 g. The results of damage are shown in Figure 19, with locations of real damage shown in Figure 20a,b.

Figure 19. Damage to the central wall in the x -direction (3Muri).

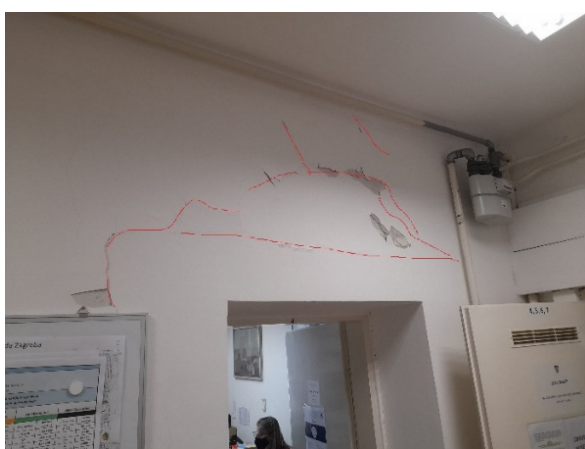
(a) Ground floor damage

Figure 20a shows the actual damage to the right part of the load-bearing wall on the ground floor corresponding to the shear damage. Figure 20b shows the actual damage to the middle part of the load-bearing wall on the first floor, which corresponds to the damage due to bending. Similar damage is detected in height in the building itself, and damage corresponds to the model.

Figure 20. Damage to the central wall in the x -direction.

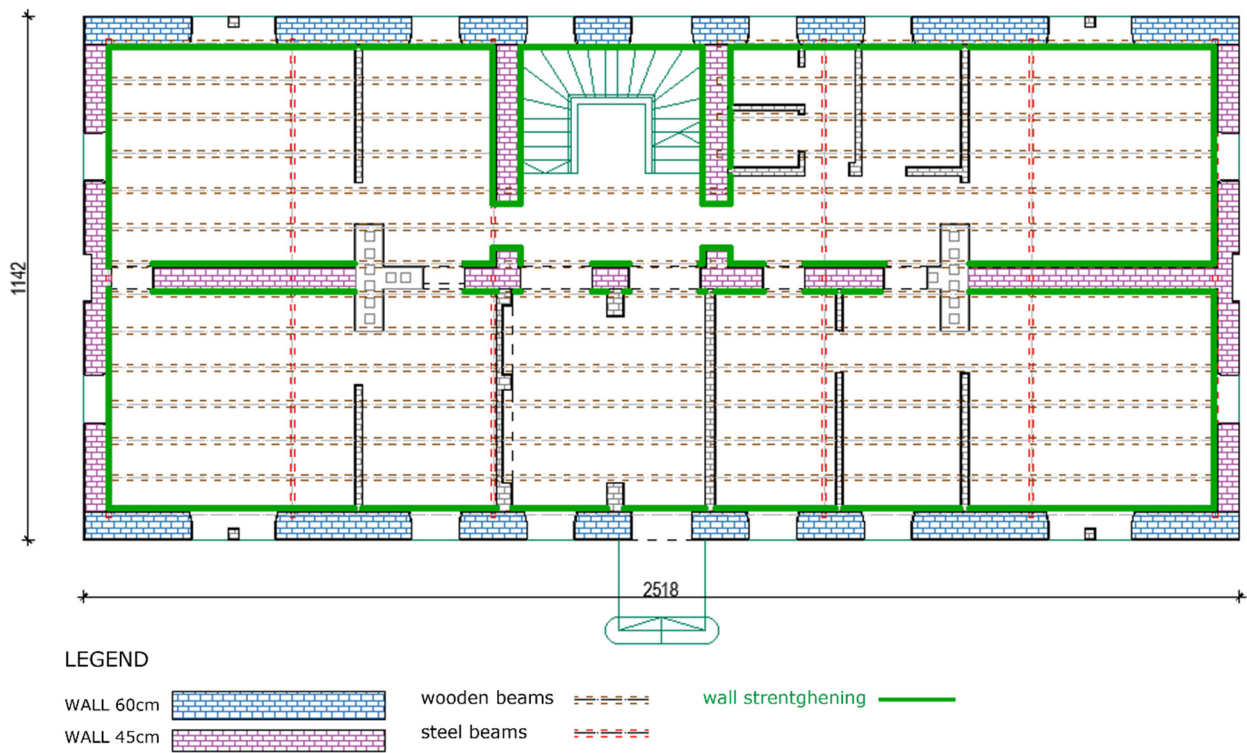
Figure 21. Proposal for reinforcement of load-bearing walls.

As a measure of repair and reinforcement of the walls of the building, it is recommended to reinforce load-bearing walls by, e.g., FRCM system or concrete jacketing. Figure 21 shows a proposal for reinforcing load-bearing walls. To obtain good resistance in the transverse direction (y -direction), it is proposed to add new load-bearing walls with a minimum thickness of 38 cm. In addition, it is proposed to remove the brick partition walls and replace them with a drywall system. Figures 22 and 23 show a proposal for the position of the new load-bearing walls and a proposal for the removal and replacement of partition walls.

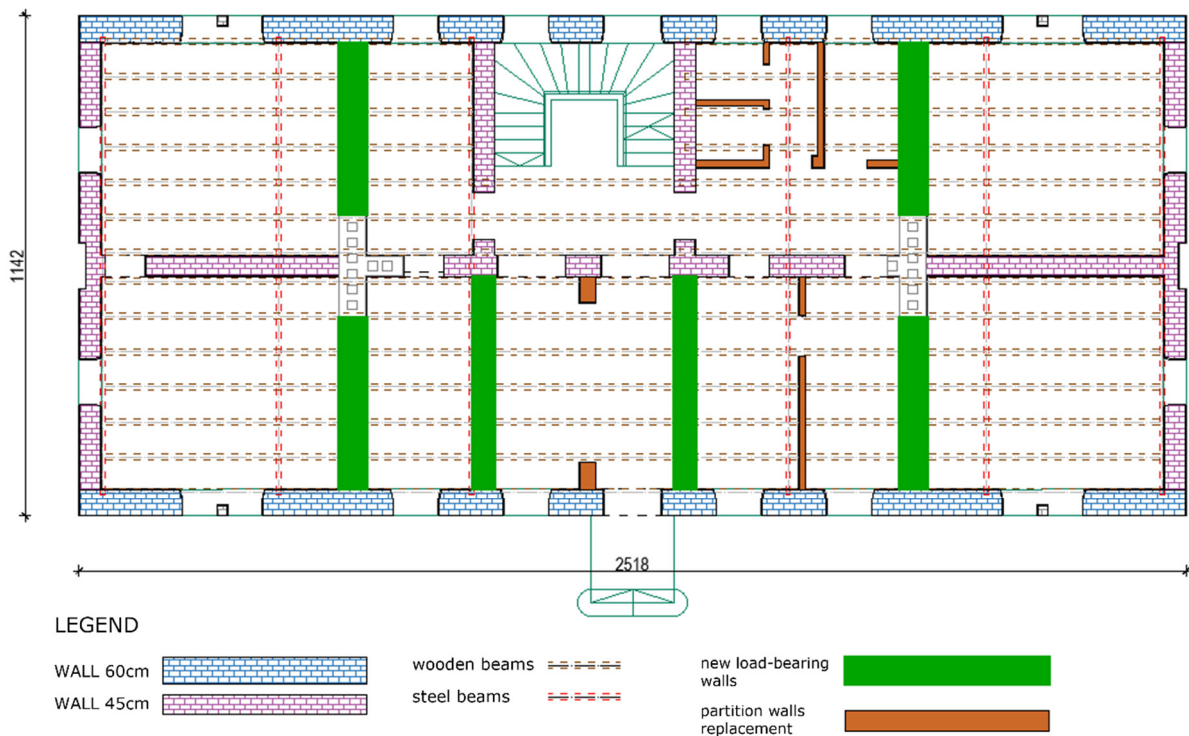
Figure 22. Proposal for the position of the new load-bearing walls and proposal for the removal and replacement of partition walls.

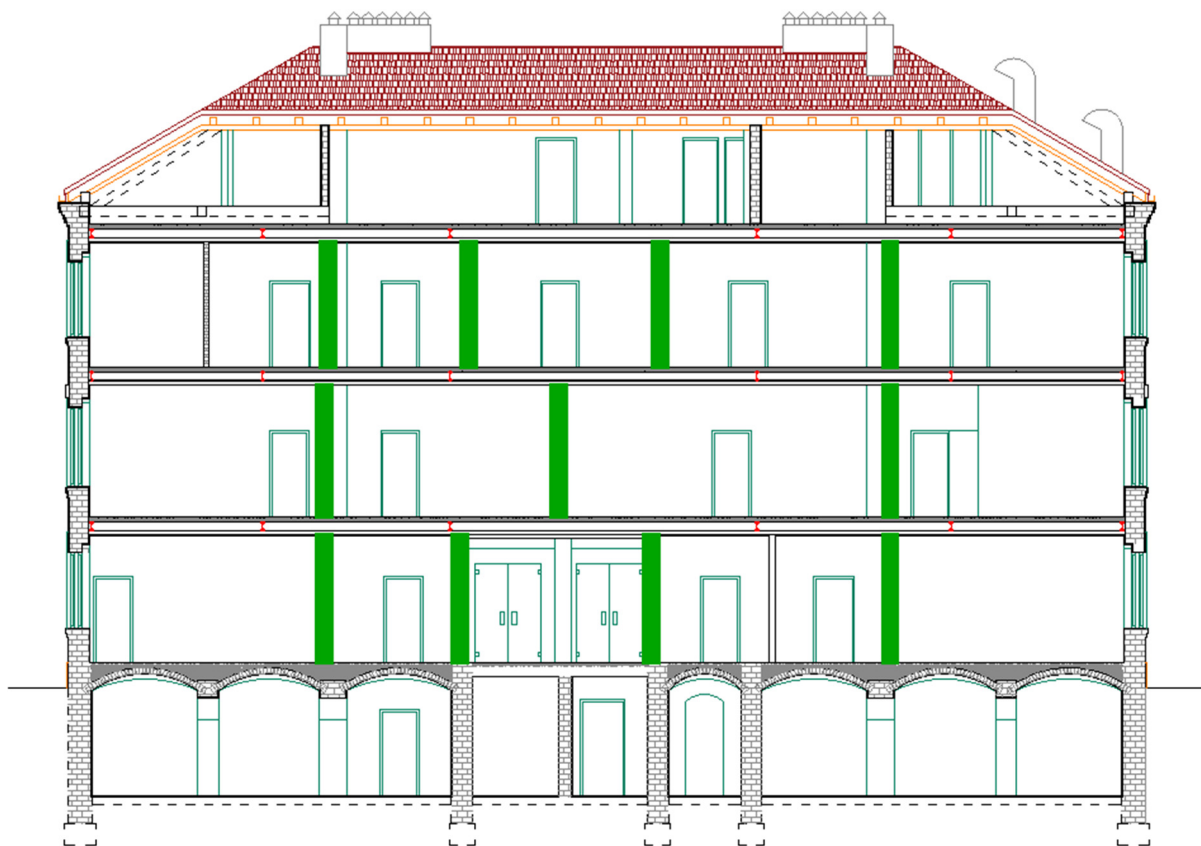
Figure 23. Proposal for the position of the new load-bearing walls and proposal for the removal and replacement of partition walls (cross-section).
