Assessment and Rehabilitation of Culturally Protected Prince Rudolf Infantry Barracks in Zagreb after Major Earthquake

This paper presents the procedure of a detailed inspection of a building under cultural heritage protection. The case study building was damaged in the earthquake and needs to be renovated according to new laws in Croatia to ensure the safe and functional future use of the building.

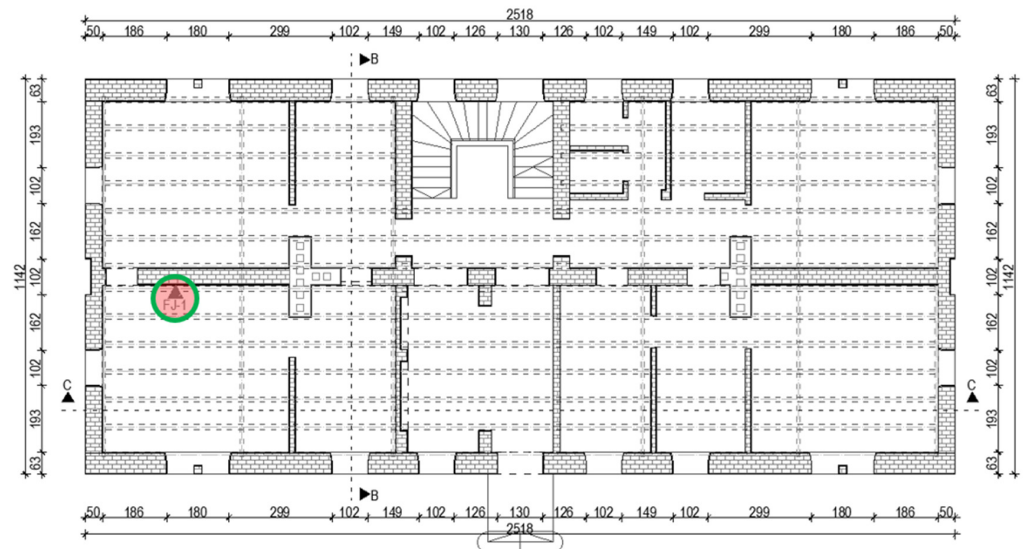
The flat-jack method determined the vertical stress, the modulus of elasticity and the masonry's shear strength. The test was conducted on the ground and first floors on the same wall (Figure 9).

Figure 9. Ground floor plan with a marked test site.

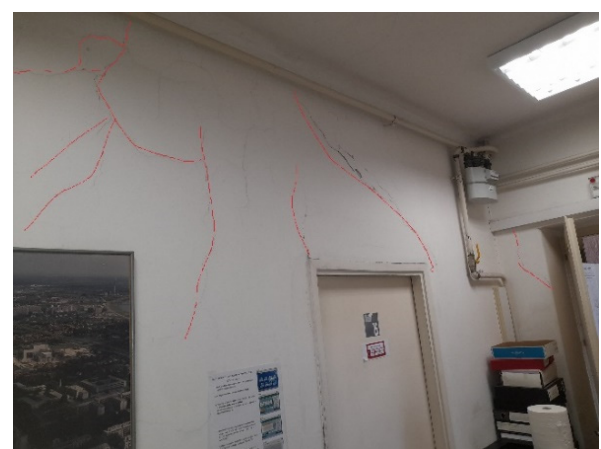
Figure 20a shows the actual damage to the right part of the load-bearing wall on the ground floor corresponding to the shear damage. Figure 20b shows the actual damage to the middle part of the load-bearing wall on the first floor, which corresponds to the damage due to bending. Similar damage is detected in height in the building itself, and damage corresponds to the model.

(b) First floor damage
