Assessment and Rehabilitation of Culturally Protected Prince Rudolf Infantry Barracks in Zagreb after Major Earthquake

Abstract: Recently, Zagreb was struck by a strong earthquake. Damage throughout the city was tremendous due to numerous aged and vulnerable masonry buildings. Many damaged buildings are under a certain level of cultural heritage protection. Hence, reliable assessment and effective rehabilitation are important to preserve cultural significance and mitigate risk for human life. With that in mind, the procedure of a detailed condition assessment of the building under heritage protection is presented. A detailed historical background of the case study building is shown, and observed damage and conducted in situ tests are discussed. The nonlinear static seismic analysis performed in the 3Muri software is extensively elaborated. Four different levels of reconstruction according to new Croatian law are briefly presented. Additionally, several strengthening scenarios are proposed with various strengthening techniques.

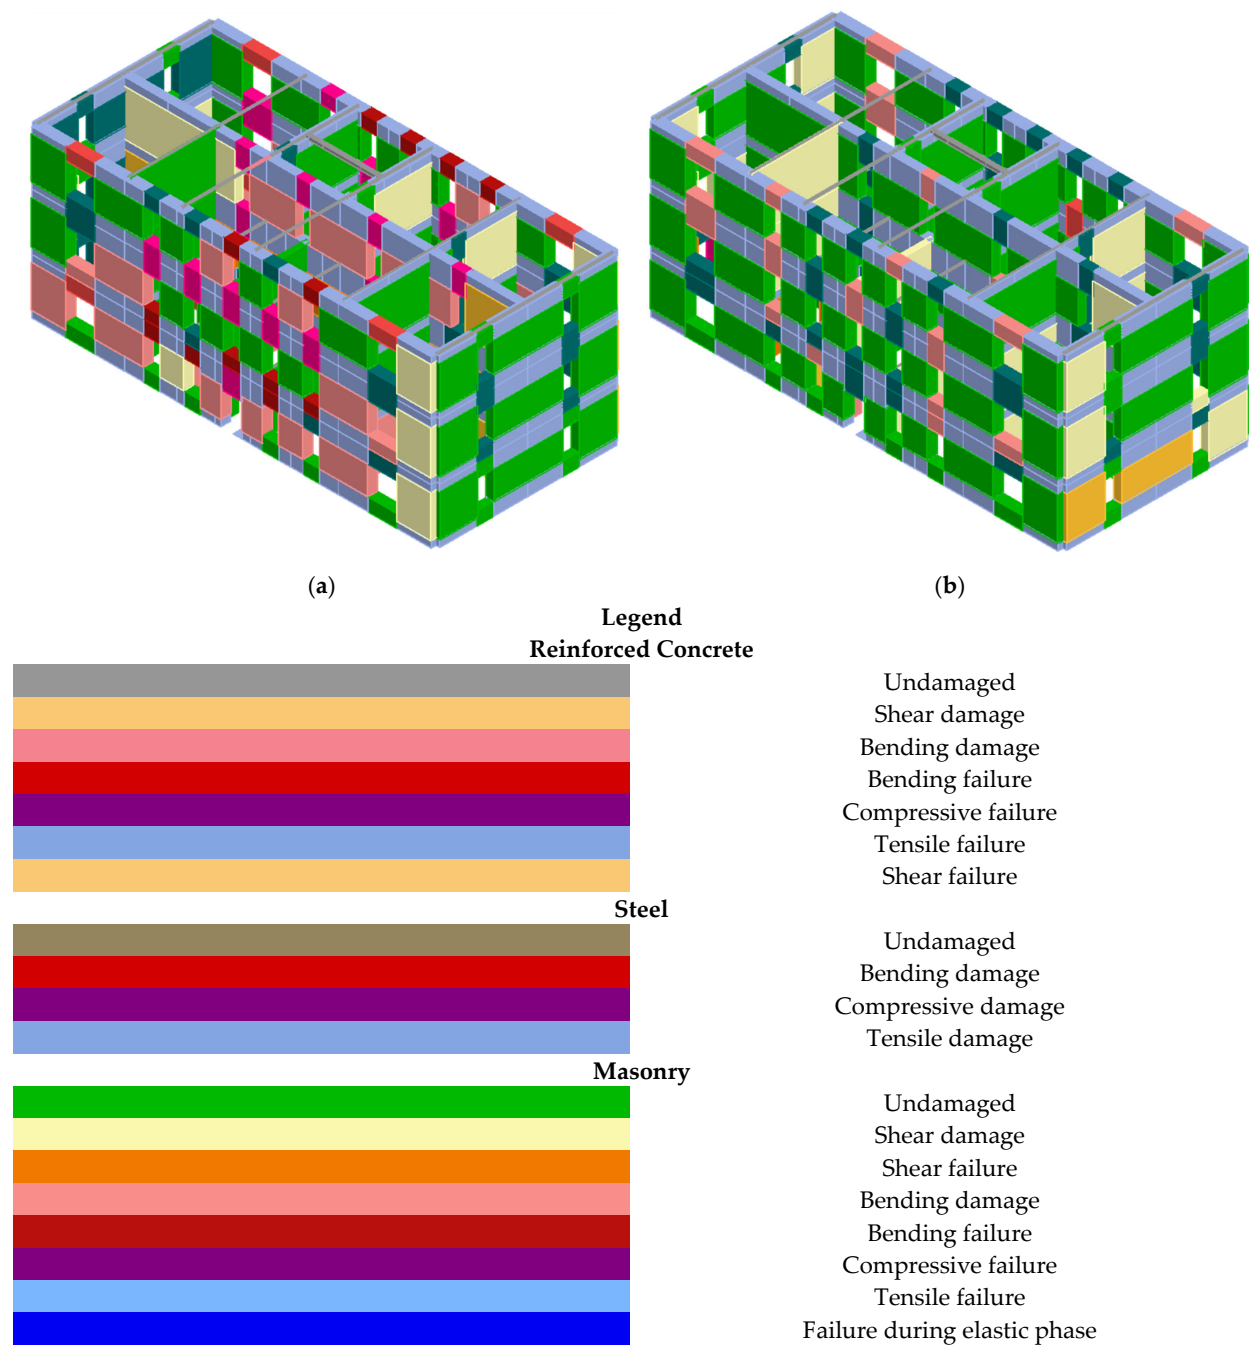
The pushover analysis was performed for all three distributions of lateral load without random eccentricity. Finally, the capacity/demand ratio obtained according to the simplified calculations and the values of the safety indices for critical analyses obtained using the 3Muri software were compared, as shown in Table 5. According to the regulation, the safety index is the ratio of peak ground acceleration for which the structure reaches a certain limit state, i.e., capacity and peak ground acceleration (PGA), i.e., demand. PGA for a return period of 95 years was used, and it has a value of 0.13 g. The limit state of significant damage (SD) was observed.

Figure 18. Three-dimensional (3D) model with damage for the near-collapse limit state: (a) x-direction; (b) y-direction.

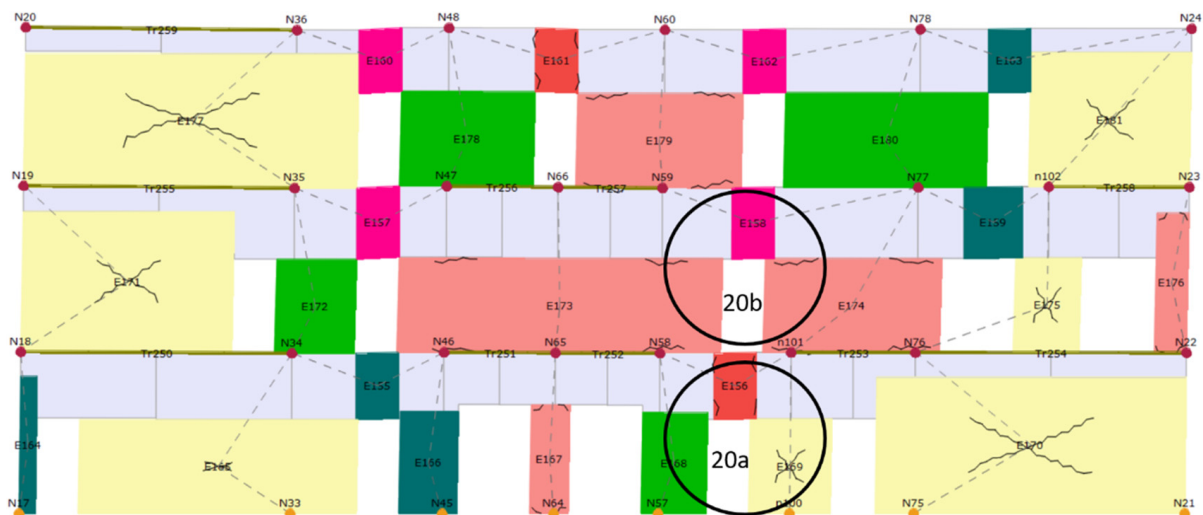
To compare the actual damage and the damage obtained using the 3Muri software, a uniform lateral load distribution was selected. It is assumed that the peak ground acceleration of the earthquake in Zagreb in 2020 was about 0.18 g. The results of damage are shown in Figure 19, with locations of real damage shown in Figure 20a,b.

Figure 19. Damage to the central wall in the x -direction (3Muri).

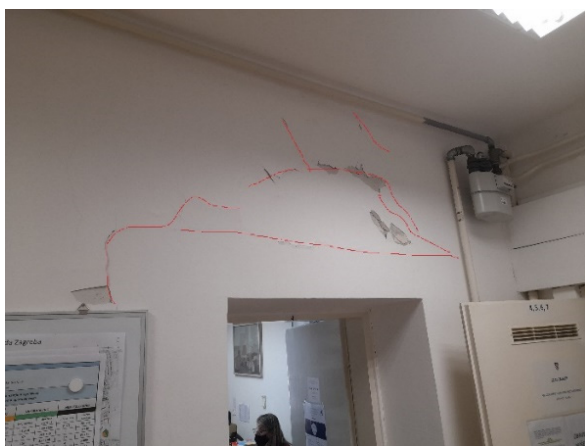
(a) Ground floor damage

Figure 20a shows the actual damage to the right part of the load-bearing wall on the ground floor corresponding to the shear damage. Figure 20b shows the actual damage to the middle part of the load-bearing wall on the first floor, which corresponds to the damage due to bending. Similar damage is detected in height in the building itself, and damage corresponds to the model.
