Assessment and Rehabilitation of Culturally Protected Prince Rudolf Infantry Barracks in Zagreb after Major Earthquake

This paper presents the procedure of a detailed inspection of a building under cultural heritage protection. The case study building was damaged in the earthquake and needs to be renovated according to new laws in Croatia to ensure the safe and functional future use of the building.

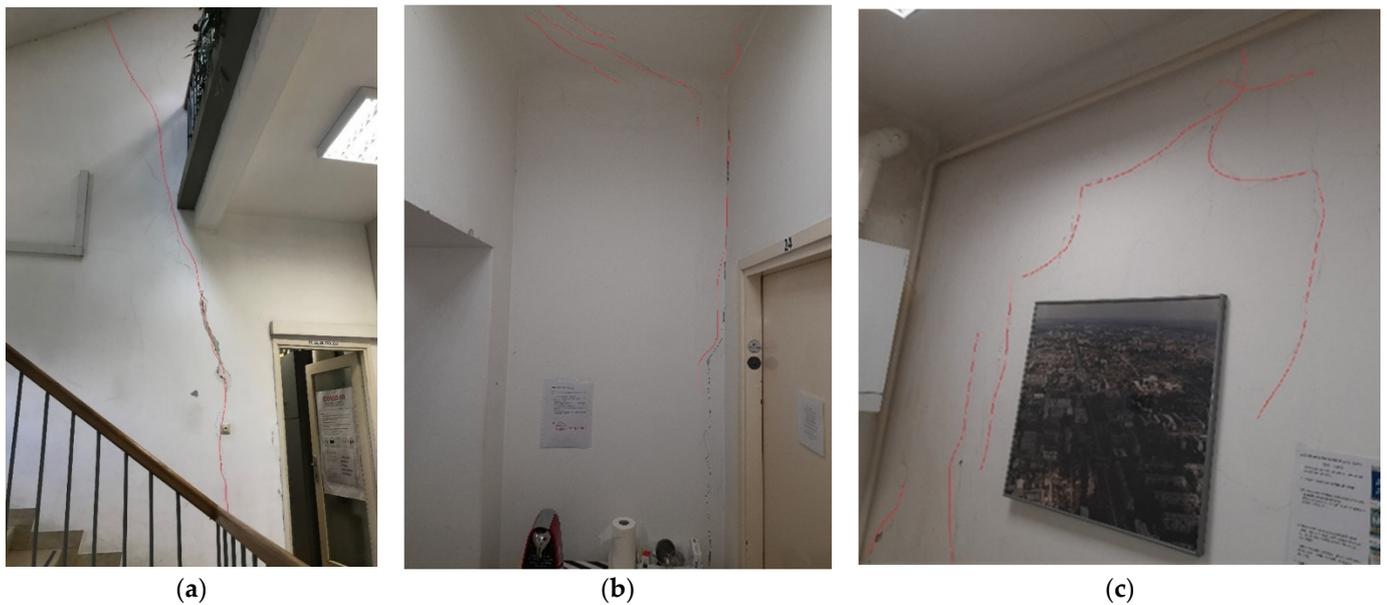
The building was inspected after the earthquake on 22 March, 2020. It was assigned the usability mark PN2. The mark PN2 refers to buildings with moderate damage without risk of collapse, but the usability is questionable due to the potential risk of collapse of some elements. The following damage was found:

- On the ground floor, small cracks were noticed at the places of the lintel and at the connections of the walls and ceiling. Lintels are weakened parts of the masonry walls and are therefore vulnerable since the damage is usually concentrated in them.

- On the first floor, major damage was noticed at the connection of partition and load-bearing walls and at the connection of walls and ceilings. Observed damage is not surprising because at the partition and load-bearing wall connections and wall and ceiling connections, there is a discontinuity of material and contact of different materials that have different behavior, and thus, there are different displacements that cause cracking. Often, such cracks do not pose a significant hazard.

- The original staircase has not been preserved, and the existing staircase has minor damage that does not indicate a threat to mechanical resistance and stability.

Some of the damaged elements are shown in Figure 8.

Figure 8. (a) Damage to the stair system; (b) Damage at the connections of load-bearing and partition walls; (c) Slight damage to the load-bearing walls.

This inspection established conservation guidelines for the repair of load-bearing and partition walls, staircases and floor structures. The façade and roof design should be preserved along, with the reparation of existing damage after conducting detailed conservation and restoration research. In addition, this paper analyzed retrofitting strategy as one of the methods to preserve the “outer look” of the building.

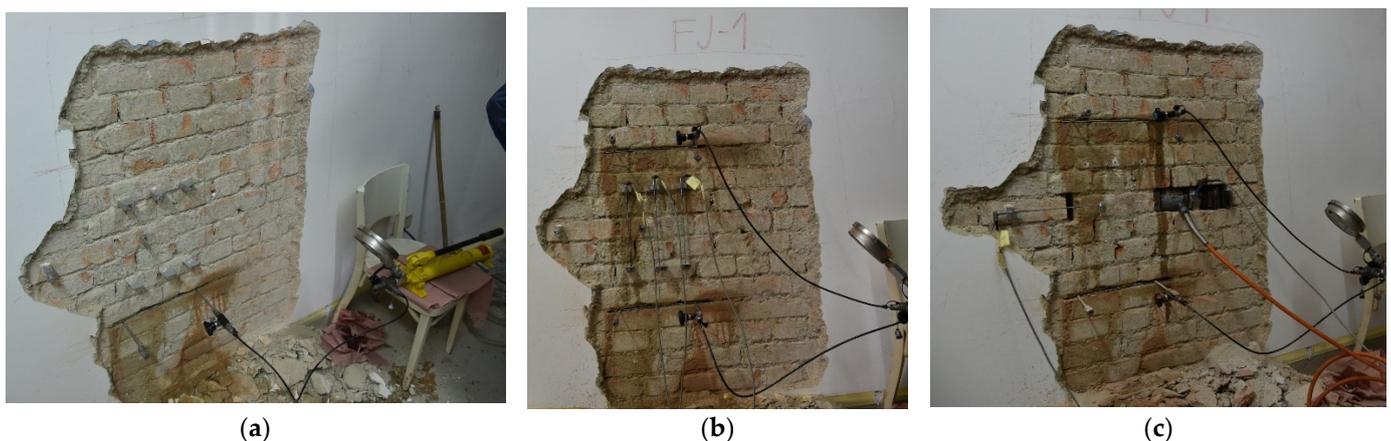
According to the tests (Figure 10), the following values were obtained: compressive stress state in masonry at test location $\sigma_0 = 0.46 \text{ N/mm}^2$ (used for model calibration regarding weight distribution), modulus of elasticity $E = 1469.5 \text{ N/mm}^2$ (used for wall stiffness definition), initial shear strength $f_{v0} = 0.323 \text{ N/mm}^2$ (used for wall shear resistance definition) and coefficient of friction $\mu = 0.447$.

Figure 10. (a) Connected hydraulic system and flat jack; (b) Determination of stress and deformation dependence of masonry; (c) Testing of shear strength of masonry with control of vertical stress by flat jacks. (photo credit: Luka Lulić).

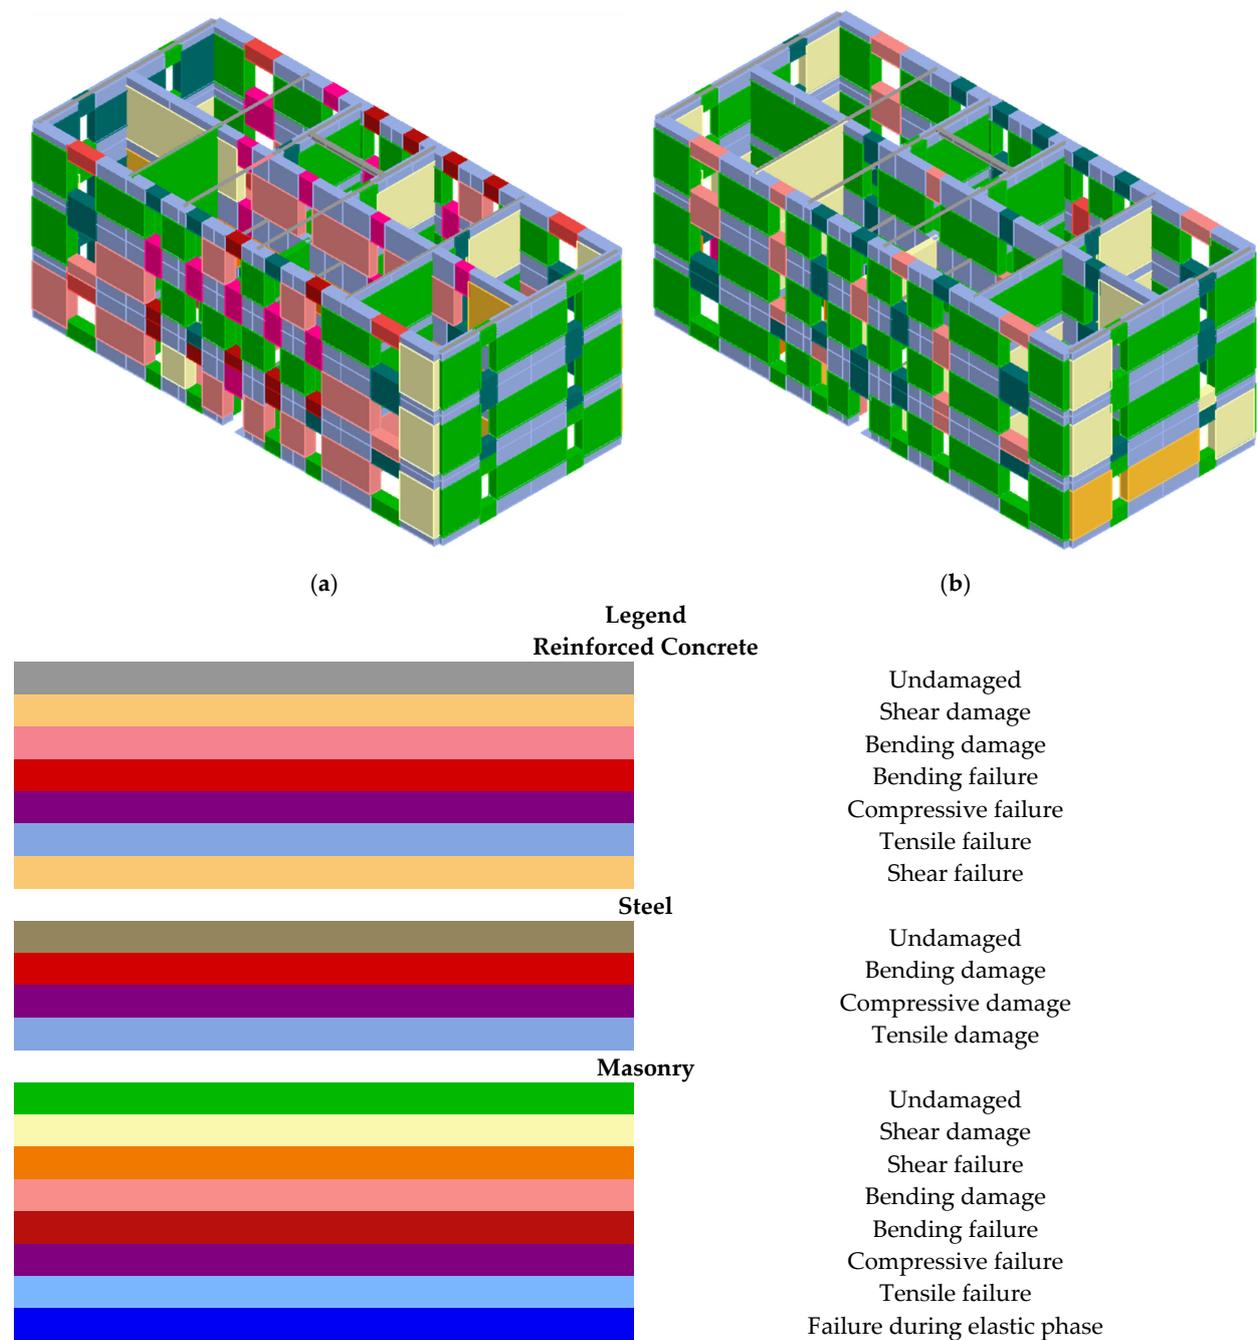
The pushover analysis was performed for all three distributions of lateral load without random eccentricity. Finally, the capacity/demand ratio obtained according to the simplified calculations and the values of the safety indices for critical analyses obtained using the 3Muri software were compared, as shown in Table 5. According to the regulation, the safety index is the ratio of peak ground acceleration for which the structure reaches a certain limit state, i.e., capacity and peak ground acceleration (PGA), i.e., demand. PGA for a return period of 95 years was used, and it has a value of 0.13 g. The limit state of significant damage (SD) was observed.

Figure 18. Three-dimensional (3D) model with damage for the near-collapse limit state: (a) x -direction; (b) y -direction.

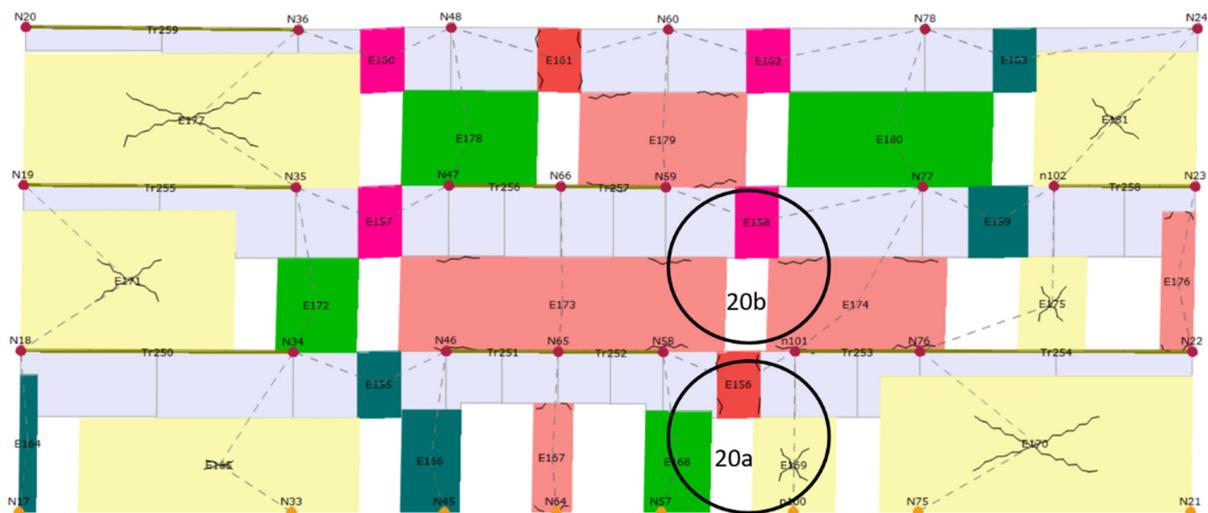
To compare the actual damage and the damage obtained using the 3Muri software, a uniform lateral load distribution was selected. It is assumed that the peak ground acceleration of the earthquake in Zagreb in 2020 was about 0.18 g. The results of damage are shown in Figure 19, with locations of real damage shown in Figure 20a,b.

Figure 19. Damage to the central wall in the x -direction (3Muri).

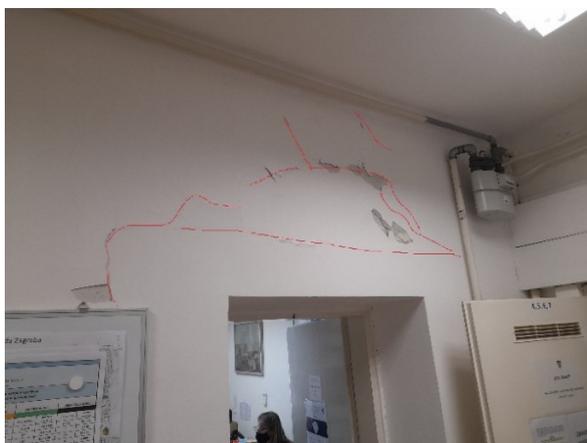
(a) Ground floor damage

Figure 20a shows the actual damage to the right part of the load-bearing wall on the ground floor corresponding to the shear damage. Figure 20b shows the actual damage to the middle part of the load-bearing wall on the first floor, which corresponds to the damage due to bending. Similar damage is detected in height in the building itself, and damage corresponds to the model.
