Post-Earthquake Rapid Damage Assessment of Road Bridges in Glina County

Abstract: In December 2020, a strong earthquake occurred in Northwestern Croatia with a magnitude of $M_L = 6.3$. The epicenter of this earthquake was located in the town of Petrinja, about 50 km from Zagreb, and caused severe structural damage throughout Sisak-Moslavina county. One of the biggest problems after this earthquake was the structural condition of the bridges, especially since most of them had to be used immediately for demolition, rescue, and the transport of mobile housing units in the affected areas. Teams of civil engineers were quickly formed to assess the damage and structural viability of these bridges and take necessary actions to make them operational again. This paper presents the results of the rapid post-earthquake assessment for a total of eight bridges, all located in or around the city of Glina. For the assessment, a visual inspection was performed according to a previously established methodology. Although most of the inspected bridges were found to be deteriorated due to old age and lack of maintenance, very few of them showed serious damage from the earthquake, with only one bridg

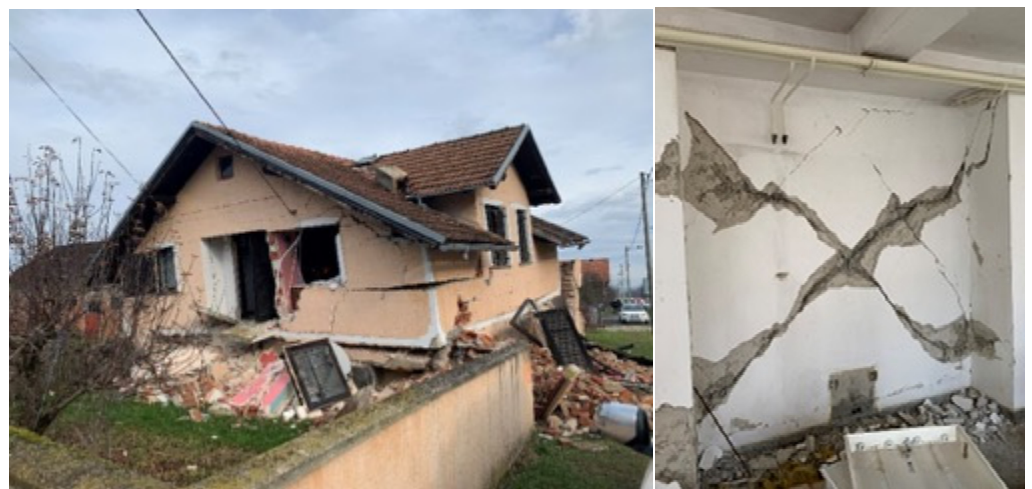
observed damage to the buildings, of which approximately 15% sustained severe damage or complete collapse (DG4 and DG5) (Figure 1), 20% sustained significant damage (DG3), and 65% sustained light-to-moderate damage (DG1 and DG2) [5]. These damage grades were assigned according to EMS98 [8,9]. The main earthquake ($M_L = 6.2$) was preceded by two foreshocks ($M_L = 4.7$ and 5.2) and a series of aftershocks (up to $M_L = 4.9$). A strong foreshock helped save lives, as many critical buildings had been evacuated before the main earthquake struck and caused them to collapse. Many significant aftershocks that occurred over the next month (though noticeable earthquakes of up to $M_L \approx 3$ are still recorded weekly even now, a year after the main earthquake) caused subsequent damage to already damaged structures, making it difficult to classify the extent of damage and demanding the reassessment of already examined structures. In contrast to the Zagreb earthquake (March 2020), the Petrinja earthquake (December 2020) showed significant damage to linear infrastructure and underlying soil (such as landslides, liquefaction, suffusion, and sinkholes) that occurred during or as a result of the earthquake over the next few months. Significant damage occurred to structures crossing the activated faults of the fault system, evident on roads, bridges, pipelines, and river embankments. Examinations of the road damage revealed dextral co-seismic strike-slip cracks and displacements [6]. The clearest evidence of an active Petrinja fault was the presence of cracks on the Brest Bridge on the Kupa River, which was under tension along the fault line [6]. Galdovo Bridge over the Sava River in Sisak showed a 10 cm abutment bearing displacement as a consequence of a still-unknown N–S fault line [6]. There was also damage to the pipelines and river embankments of the Kupa and Sava rivers. More than 90 sinkholes occurred within a radius of about 10 km without prior warning of ground deformation. Many of them had a radius of 25 m and a depth of 12 m and endangered the surrounding buildings and infrastructure [7]. Some of them are still active and make any reconstruction work impossible. After the Petrinja earthquake, structural engineers from all over the country were called upon by the Civil Protection Agency to assess the extent of the structural damage, safety, and restrictions on use, as well as to work in collaboration with emergency rescue and demolition services to mitigate the consequences of the disaster. Assessments were prioritized based on the extent of damage and the importance of the structures. Thus, health and infrastructure structures were assessed first. The assessment of bridges was particularly important due to the need for their immediate use by rescue teams working with heavy machinery that needed to be quickly and safely moved. Moreover, due to cold and snowy winter weather, a humanitarian crisis occurred as people evacuated their destroyed or damaged homes and had to be temporarily housed.

Figure 1. DG4 and DG5 damage from the December 2020 earthquake in Sisak-Moslavina county.

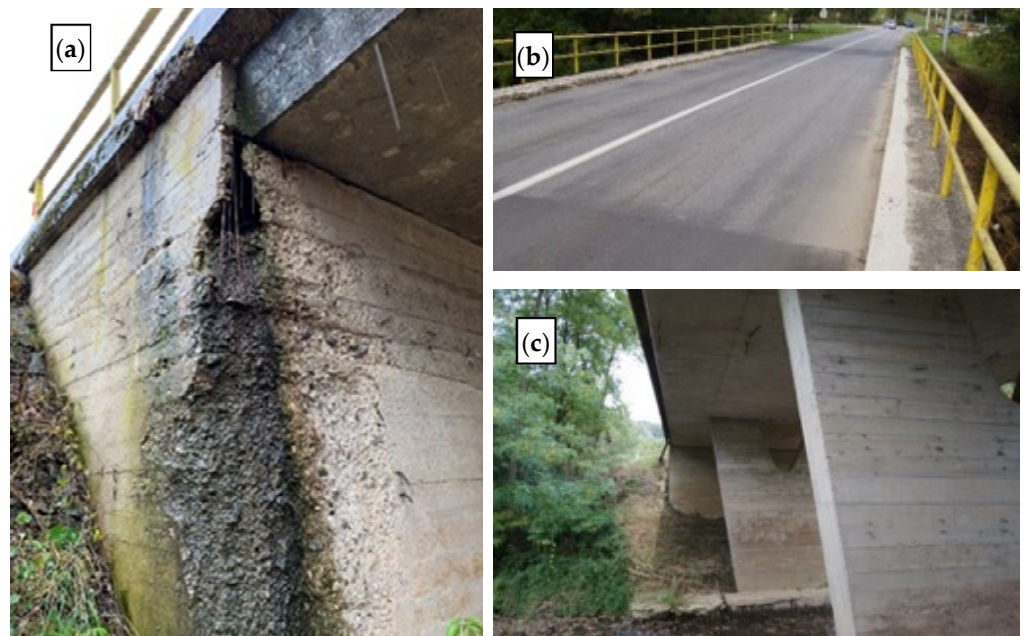
This bridge is located in the south access road to the town Glina (Figure 5). It is a reinforced concrete slab bridge with over three spans of 7.5 + 10 + 7.5 m (Figure 6). The superstructure comprises a 50 cm thick reinforced concrete slab that is directly supported by wide columns branching at the top. The width of the bridge is 8.5 m, columns are of variable cross-section between 3.2 × 0.5 m at the bottom and two branches (arms) at the top, each 1.5 × 0.5 m. The height of the columns is 5.7 m. The abutments are massive reinforced concrete structures with about 3–4 m high walls and 3.8 m long wings. Column foundations are 4.0 × 2.2 m slabs. There are no bearings present on the bridge and bridge is without any drainage elements. There was visible damage on the abutment walls, where the corner part of the side walls was found to be missing on both abutments, and reinforcement bars were protruding out of concrete (Figure 9a).

Figure 9. Roviška bridge: (a) damage to the abutment wall and wing, as well as drainage problems; (b) degraded footway (left) and new footway (right); (c) substructure without signs of earthquake damage.

Since the damaged parts of the wall showed heavy discolorations, traces of long-term water leakage, and algae sedimentations, it was evident that this damage was not caused by this earthquake. The quality of concrete in these fallen off parts of the abutment corners could be described as poor, exhibiting the local segregation of large fractions of aggregate and very low quantity of reinforcement. It is possible that this damage was a consequence of faults during erection since it resembled typical damage observed when improper concreting without vibration is performed. Since this damage was very localized and not in the main load transfer path, it was not considered serious at this stage of post-earthquake bridge evaluation. It did not compromise the load-bearing capacity of the abutment wall. One of the bridge footways and cornices were heavily degraded due to lack of waterproofing and reinforcement corrosion. The other footway had been rehabilitated in the past with a new concrete layer (Figure 9b).

Overall, the bridge was found to be in structurally good condition and showed no signs of damage due to the earthquake. There was no damage to the asphalt joint between the abutment and superstructure, and no displacements were recorded at the superstructure supports. Columns and abutments were without any major cracks, rotations, or settlements (Figure 9c). After the earthquake, the bridge was continued to be used for traffic without any restrictions. Further inspection and rehabilitation were recommended due to prior

abutment wall damage, visible reinforcement corrosion, and possible scour on foundation piers.

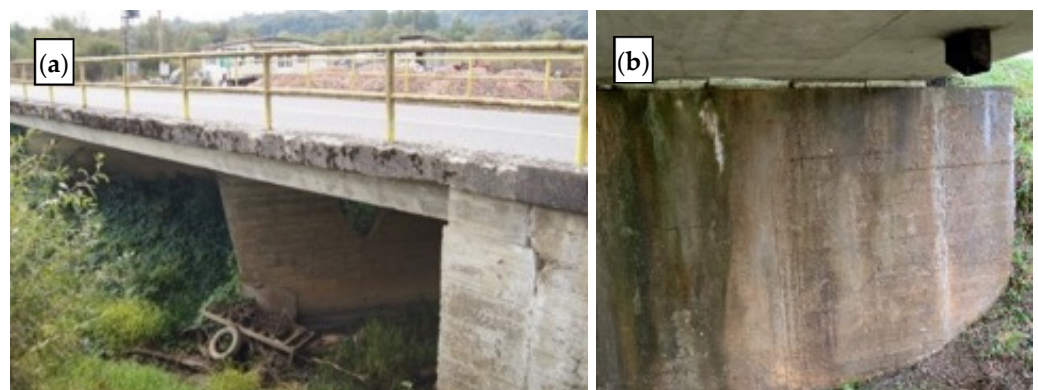
Maja bridge is located just south of previous Roviška bridge (Figure 5), and it is of similar type but smaller length. The bridge is also a continuous girder slab bridge with over two spans of 7.5 + 7.5 m (Figure 6). The slab girder is 35 cm thick and 7.7 m wide, with short consoles on both sides. The superstructure is skewed in regard to abutments, columns, and the riverbed (Figure 10a). Height of the columns and abutments is about 3.5 m. There were no bearings or expansion joints causing dilatation cracks in the asphalt. There was also a visible vertical dilatation crack between the abutment wall and wing, suggesting that they were not fixed together and moved separately. The superstructure concrete was seen to be in relatively good condition, without signs of progressive reinforcement corrosion or concrete spalling but with visible signs of discoloration due to water leakage. Although drainage was present on the bridge, gutters were clogged and caused water to seep through the concrete slab. The slab consoles (footways) were observed to be heavily degraded due to a lack of waterproofing and poor concrete quality. Abutment walls were exposed to water draining from above (Figure 10b). There was no visible damage due to the earthquake. No new cracks or movements of the substructure or superstructure elements were detected. No restrictions regarding traffic were given. Further inspection and maintenance were recommended due to the noticeable water leakage due to failed waterproofing and drainage.

Figure 10. Maja bridge: (a) side view of the bridge; (b) abutment wall.

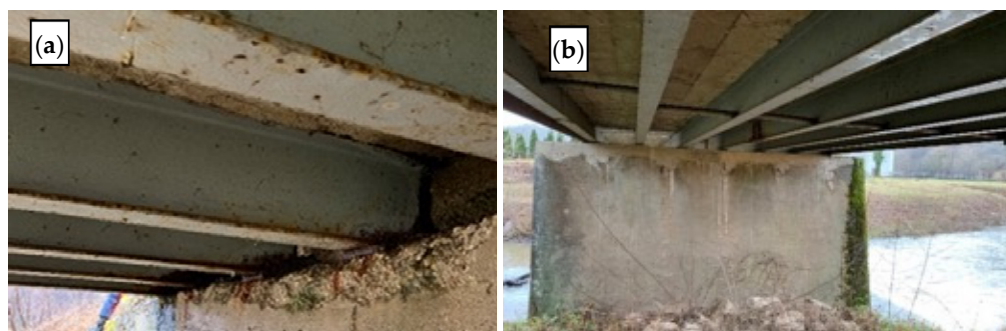
were visible in the asphalt at the end of the superstructure. The deck slab concrete was in good condition. The concrete columns showed signs of reinforcement corrosion, with protective layer only locally spalling. The main reason for this problem is heavy water leakage due to non-existent drainage and waterproofing. Since there was a dilatation in the superstructure above the central column, the water is draining through the asphalt directly onto the column. The spalling of concrete showed a different type of concrete underneath and occurred at the contact of these different materials, so it very likely that columns had undergone rehabilitation work in the past. There was no visible damage from the earthquake, either in permanent deformations or movements of the superstructure or substructure elements. Therefore, the bridge was maintained for operation without restrictions. Further inspection and maintenance were recommended due to steel girder corrosion and signs of column reinforcement corrosion.

Figure 11. Svračica bridge main girder support: (a) abutment; (b) column.

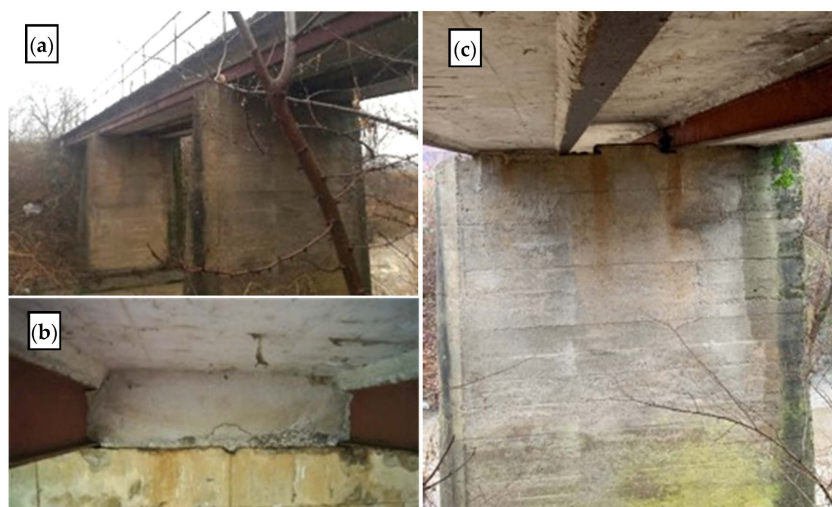
Figure 12. Nikola Tesla street bridge: (a) view of the bridge; (b) main girders to abutment support; (c) superstructure under view.

Abutment walls are 1.4 m high, and abutment wings are 2.9 m long. The bridge superstructure was found to be in a moderate-to-poor condition, with problems regarding structural steel corrosion and water leakage due to non-existent waterproofing and drainage. The asphalt layer was heavily worn out and almost completely missing in the footway area. The edges of superstructure consoles were missing a cornice, and reinforcement bars were protruding out of the concrete. Columns and abutments were found to be in fairly good condition, with no visible cracks or concrete spalling. Discoloration was visible due to water leakage from the superstructure onto columns, thus causing long-term damage to the column concrete and possibly reinforcement corrosion (Figure 12c). The bridge showed no signs of serious damage caused by the earthquake on the superstructure, substructure, or embankment slopes around abutments. Visible cracks were detected in the area of connection between the superstructure and abutment, where the superstructure is supported on the abutments, between the abutment wall and the cross girder (Figure 12b). Since this connection was not assumed as fixed in the statical system, it was expected that the opening of this crack occurred and was of no importance regarding bearing capacity. After inspection, the bridge was maintained for operation without restrictions. Further inspection and maintenance were recommended due to the poor state of the traffic surface (asphalt layer and footways), column reinforcement corrosion, failed waterproofing, and possible scour developing on column foundations.

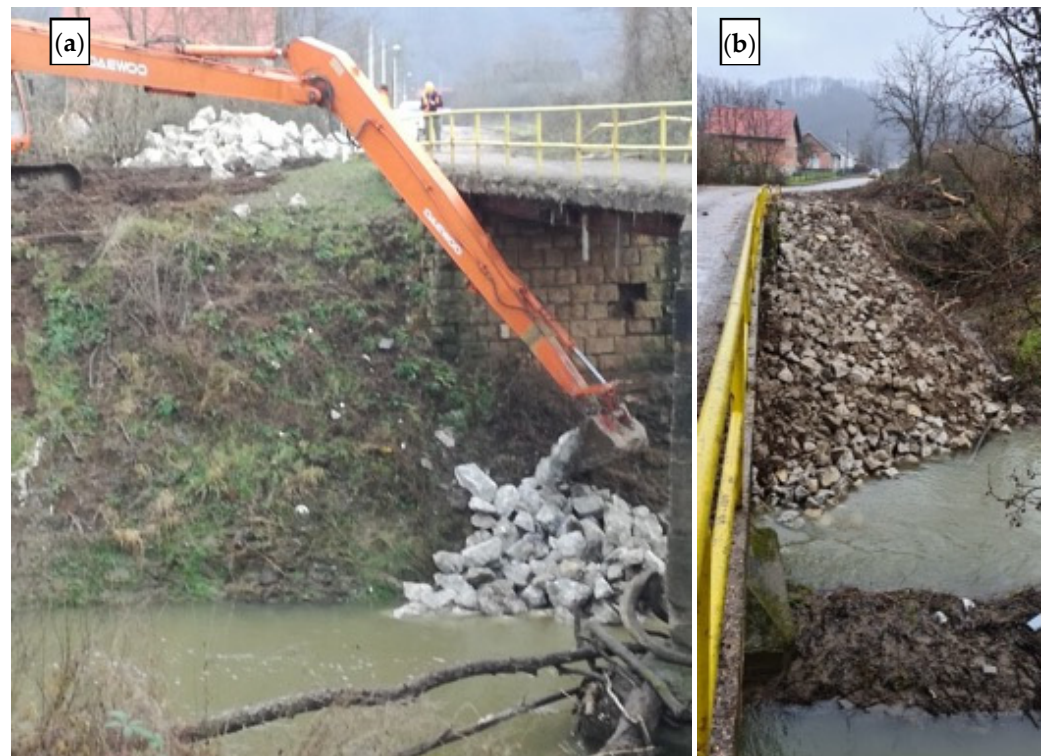
Figure 15. Immediate measures to secure the abutment of Matija Gubec street bridge: (a) beginning of the work; (b) completed infill.

Only one of the assessed bridges needed closure and immediate strengthening measures. As discussed in Section 4.2, Matija Gubec Street bridge leading to Majske Poljane showed signs of west abutment slippage and rotation, and its stability and integrity were compromised. Following the closure of the bridge for traffic, emergency measures were prescribed for the immediate strengthening of the abutment to prevent its total collapse. The immediate danger of collapse was even more emphasized due to heavy rains that followed in the days after the earthquake, which caused the water level to rise and further erode the west riverbank that had already shown scour signs under the abutment foundation. Additionally, multiple aftershocks threatened the unstable balance of the abutment wall. The decision was made to use large stone block material and to fill the slope of the riverbank up to the top of the abutment, around its wings, and as far as the middle columns in the riverbed (Figure 15a). The stone material needed to be of very large

fractions (from 50 to 100 cm) to prevent it from being washed away by the river flow. The abutment foundation, wall, and wings were enveloped by this stone infill, thus preventing the further erosion of the soil and acting as a support for the abutment (Figure 15b). The whole work was performed over just two days in hard working conditions due to soaked soil from continuous rains. The measure was proven to be effective since it stopped the further movement of the abutment. Nevertheless, the bridge was closed for traffic as a precautionary measure until it was to be evaluated further and permanent solutions were found.
